Rail Accident Investigation Branch

Rail Accident Report

Fatal accident near David Lane tram stop 15 August 2016

Report 06/2017
April 2017

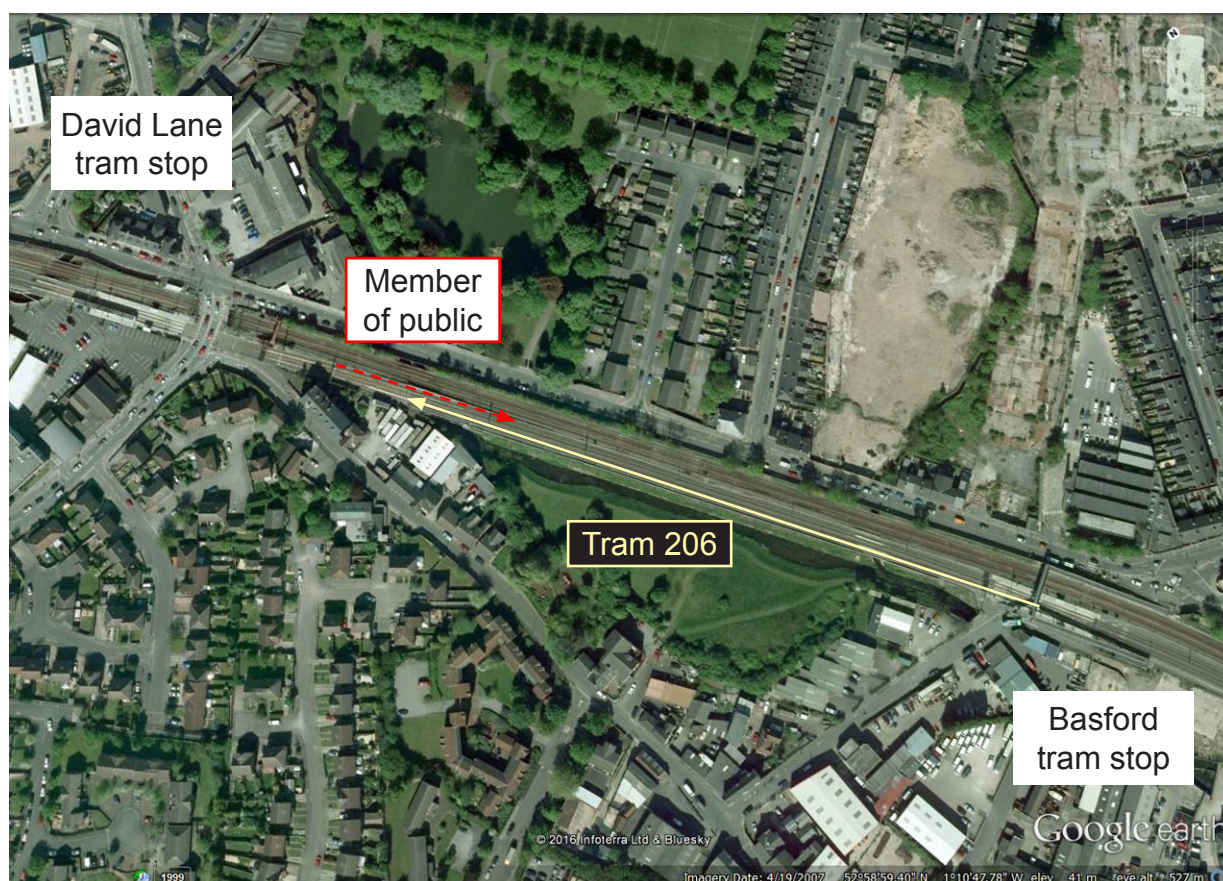
Figure 7: Passage of tram 206 at 22:48 hrs

- 19 The next tram through the area between the tram stops was tram 206 heading northbound from Basford to David Lane tram stop (figure 7). Soon after departing from Basford tram stop, the driver identified that there was a person on the adjacent line ahead of his tram. He proceeded cautiously at a reduced speed and passed the member of the public. At 22:48:18 hrs, the driver of tram 206 called the control room³ and spoke to SDS3 to report encountering a person walking southbound on the southbound track a 'couple of hundred metres' from David Lane tram stop.

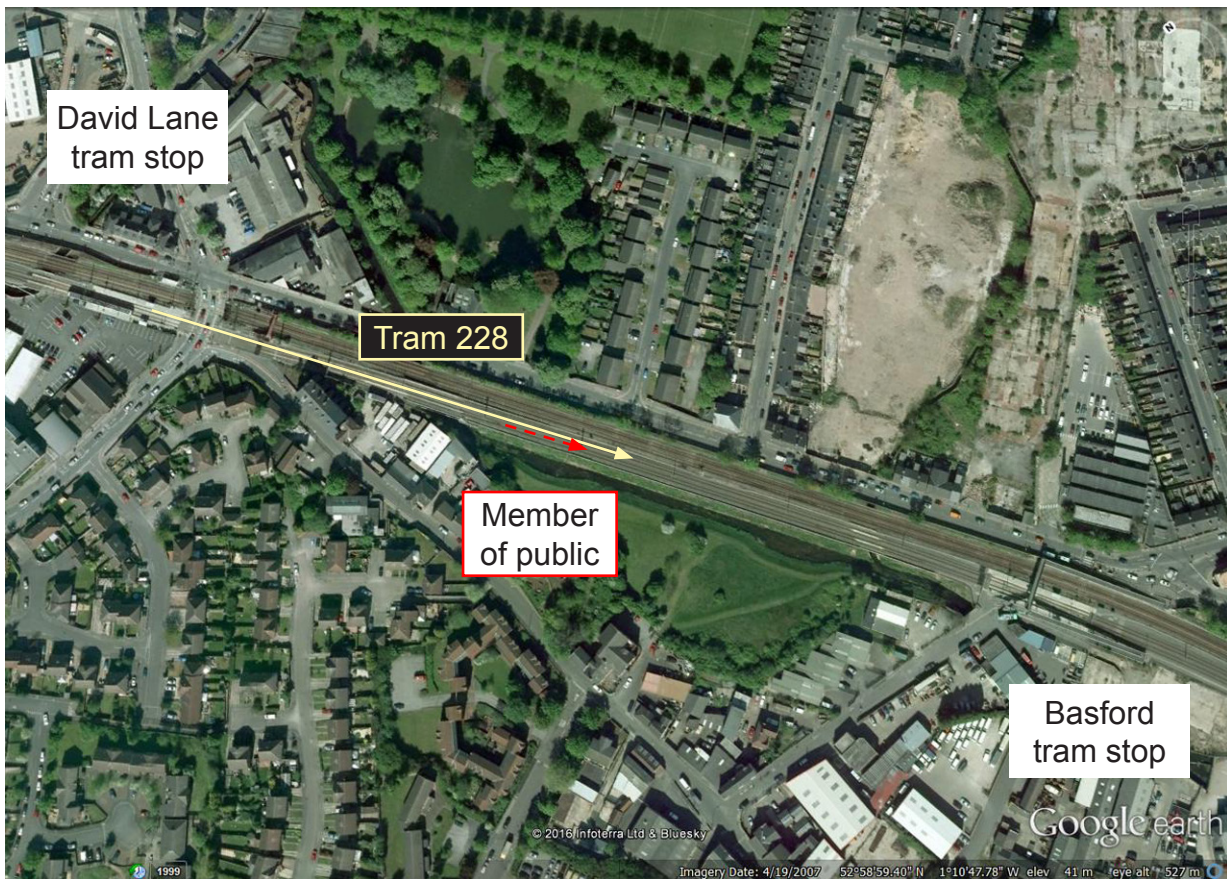
Figure 8: Passage of tram 228 between 22:49 hrs and 22:51 hrs

- 20 At 22:48:45 hrs and while the conversation between the driver of tram 206 and SDS3 was still taking place, SDS2 placed a call to the next tram through the area, which was tram 228 (heading southbound). Having overheard the report from the driver of tram 206, SDS2 instructed the driver of tram 228 to exercise caution through the area between David Lane and Basford tram stops. Tram 228 was on its approach to David Lane tram stop at the time of the call.
- 21 At 22:49:34 hrs, tram 228 stopped at David Lane tram stop (figure 8). At 22:49:49 hrs, tram 228 departed from David Lane tram stop at low speed. The CCTV footage from that tram shows that the member of the public was still walking southbound but that he was now in the area between the two tramway lines (an area known as the *six-foot*). Tram 228 approached the member of the public from behind at walking pace.

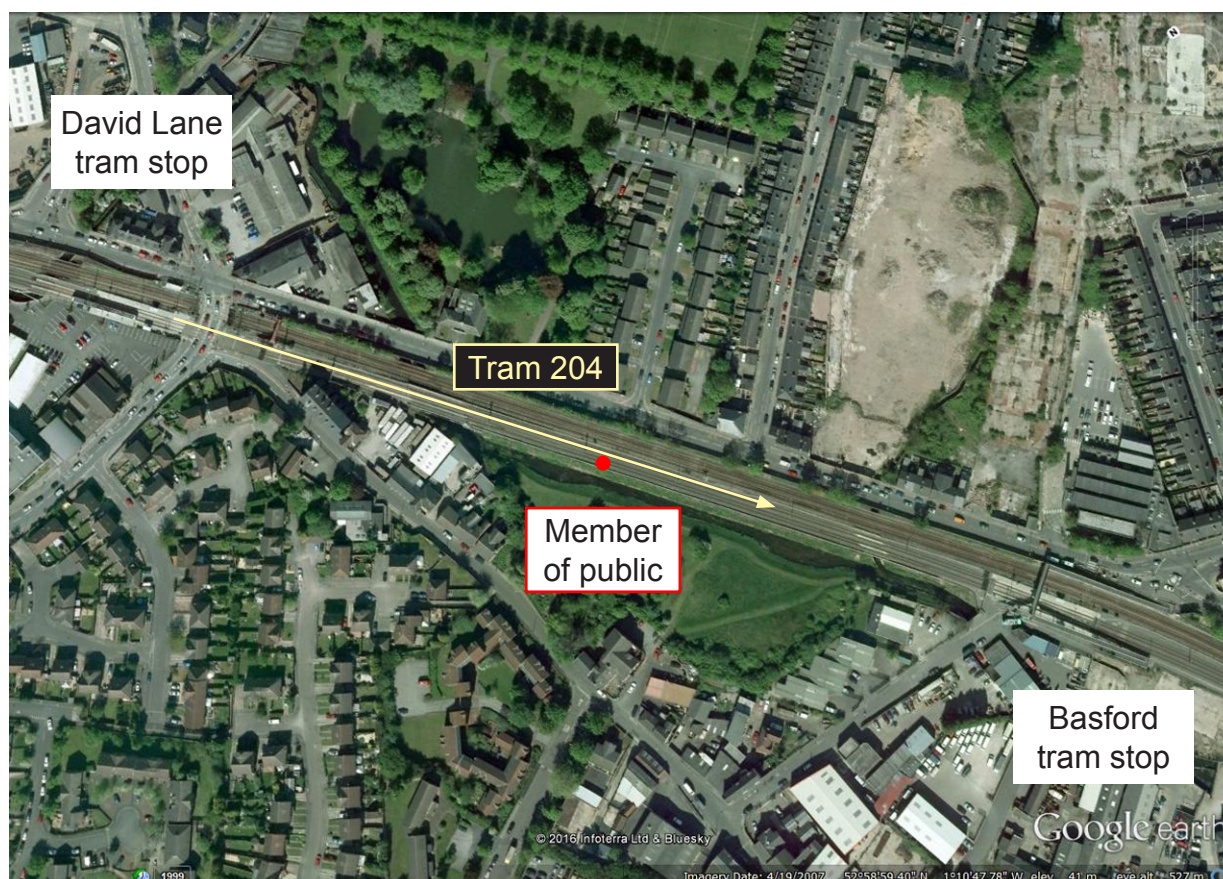
Figure 9: Passage of tram 204 at 22:56 hrs

- 28 At 22:56:09 hrs, tram 204 left David Lane tram stop heading towards Basford at normal speed (figure 9). Tram 204 reached Basford tram stop at 22:57:00 hrs, just as tram 225 was about to depart. As instructed, the driver of tram 204 placed a call with the control room at 22:57:10 hrs during which he was asked by SDS3 to exercise caution between Basford and Wilkinson Street.

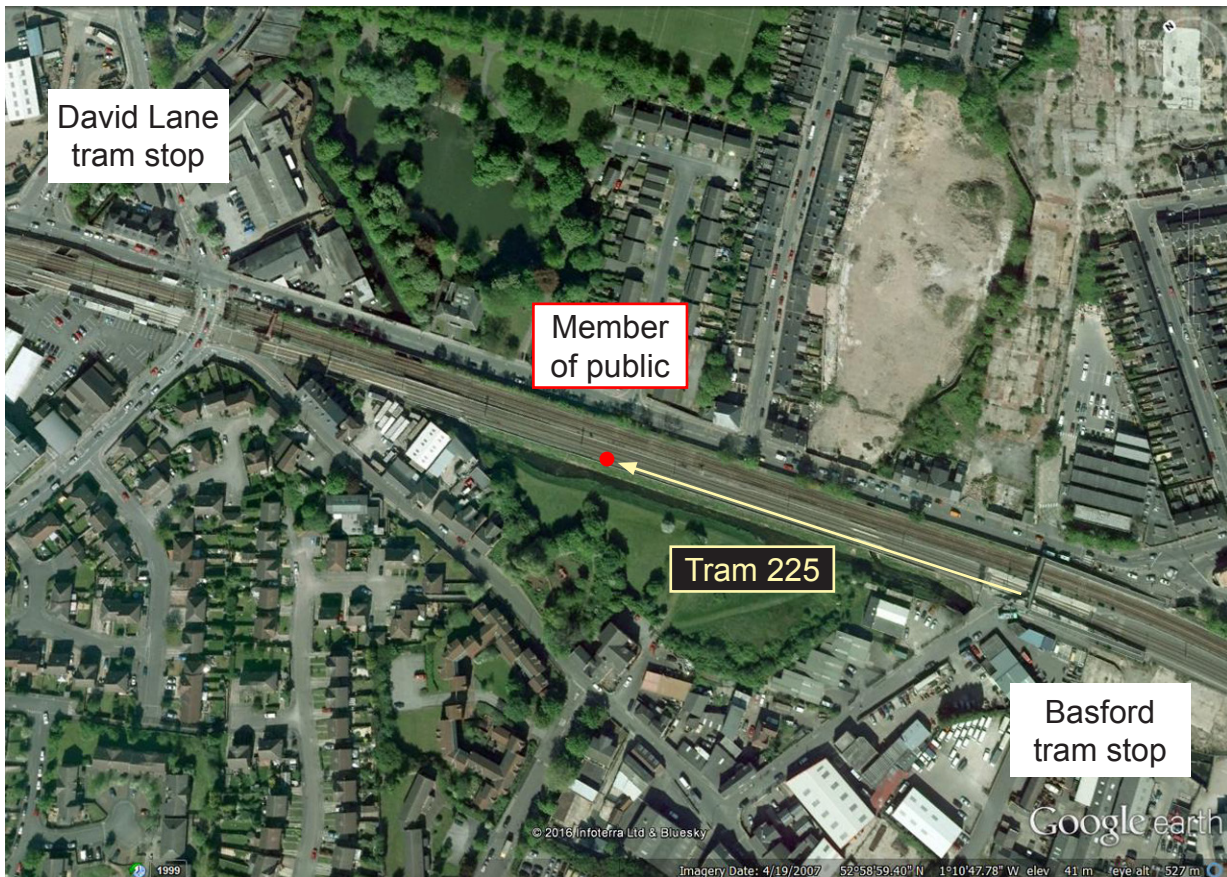
Figure 10: Passage of tram 225 at 22:57 hrs

- 29 At 22:57:02 hrs, tram 225 left Basford tram stop (figure 10). The tram accelerated and reached a speed of approximately 50 km/h about 130 metres away from Basford tram stop at which point the driver stopped accelerating.
- 30 Approximately 180 metres from Basford tram stop, the on-tram data recorder (OTDR) shows that the driver started to apply the service brake. This was in response to the driver detecting that there was something in between the rails on the track used by his tram (an area known as the *four-foot*). The driver was unaware that this was the member of the public who was now lying in the four-foot of the northbound track close to the position where he was last seen on the footage from tram 228.

- 31 At 22:57:25 hrs, one second after applying the service brake, tram 225 struck the member of the public at a speed of 48 km/h. One second later, the OTDR shows that the driver applied the emergency brake and the tram came to a stop 42 metres from the point of collision.
