Appendix B. Air tightness test reports

Air tightness test field reports

LEEDS
METROPOLITAN
UNIVERSITY
Leeds Sustainability Institute

Dwelling C-01, before and after retrofit

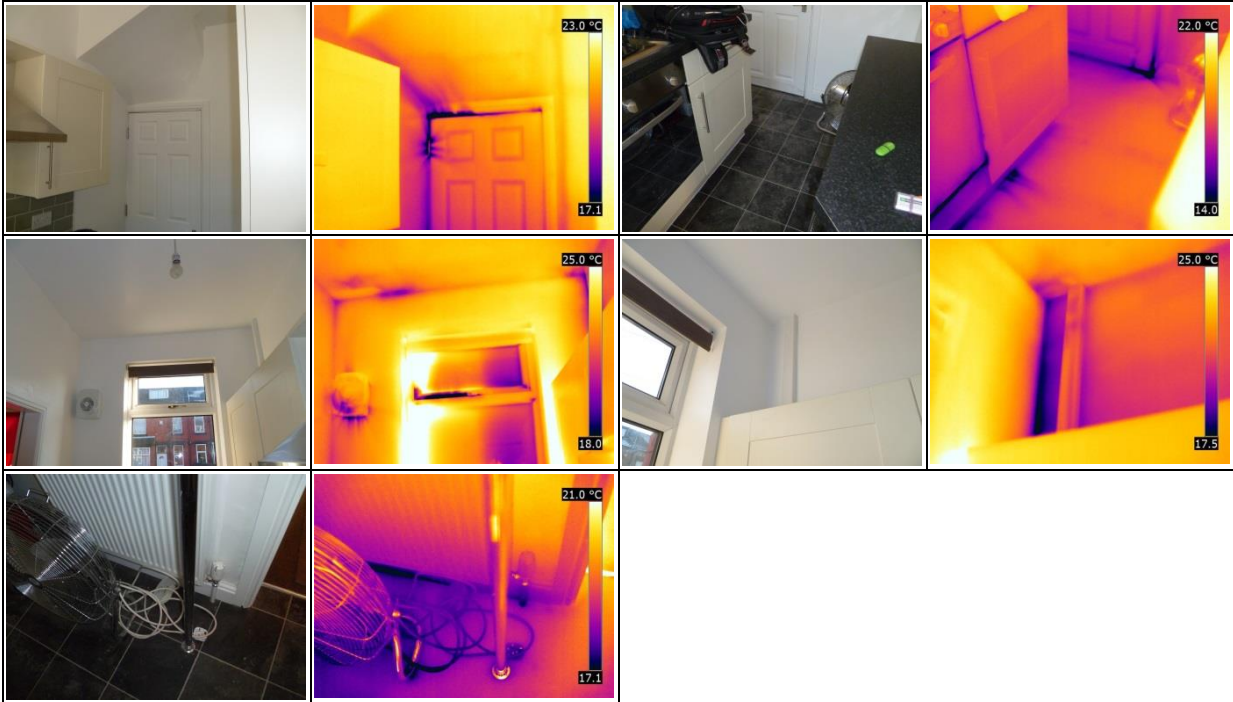
Some temporary sealing was applied at the base of the cellar door, but infiltration was observed at a number of areas around it. Air leakage was also detected around the extractor fan and at the window opening light. Some air movement could be distinguished at the external wall/ceiling junction into the intermediate floor void, but not at the vertical junctions. Air leakage through the ground floor was drastically reduced, and although some air could be observed emerging from beneath the plinth, very little was seen at the wall/floor junctions and around observable penetrations.

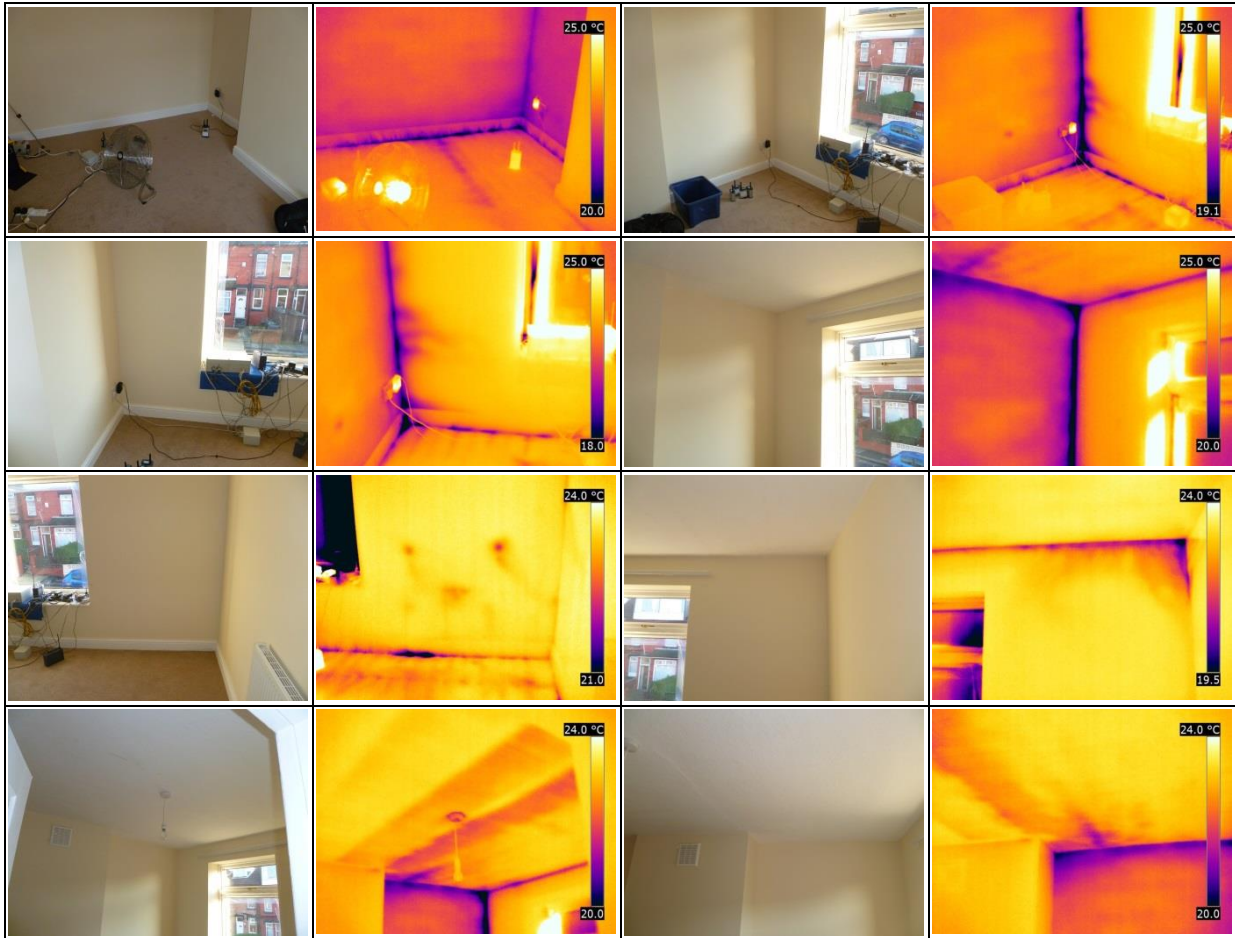
A small amount of air leakage was observed at the floor junctions with the separating walls and the external wall. More significant infiltration was seen entering the void behind the plasterboard at the party wall/external wall junction and, to a lesser extent, at the ceiling junction with the external wall. Air movement was also detected at small gaps around the window frame and at some isolated points on the external wall.

A slight difference could be seen on the ceiling between the areas directly underneath the 2nd floor bedroom and the roof void, although no direct air leakage paths could be observed.

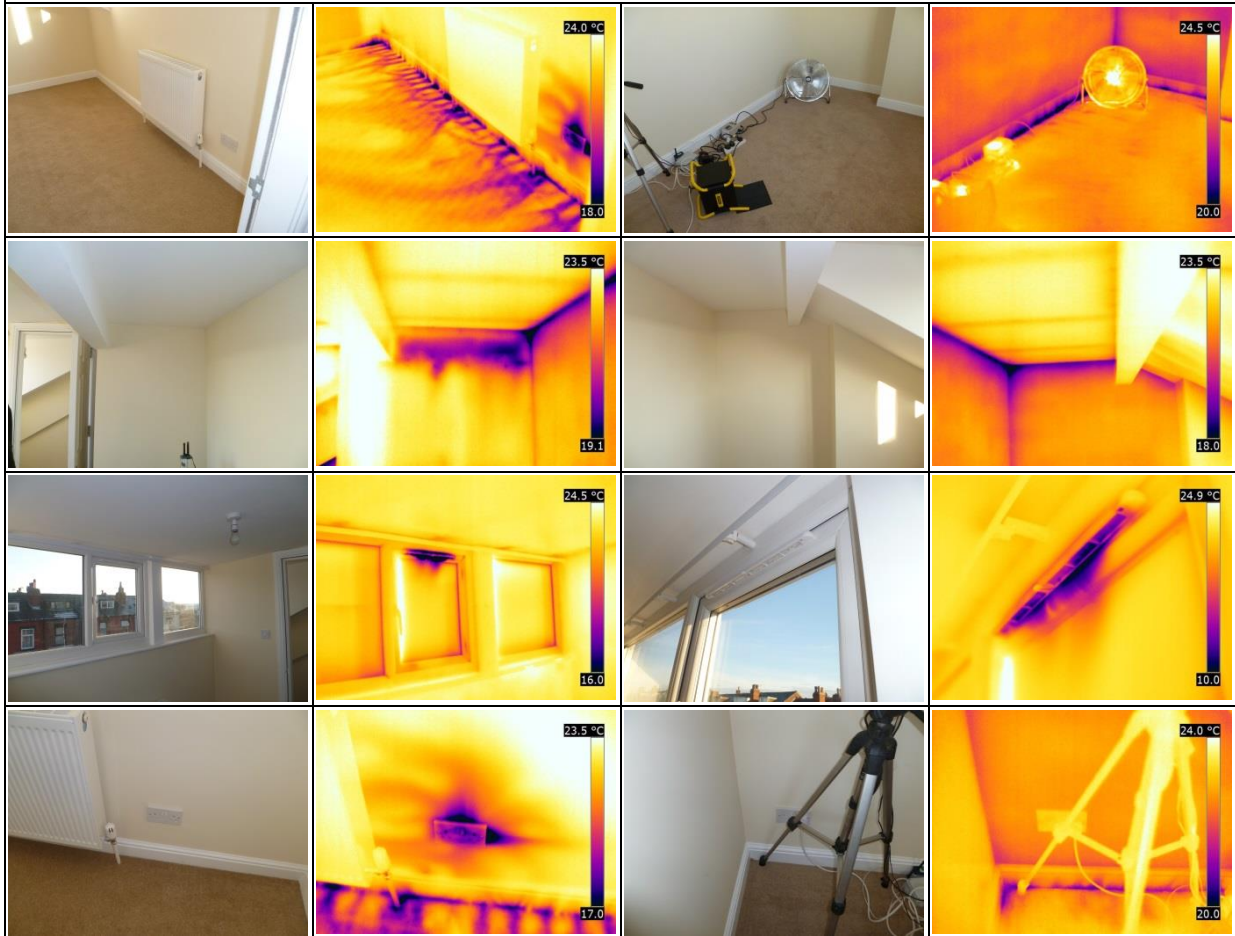
As on the landing, infiltration at the floor/knee wall junction was significant and lifted the carpet, flowing under the carpet and emerging elsewhere in the room at the floor perimeter. Some air could also be seen being drawn down from the central roof void into the internal wall adjacent to the stairs.

The new window performed very well apart from the trickle vent, which permitted air movement both through and around the closed vent. The final 2 thermal images highlight the difference between electrical pattresses on the rear separating wall and the knee wall backing on to the front roof void.

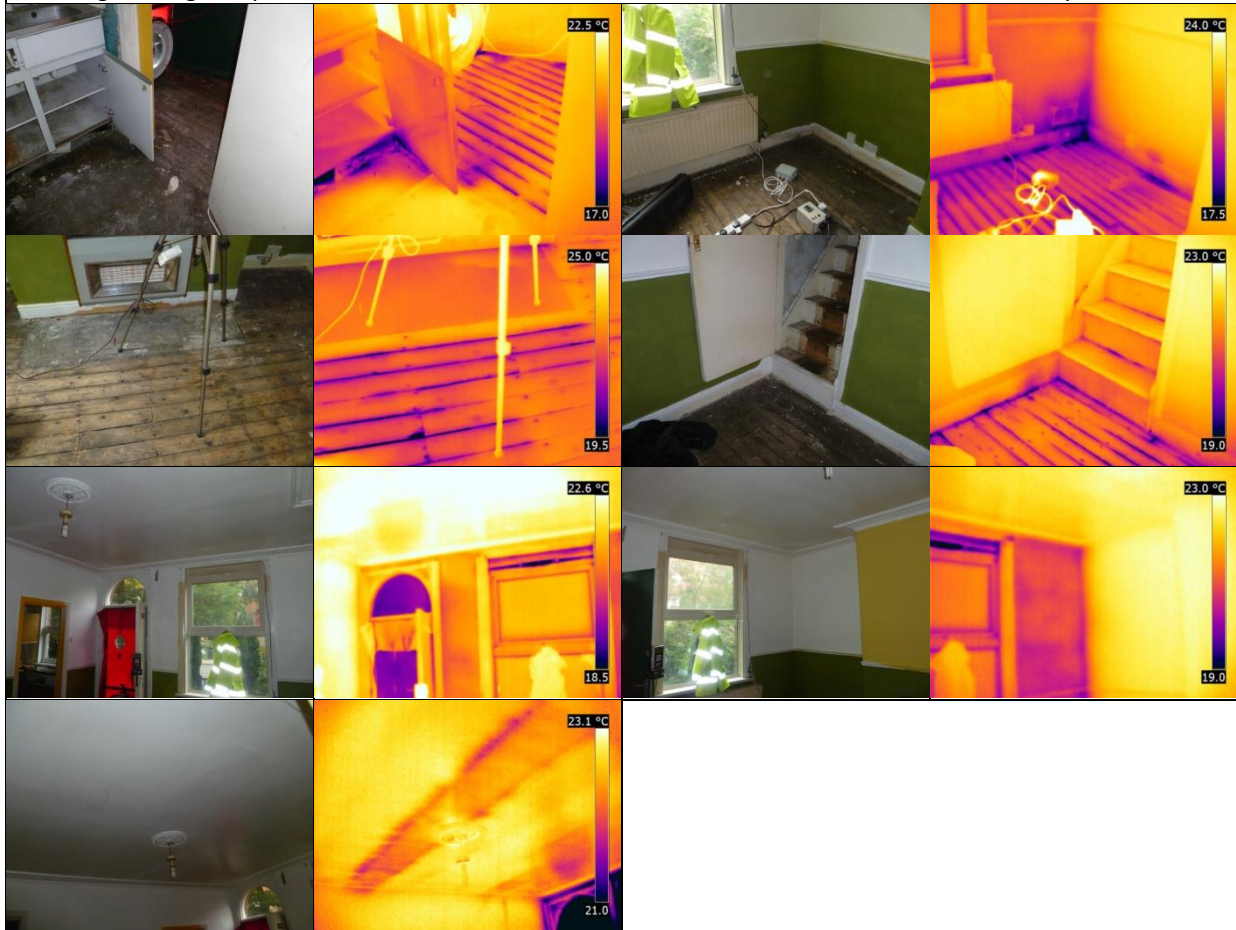
Airflow up through gaps between the floorboards was equally bad from both the open cellar and the closed cellar under the lounge floor and again the trickle vent did not fully close. A cooler strip between joists running across the lounge ceiling was presumed to be a link between the intermediate floor void and the chimney.

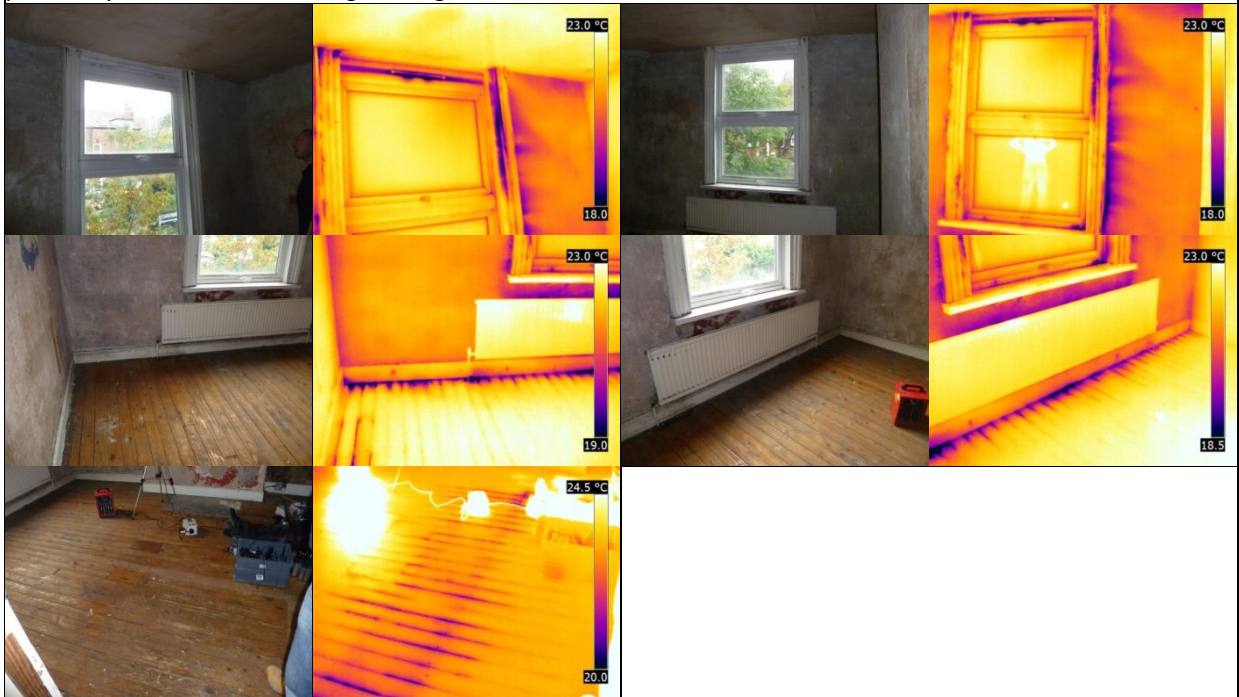
Infiltration around the window frame was substantial, with a gap between the external wall and frame at the top-right of the window where it was possible to see directly to outside. Airflow up through gaps between the floorboards was detected across the whole floor, but only visible in the thermal images at the external wall, junction where the infiltrating air was coolest, and along the cooler strip running across floor above that previously observed in the lounge ceiling.

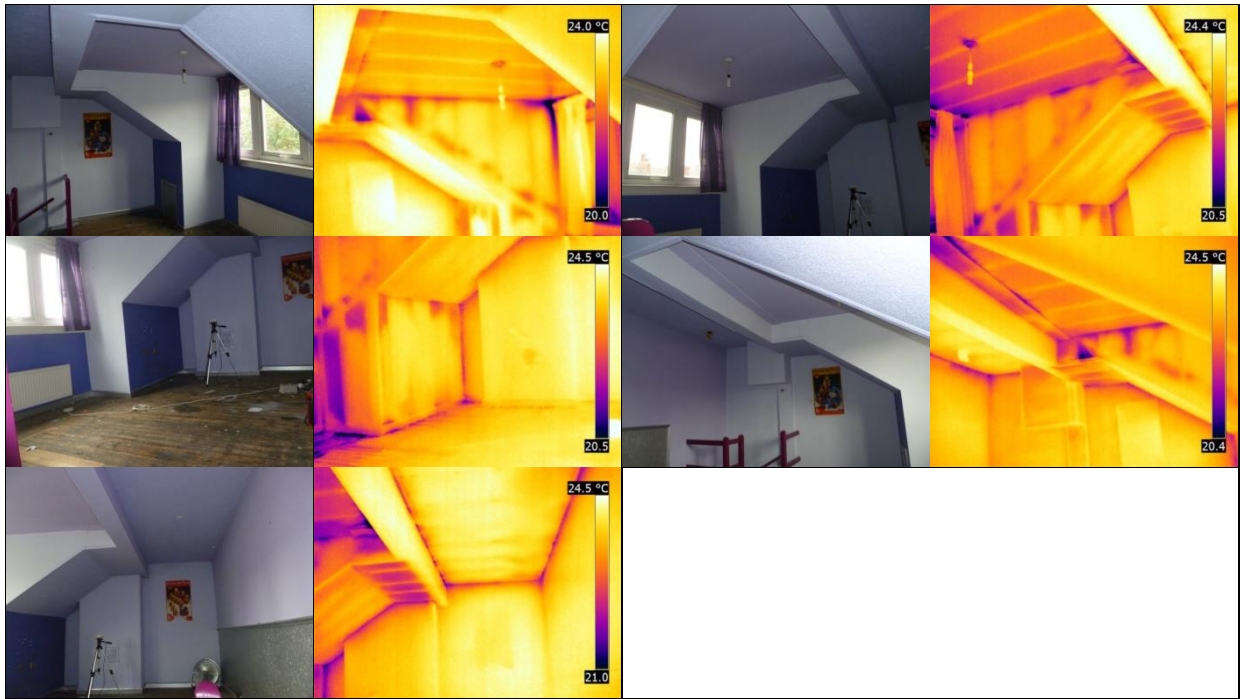
Top Floor Bedroom:

The main leakage paths were around the unsealed access door into the loft void to the left of the dormer and up through the floor (again this shows more clearly in the thermal images near the perimeter as the infiltrating air was coolest, but was detectable throughout the floor). Lesser infiltration was observed around the dormer window frame and sill and at a number of small gaps and cracks at junctions between walls and ceiling surfaces. In the sections of flat and sloping ceilings, knee walls and dormer cheeks, an indication to the level of insulation between the timber studs by using the surface temperature patterns to determine whether the studs allowed more or less heat to escape than the areas between them; although direct sun onto the sloping roof can cause confusion.

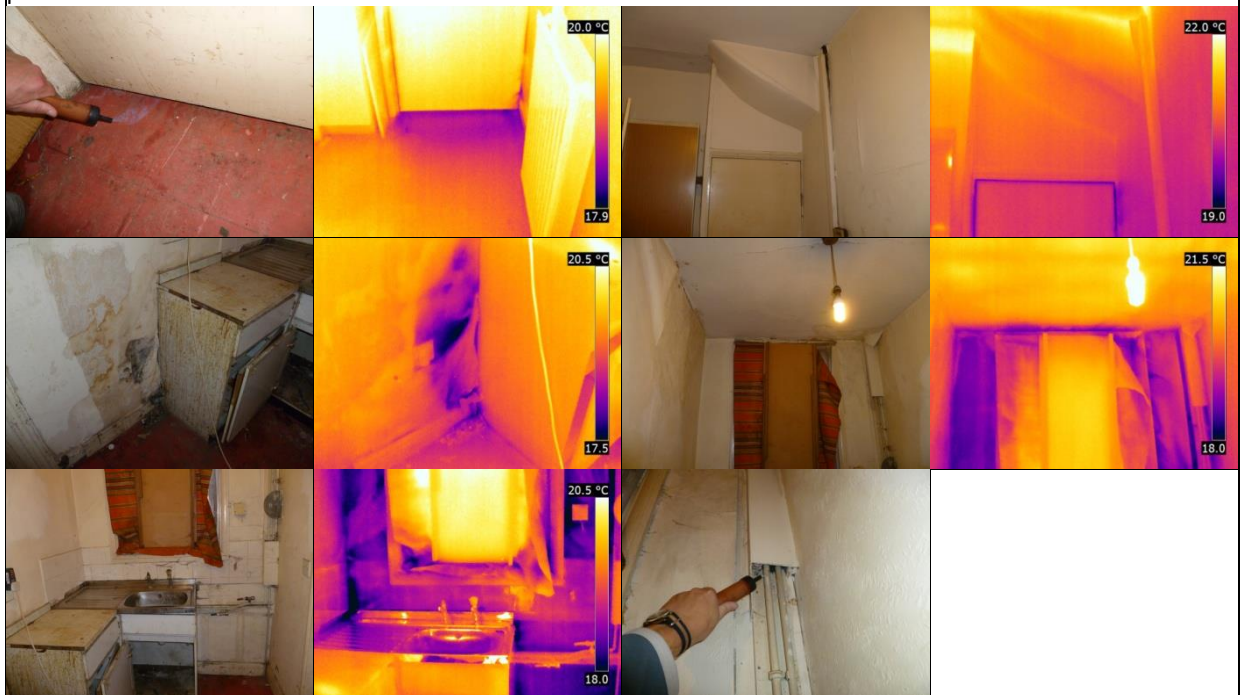
Kitchen:

As at Hall Grove, the most severe leakage occurred under and around the cellar door, although substantial air movement was also observed from behind the kitchen units, around the window and around unsealed service penetrations.

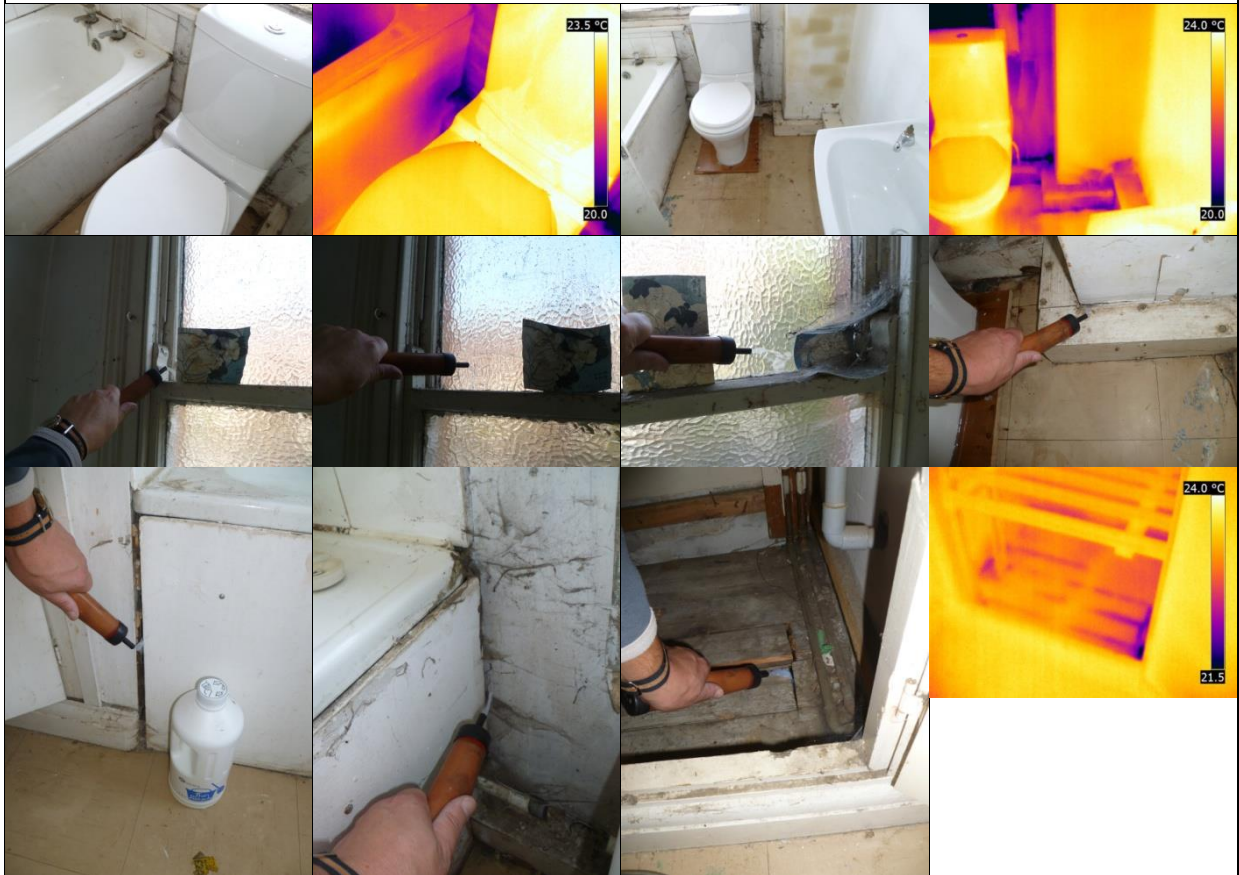
Air leakage was significant around the bath panel, the floor/wall junctions (particularly around the base of the boxed in service riser) and through the airing cupboard floor. As in the lounge, considerable airflow occurred at the window between the sashes.

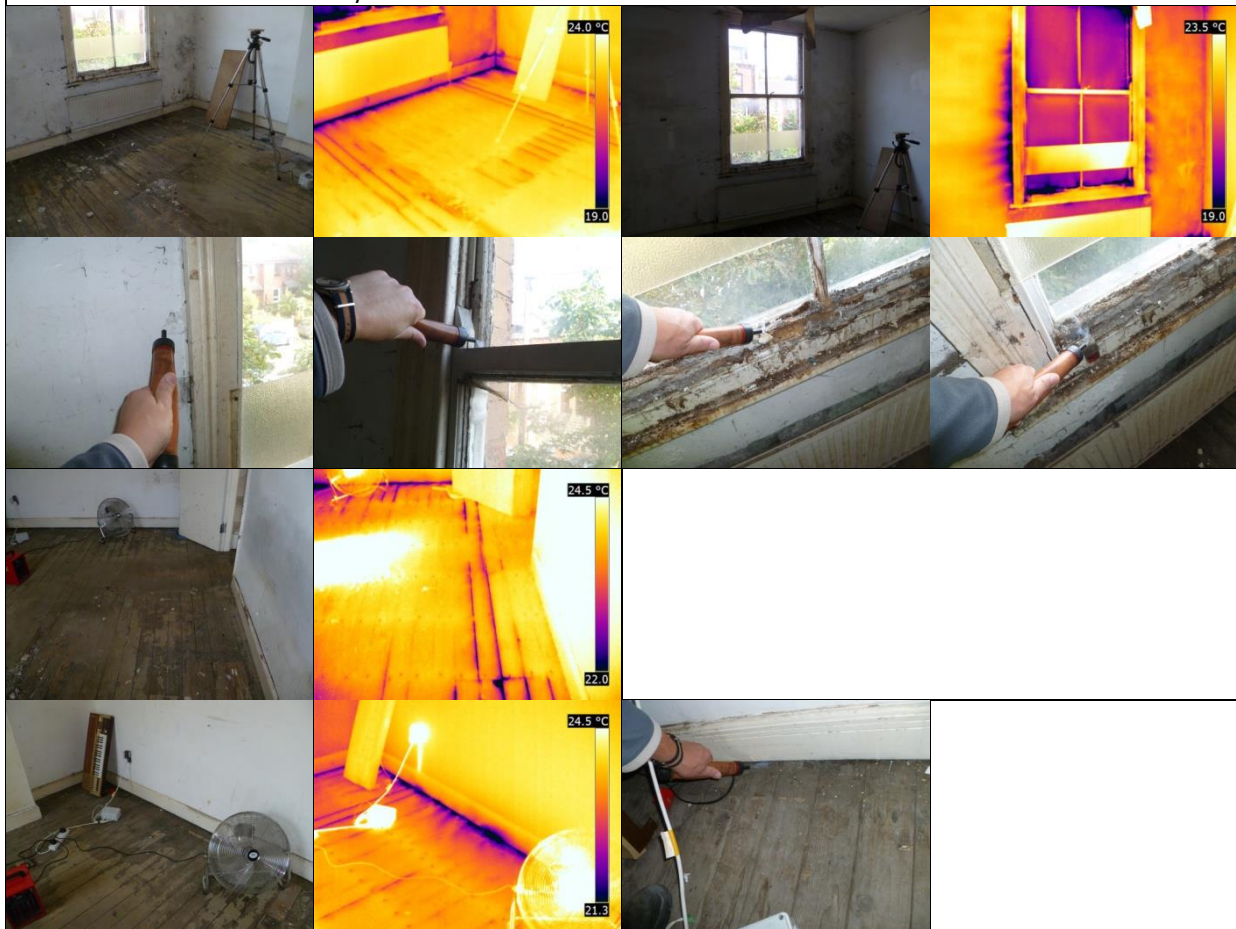
First Floor Bedroom:

Infiltration up through the floor, at all floor/wall junctions and through and around the window and frame was again substantial. A gap of up to 6mm has developed between the bottom rail of the lower sash and the glazing where the wood has rotted away.

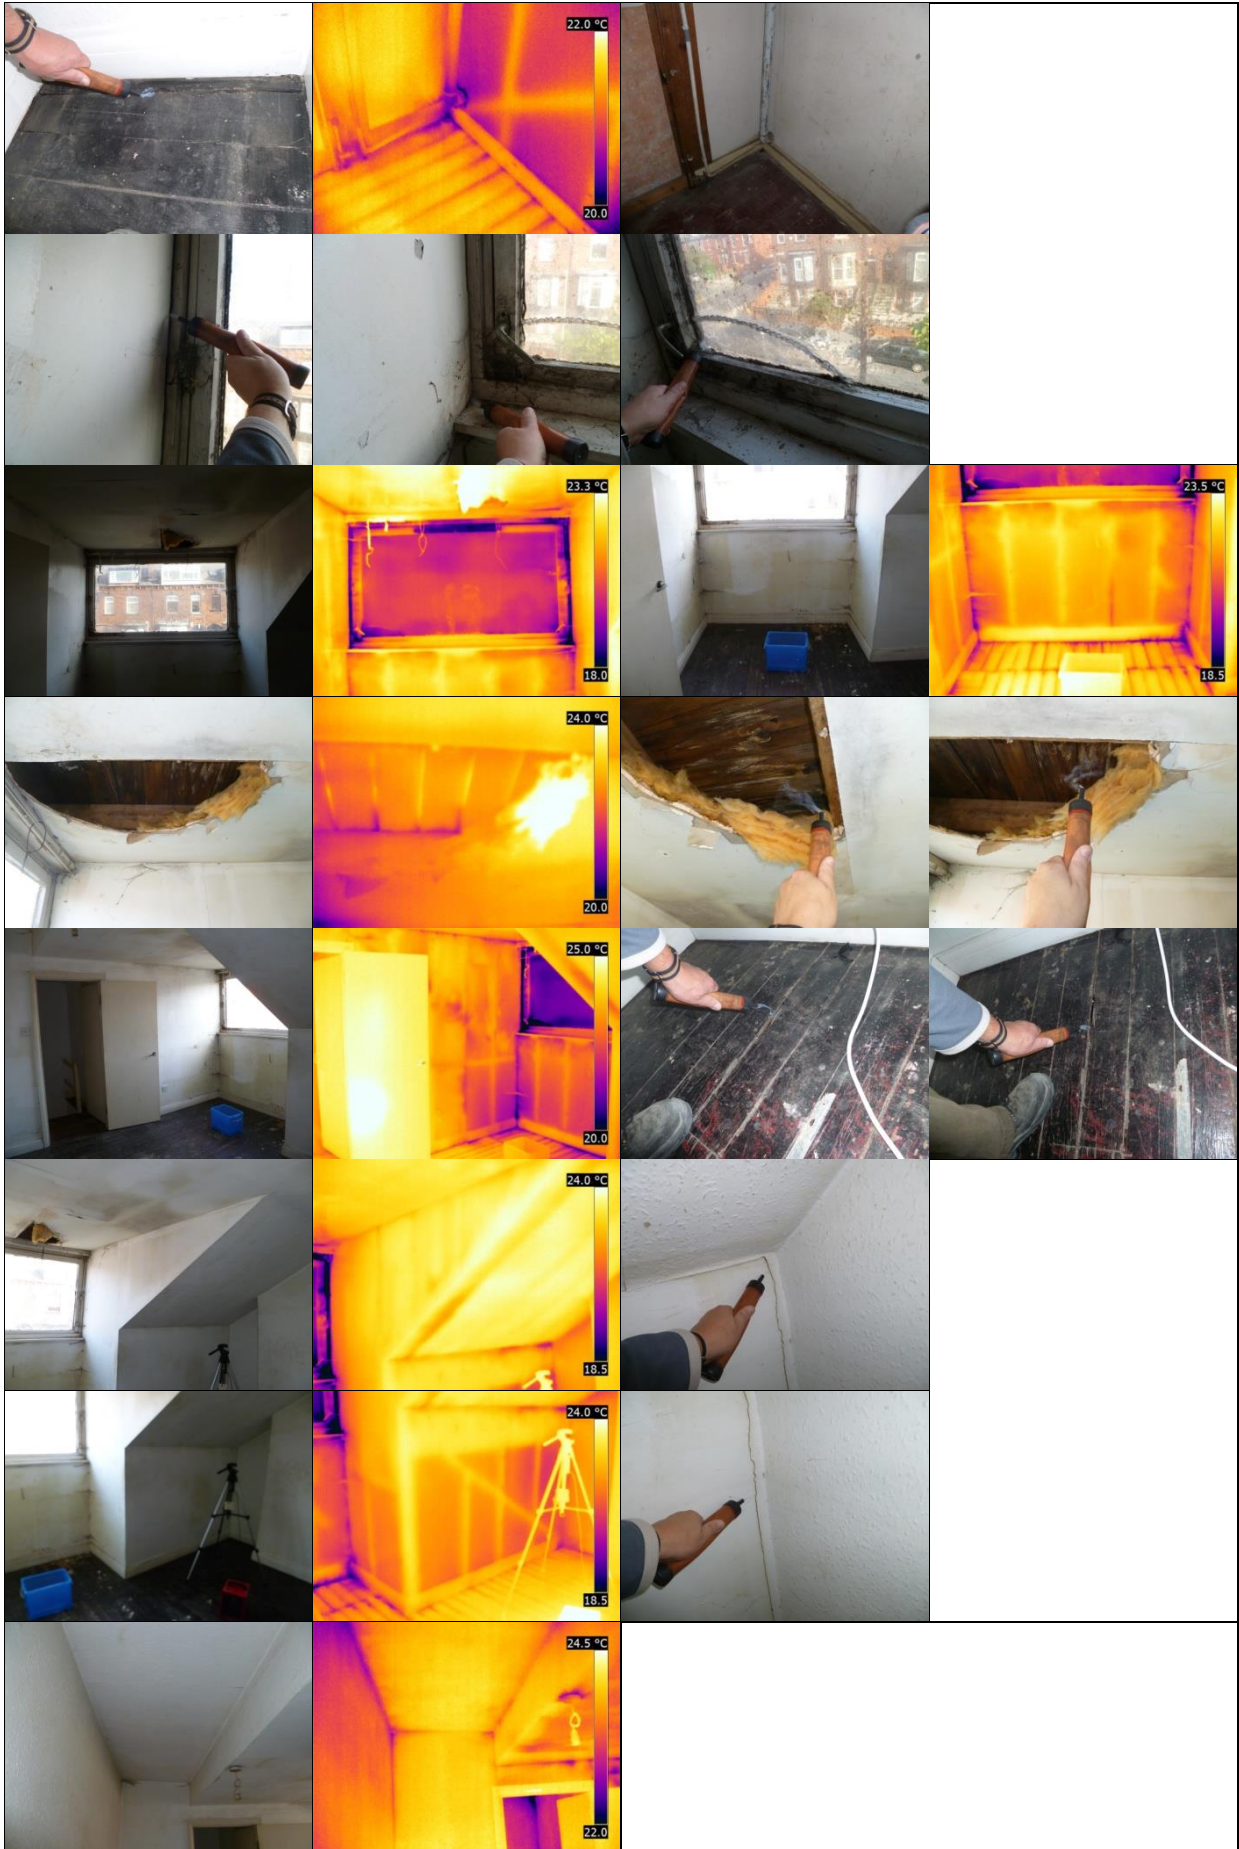
Air leakage was detected in numerous places: up through gaps between the floorboards and at most floor/wall junctions; around the dormer window frame, sill, trickle vent and crack in the glazing; at a number of small gaps and cracks at junctions between walls and ceiling surfaces; and through a large hole in the dormer roof.

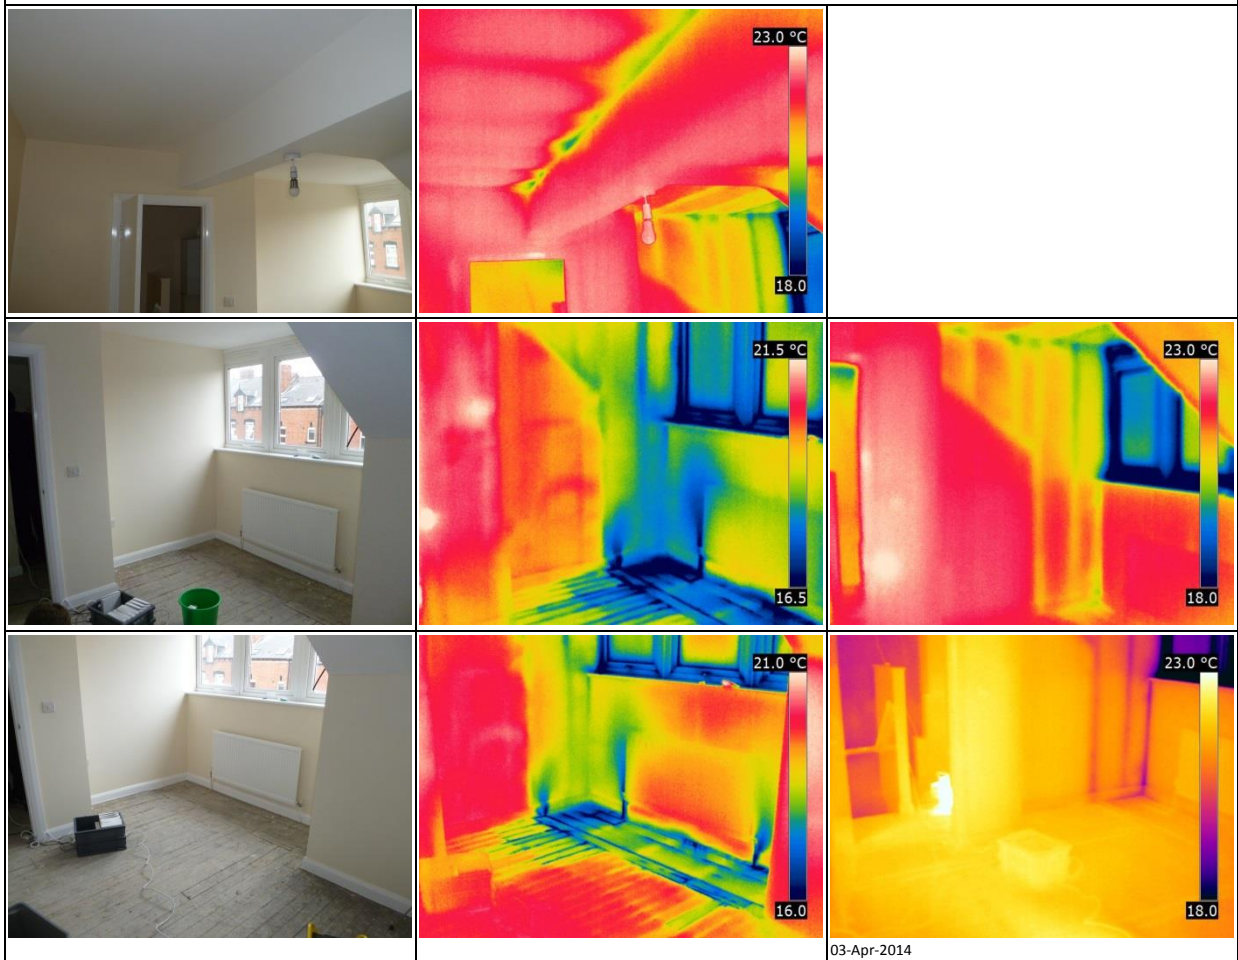
2nd Floor Bedroom

Air leakage up through the intermediate floor and through the window remained similar to that observed in the tests prior to renovation, but the rest of the room in roof structure had improved dramatically. The high visibility of the thermal bridging through the timber formwork indicating that there is effective insulation between.

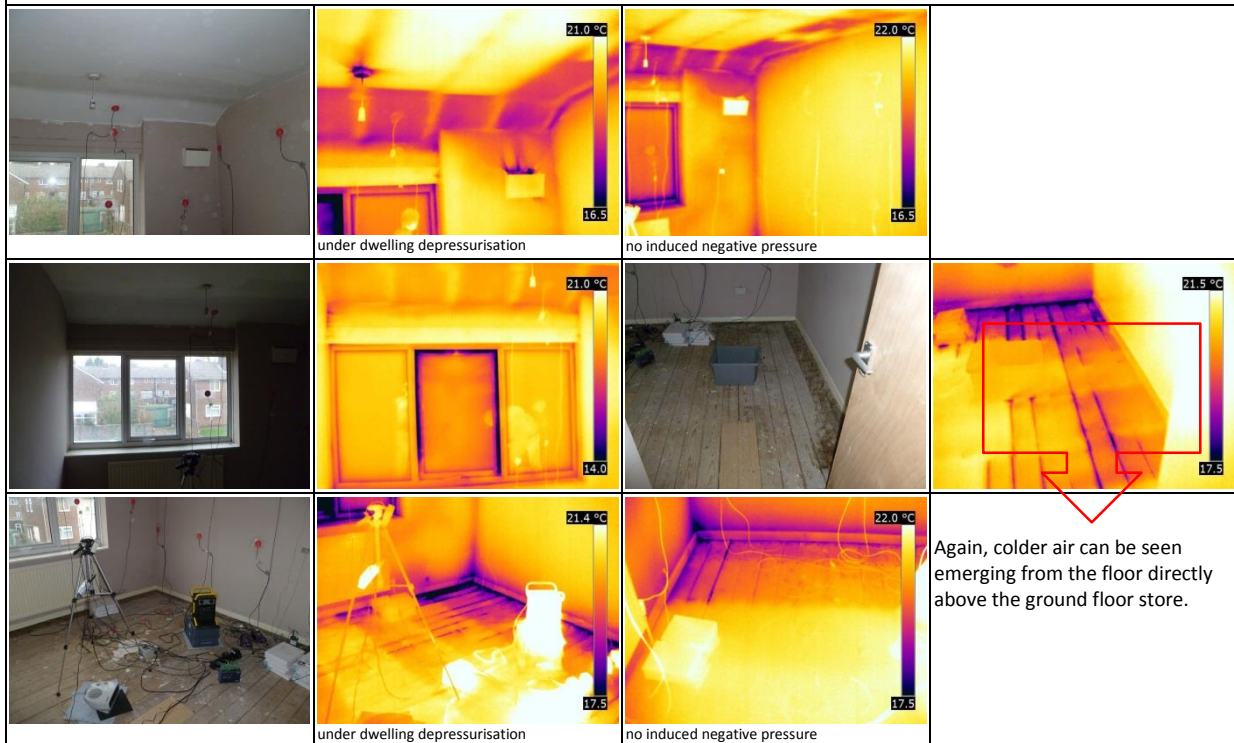
Similar observations to those made in Bedroom 2. Also there was significant air leakage around 3 sides of the opening light of the window.

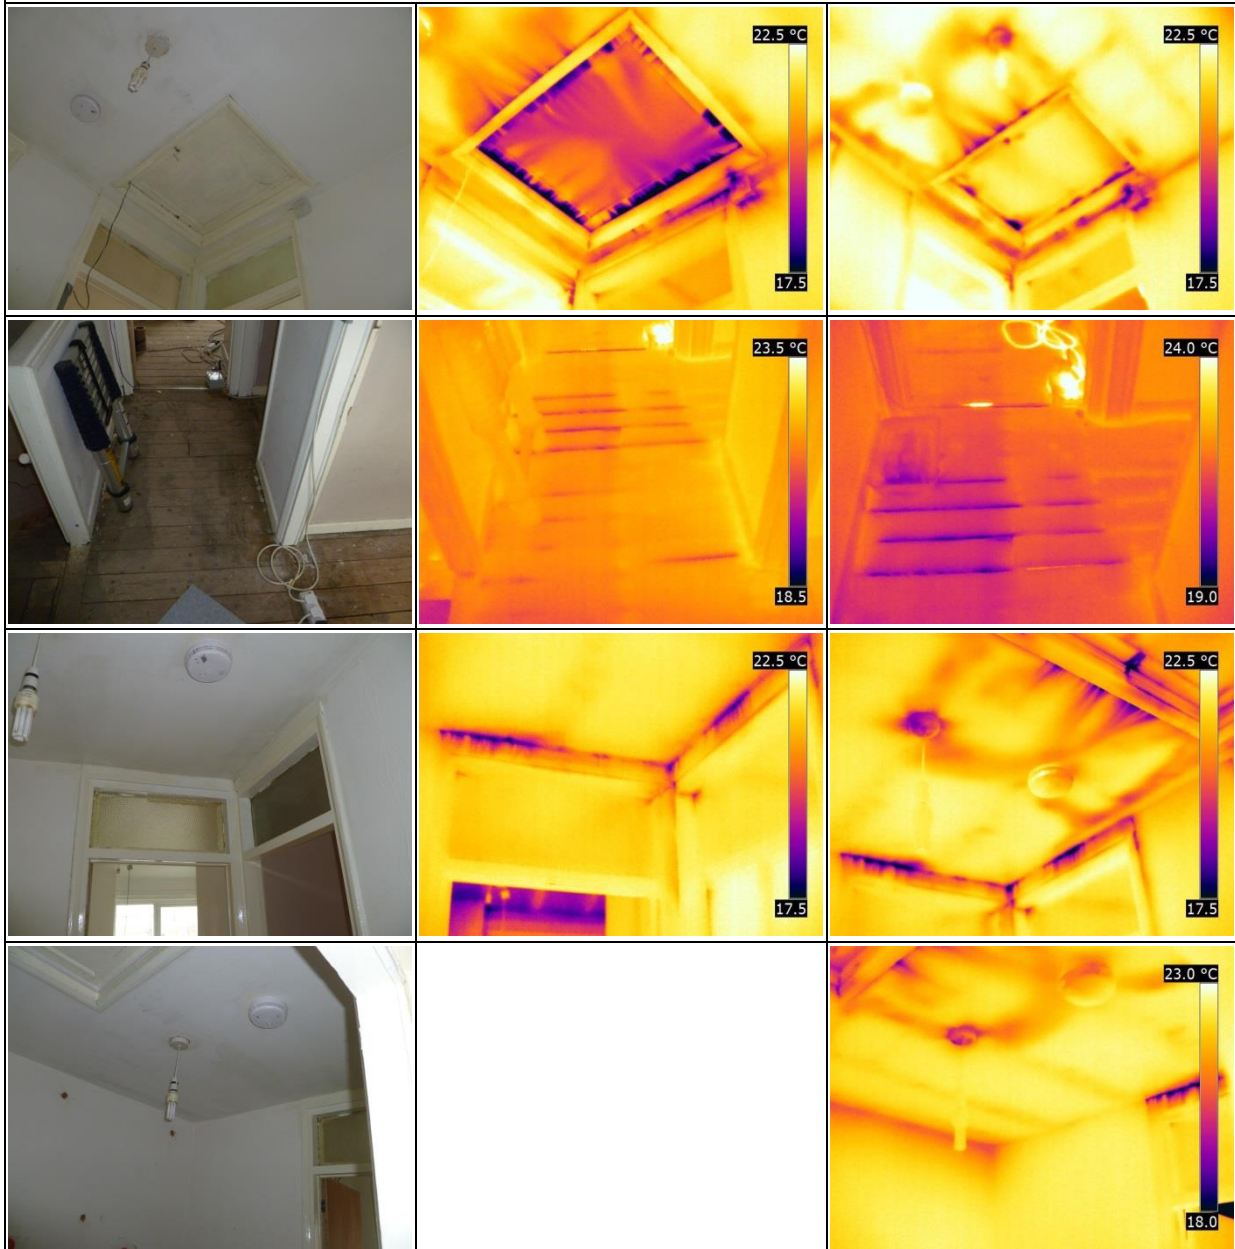
Air leakage detected here was similar to previously observed with the exception of the loft hatch, where the draught-stripping applied as part of the loft upgrade drastically reduced air movement between the loft door and hatch.

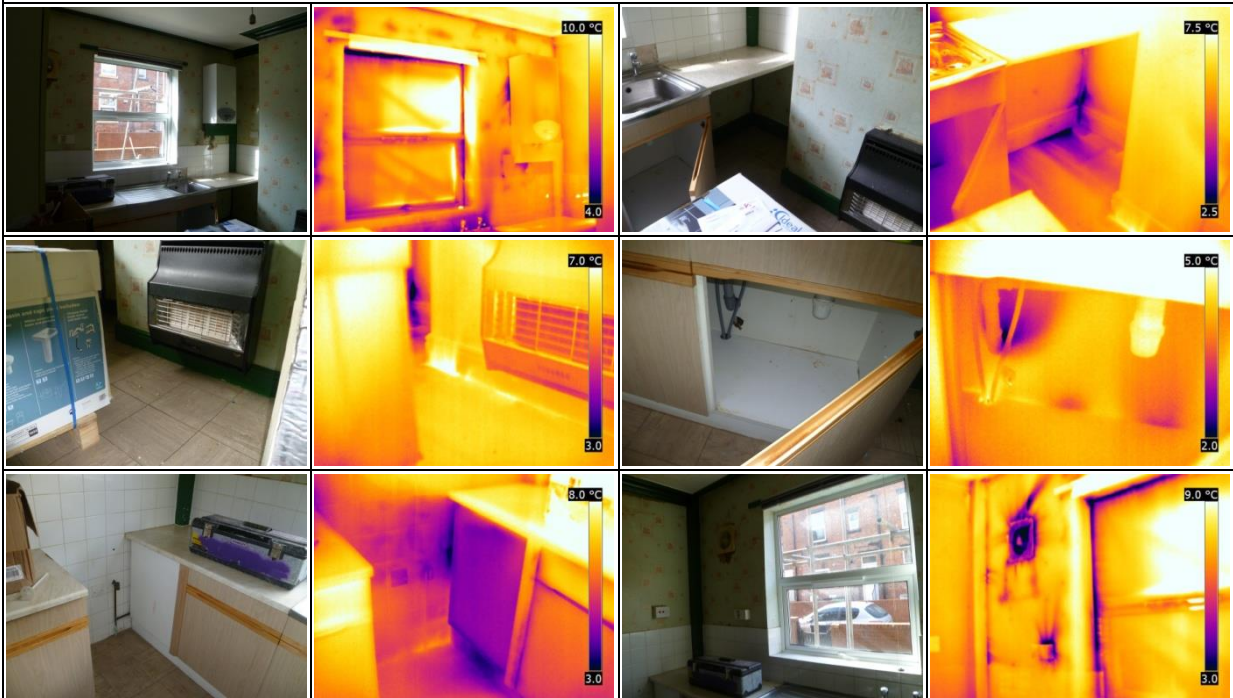
leakage was also noted from the void behind the kitchen units and at the junction of external wall, party wall and floor, the cold temperature of the infiltrating air here suggesting that this leakage path was directly from outside rather than coming up from the cellar.

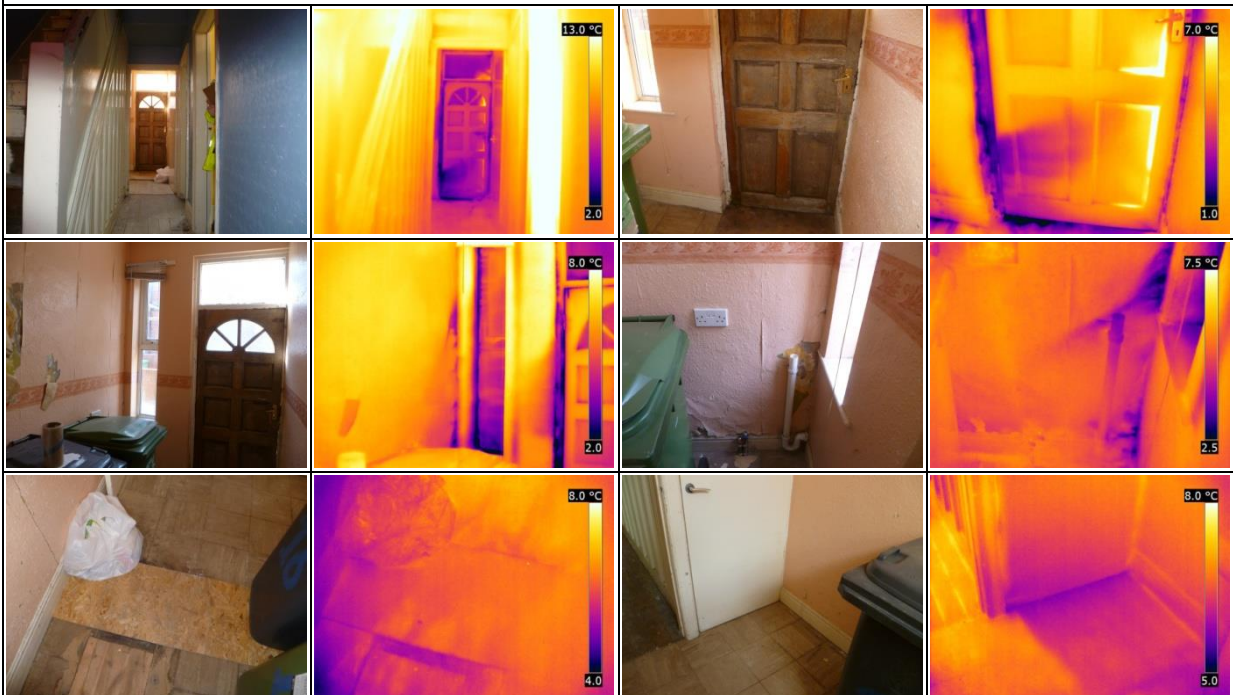
Rear Lobby

Significant air paths were detected around the back door and the window. Also, there was external air entering at the party wall junction with the external wall. The greatest infiltration was felt around the gap at the bottom of the cellar door and around a piece of OSB used to repair the floor, although these do not appear as bad on the thermal images below as the infiltrating air from the cellar was notably warmer than the external air entering at other locations mentioned. Cooler air was also observed entering the partition wall above the cellar door, it was unclear whether this was being drawn up from the cellar or coming in from the “cavity” in the solid party wall (see comments for Bedroom 2).

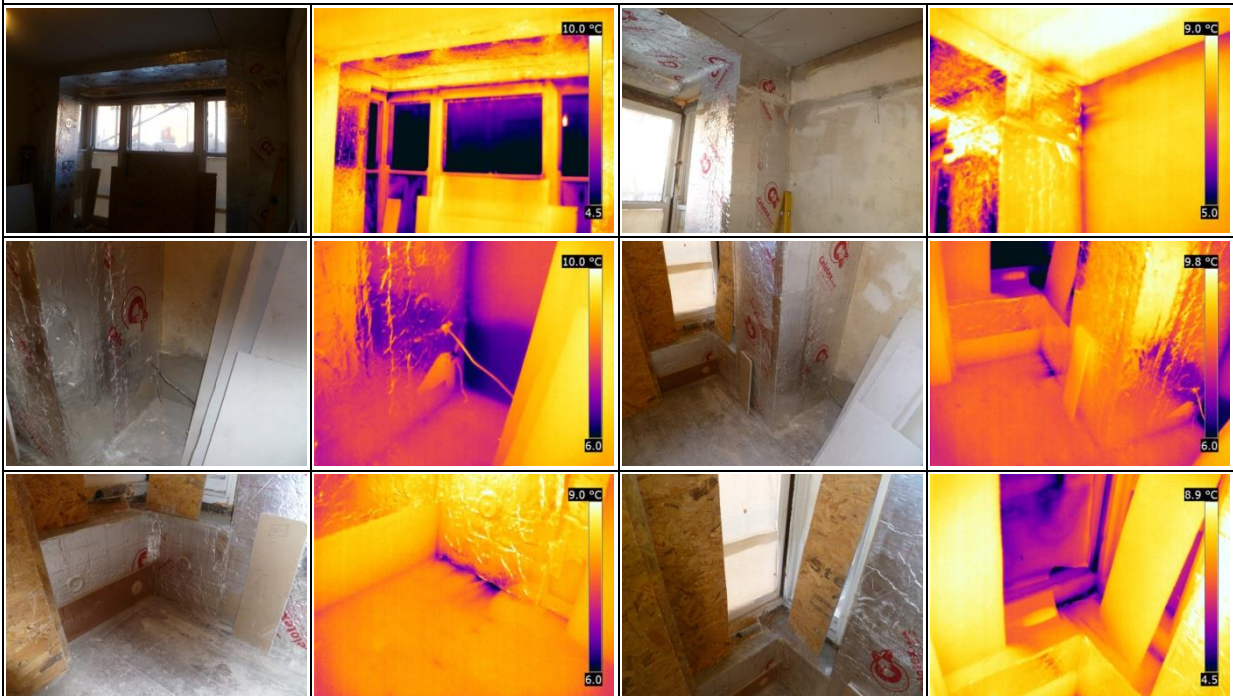
Air leakage detected around the bay window and around the wall insulation at external/internal wall junctions, at the wall/floor junctions and around the bay roof. The penetration through the insulation appeared well-sealed with no detectable air movement. Some air leakage was also observed at the intermediate floor junction with the party wall.

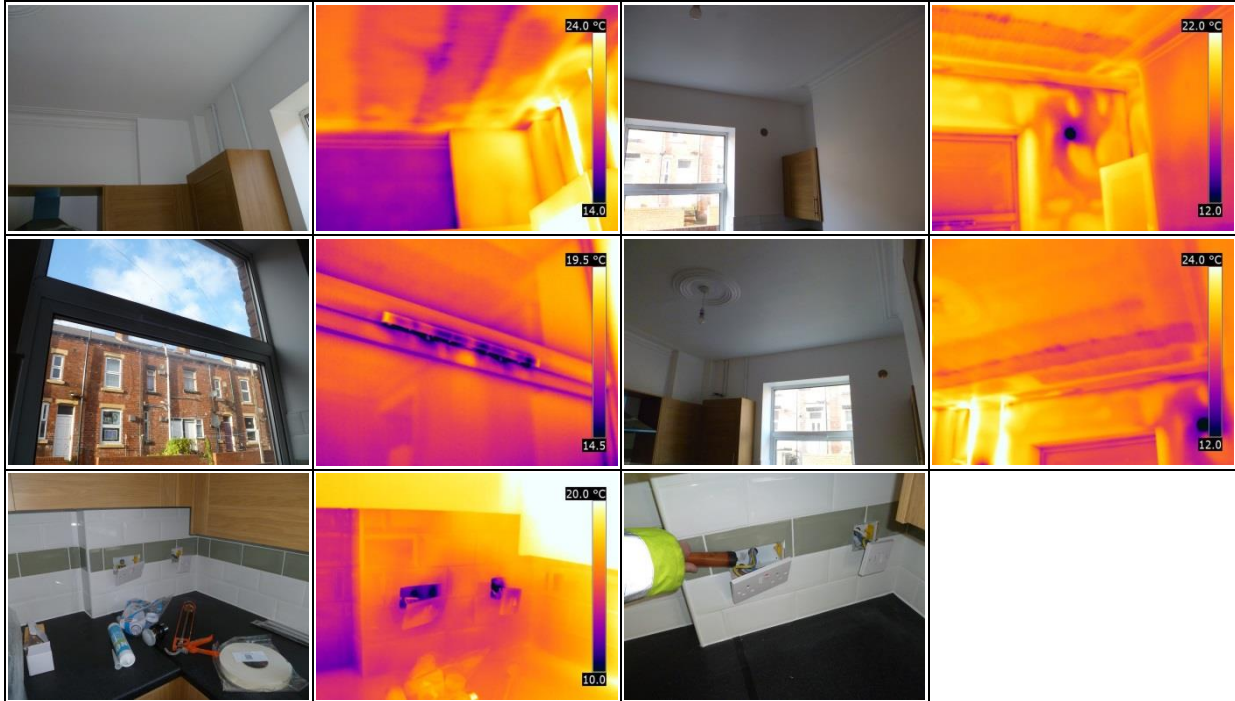
Kitchen

Infiltration was again observed around the window, particularly between the trickle vent and the window frame. The penetration for the extraction fan was temporarily sealed for the test, but still allowed significant air movement into the void behind the plasterboard directly from outside, hopefully this will reduce markedly once the device is installed and sealed around externally. Leakage was also detected around the wall-mounted patresses, from areas obscured by the kitchen units and at the floor/party wall junction around the chimney breast.

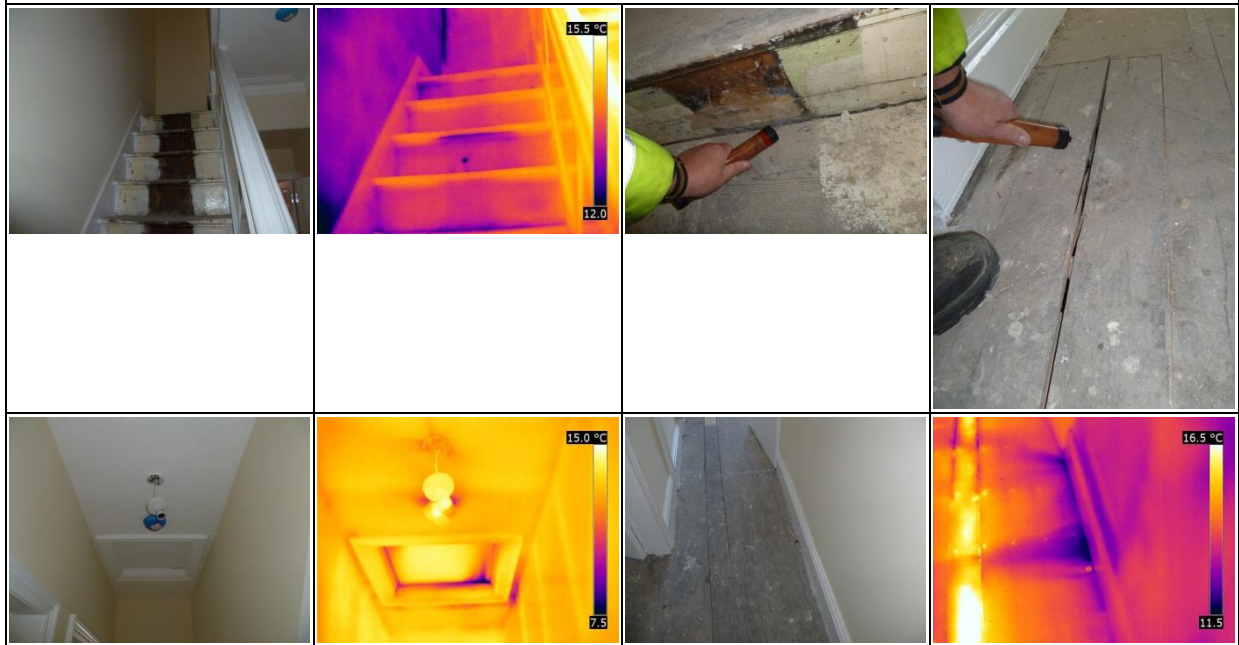
Little infiltration was observed through the stairs apart from one large knot hole and the junction between the stairs and the intermediate floor. On the landing very cold air was being drawn in through the loft hatch, with some lesser air leakage detected around ceiling penetrations. The landing floor junction with the void over the stairs performed relatively badly and air leakage into the intermediate floor void was also detected..

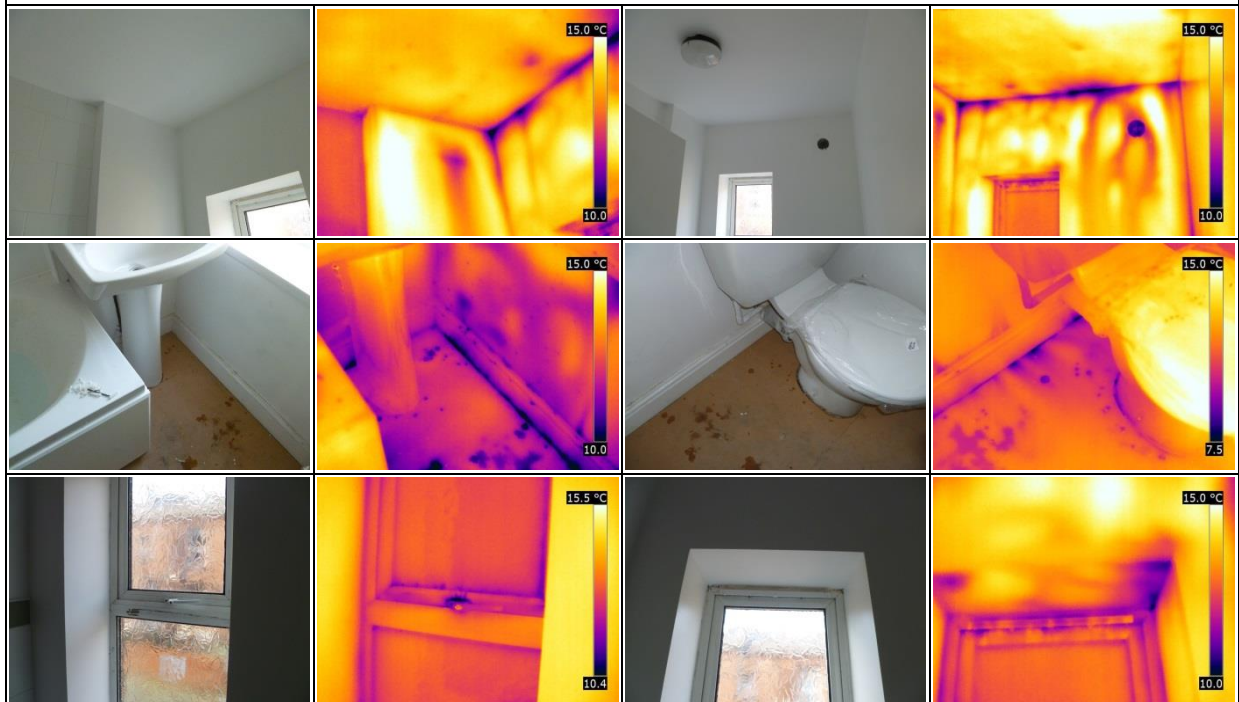
Bathroom

On the external wall air leakage was observed at the ceiling and floor junction, behind the plasterboard at the ceiling junction and into the room at the floor junction. Infiltration seen at the intermediate floor junction behind the WC was at temperatures which suggest this air was coming directly out of the external wall. The same issue with the extractor fan penetration as in the kitchen was also repeated. Again, air leakage was observed at the window.
