Appendix B. Air tightness test reports

Air tightness test field reports

LEEDS
METROPOLITAN
UNIVERSITY
Leeds Sustainability Institute

Dwelling C-01, before and after retrofit

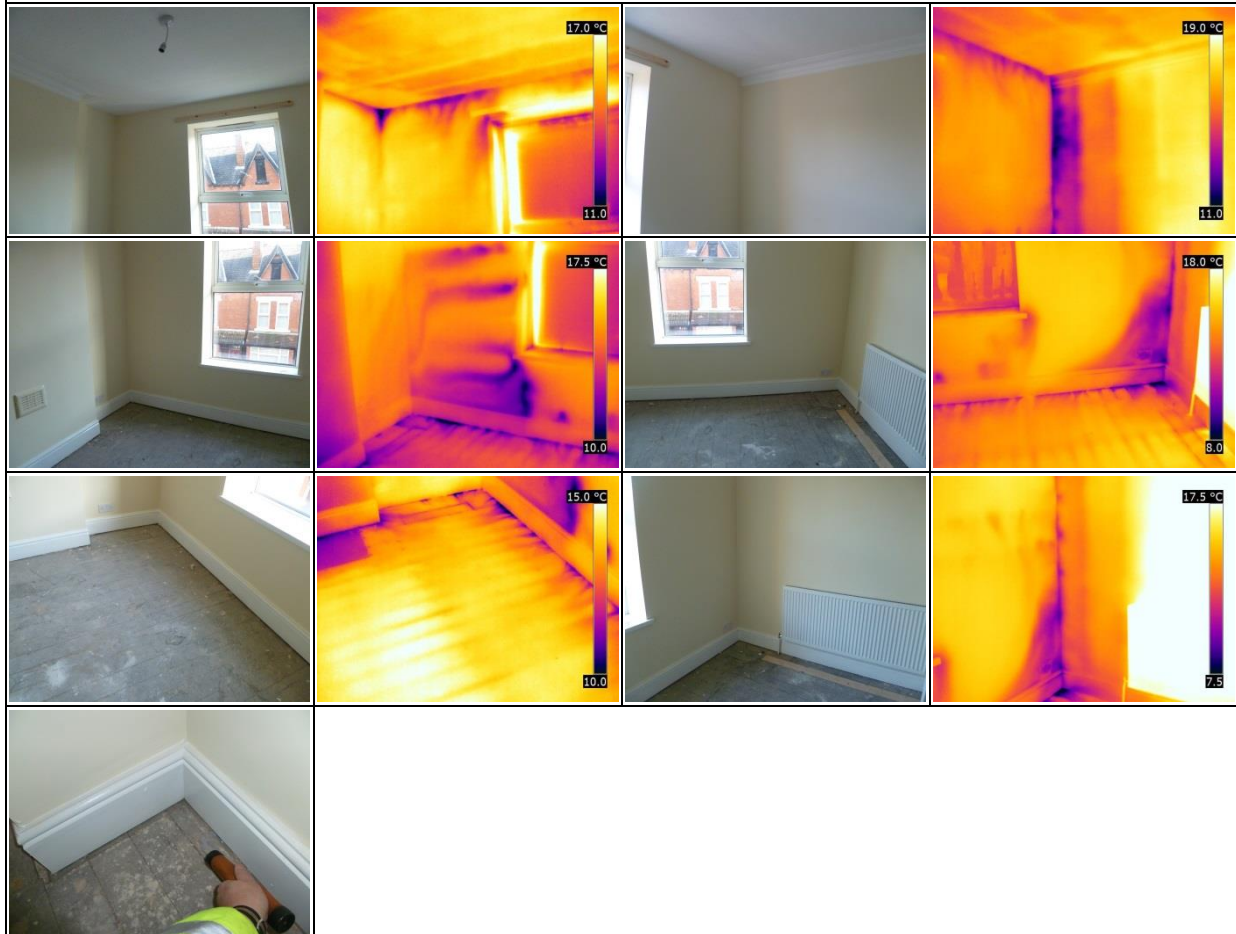
Bedroom 1

As observed in previous tests, leakage at the trickle vent, window and intermediate floor perimeter and it was possible to see discrete temperature changes between joists across the intermediate floor void as the distance from the external wall increased. This compartmentalisation was also seen in the internal partition wall adjacent to bedroom 3, although the location of the radiator will also have had a significant effect here. There was a considerable amount of air movement behind the plasterboard of the external wall showing up as cooler areas in external wall, particularly by the window sill and partition wall junction.

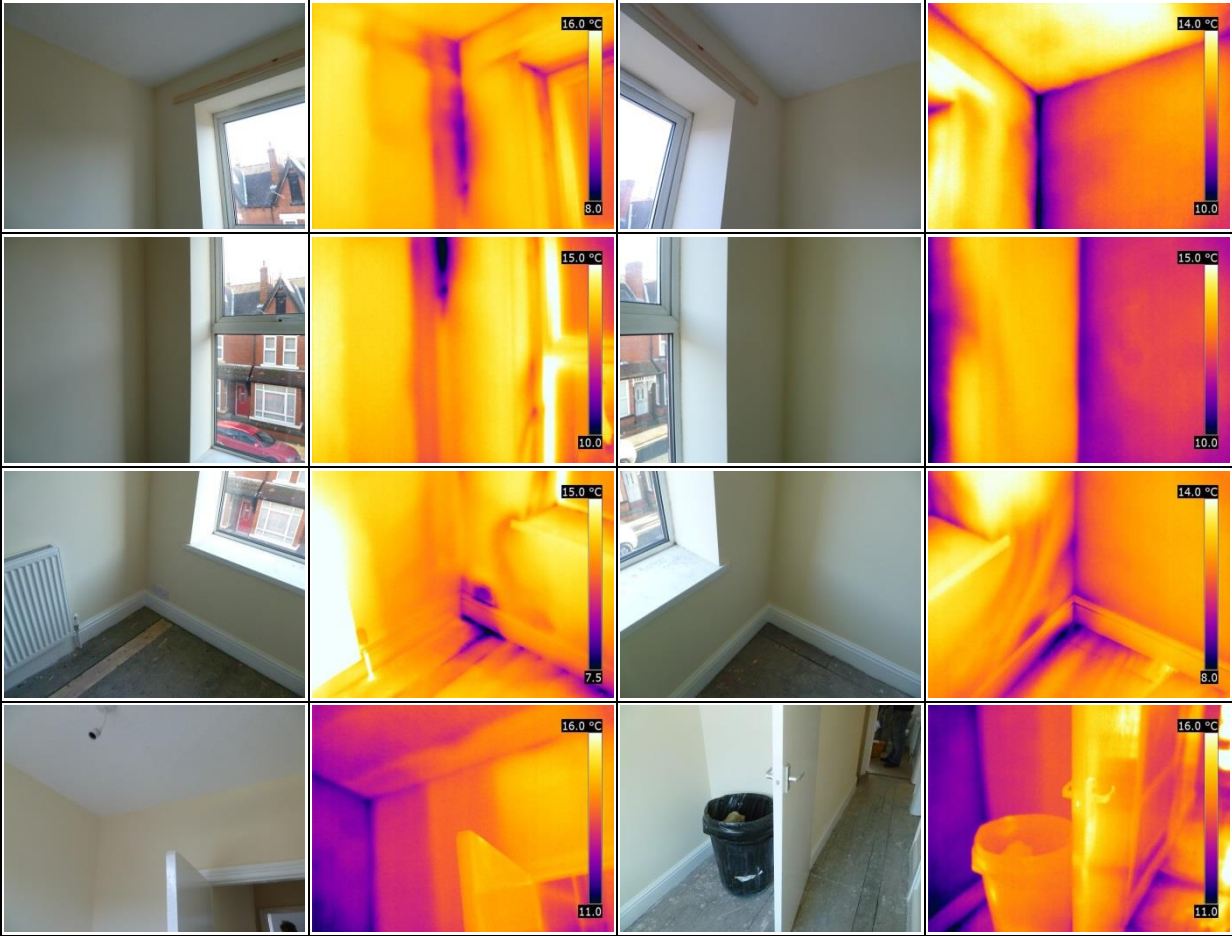
The compartmentalisation of the partition wall observed from bedroom 1 was also apparent from this room, as again was some air movement behind the plasterboard on the external wall and at the window reveals; although little air movement was observed entering here from the attic. Also, the void above the stairs showed similar temperature variation between sections. Air movement around the floor perimeter was also detected once more.

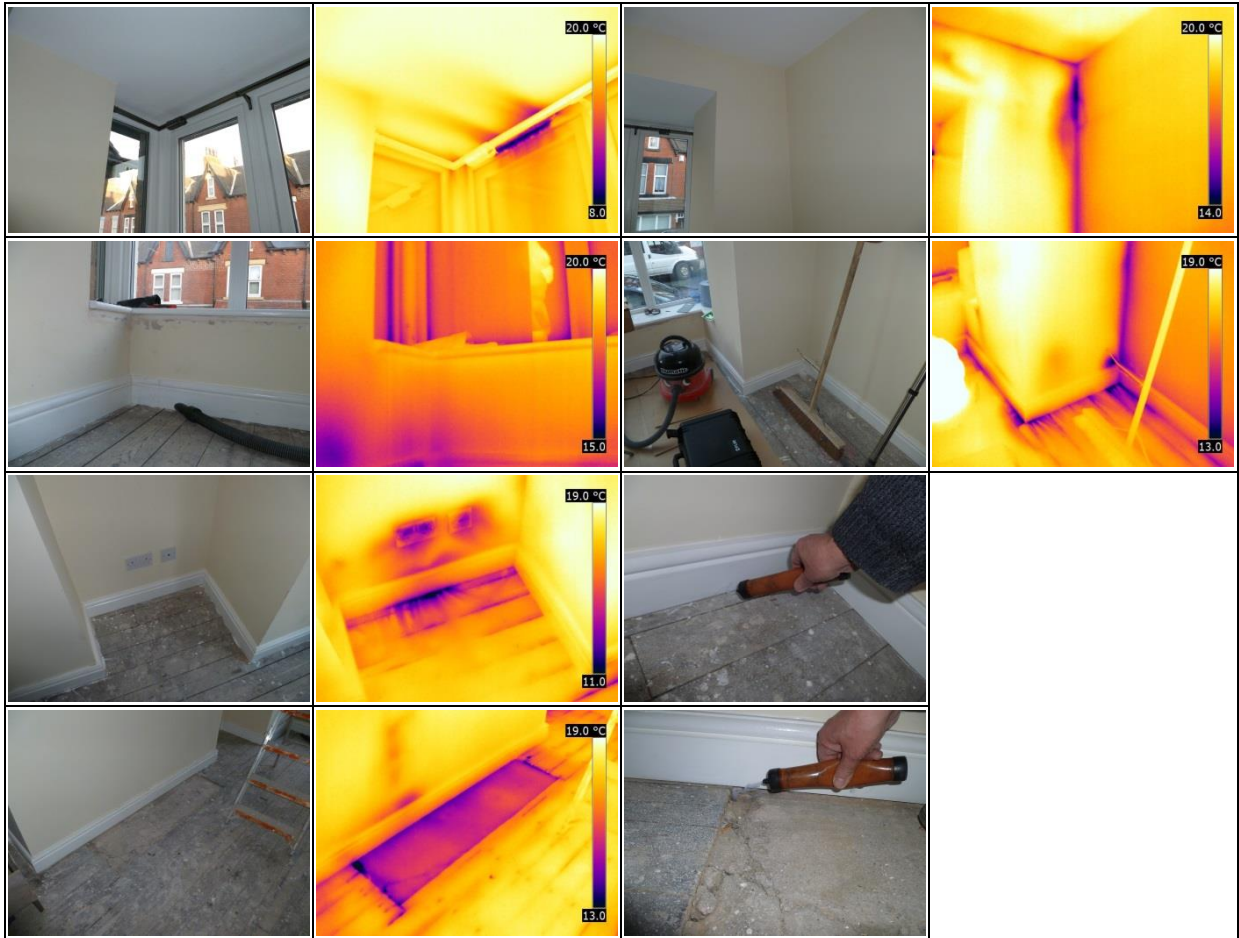
Lounge Air leakage was detected at the floor perimeter; on the internal wall adjacent to the kitchen, on the party wall at the chimney breast and beneath the electrical socket and around the side of the bay adjacent to the hall. Air leakage was again detected at the trickle vents, this time primarily between the vents and the window frames rather than through the vents themselves. No significant air leakage was detected around the external wall insulation, around the window reveals and sills or through the windows themselves, as had been apparent previously and in No.16.

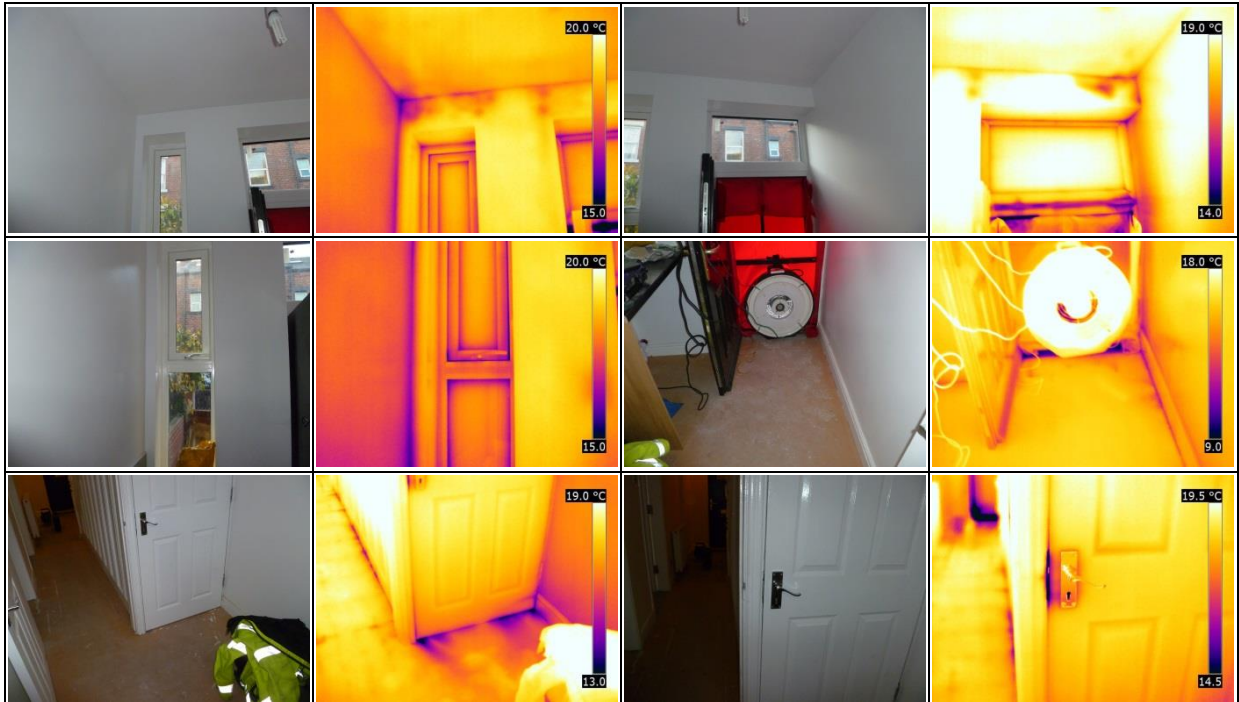
As previously observed there was minor air leakage at the external wall junction with the intermediate floor and at the ground floor perimeter. However, more significant air movement was detected around the cellar door around the lock and underneath the door.

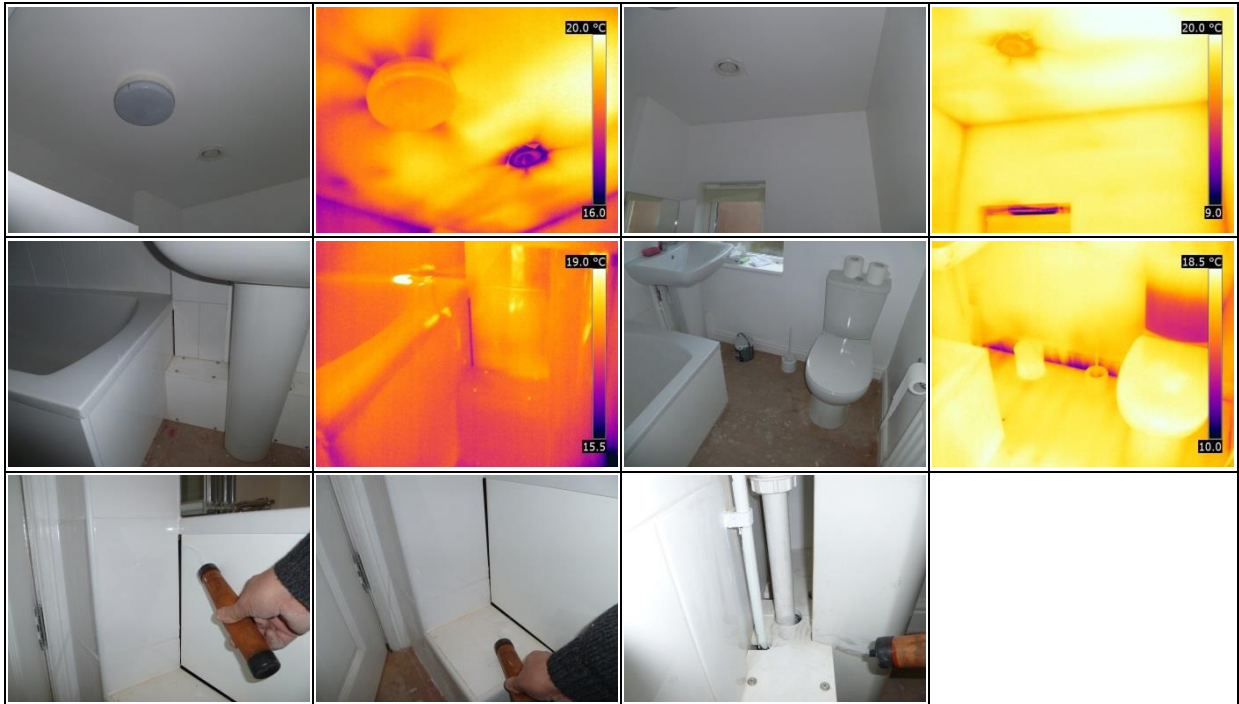
No cooler air was detected being drawn down from the loft at the wall/ceiling junctions, just a small amount around the penetrations for the central light and MVHR extract grille. There was much more significant air movement into/out of the connected service voids behind the pedestal and bath panel, this was barely detectable using thermography as the emitted air was at near room temperature but under pressurisation proved to be the areas where smoke was drawn most strongly in the whole house. Infiltration was also detected at the external wall junction with the intermediate floor and at the trickle vent.

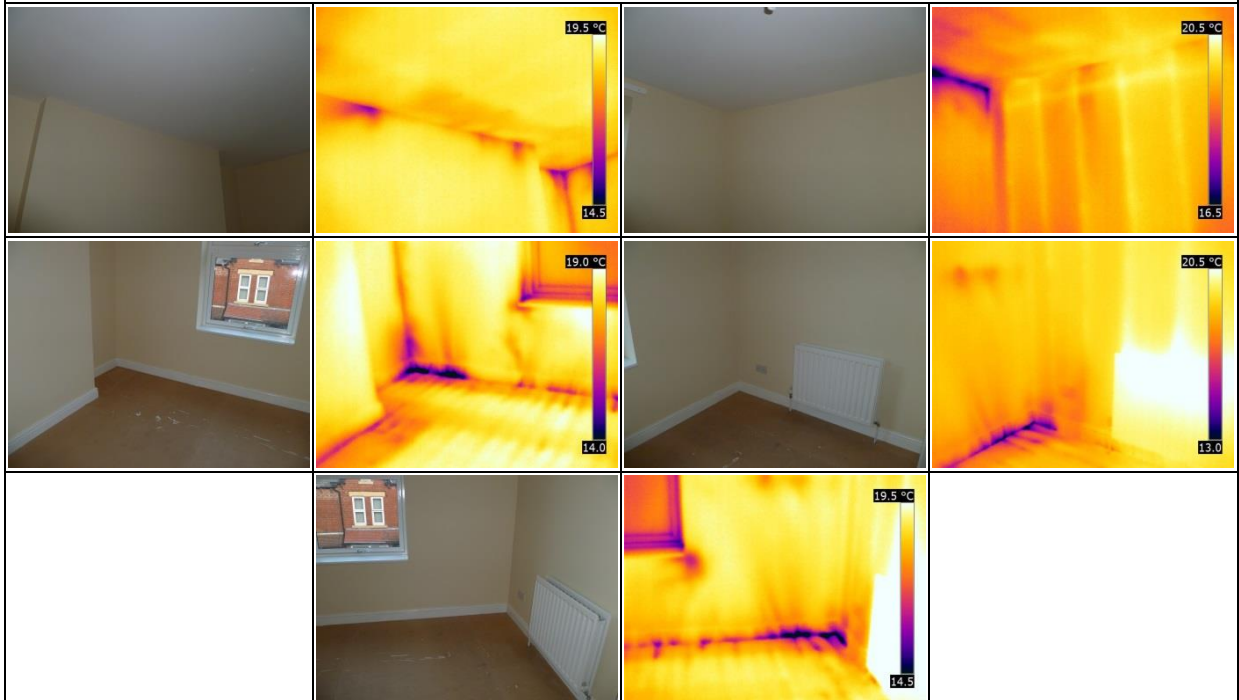
Bedroom 1

Infiltration was observed at the loft perimeter, behind the plasterboard, and more significantly at the junction of the external wall and intermediate floor. Some air movement was also detectable around the window sill.

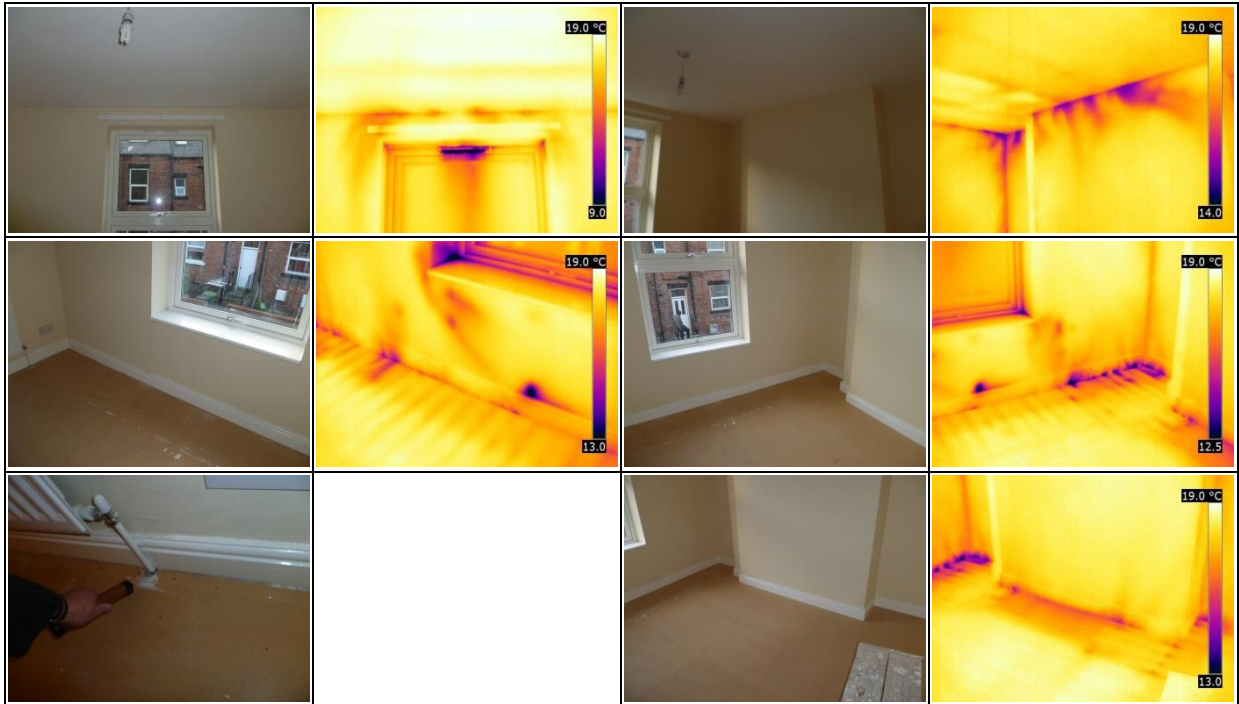
Bedroom 2

As in bedroom 1, air movement was detected at the floor and loft perimeters and at the trickle vent. At the external wall junction with the intermediate floor there were a number of spots where this was much more clearly seen, with the section of intermediate floor between the wall and the first floor joist noticeably cooler. Also, there was increased air movement around the window opening, behind the plasterboard, than had been previously detected in this property.

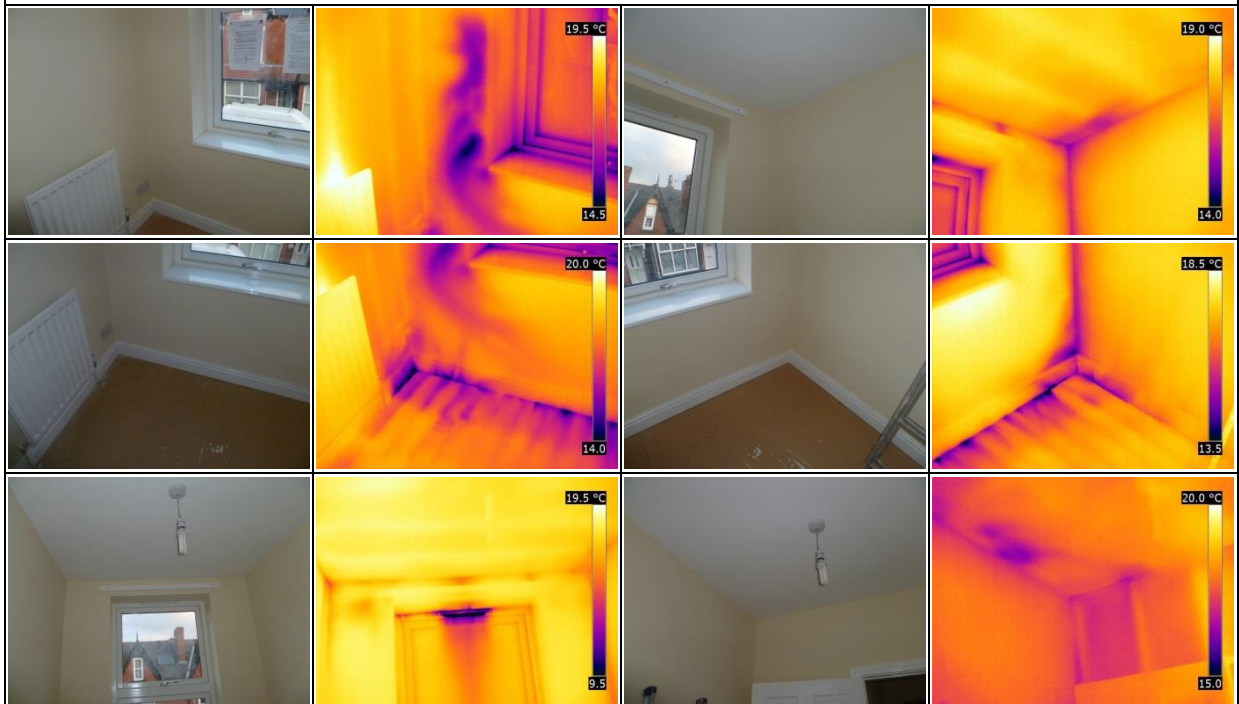
Bedroom 3

Air leakage around the window was detected, more so than throughout the rest of the dwelling. The external wall junction with the intermediate floor was also less airtight than elsewhere in the house. Leakage around the trickle vent was again conspicuous and small areas of the ceiling and the internal wall adjacent to the void above the stairs also showed cooler areas, but not as marked as those seen in No.16.

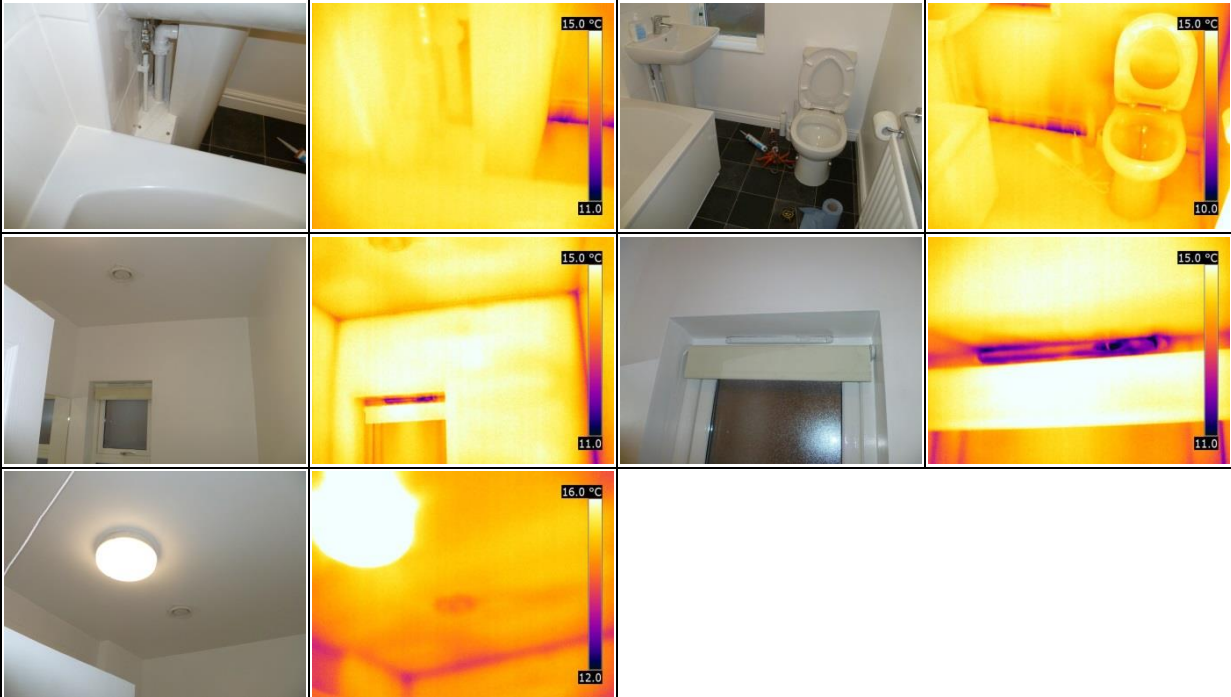
The additional sealing around the service voids behind the pedestal and bath panel greatly reduced the leakage detected at this detail, but it was still one of the major air leakage areas in the property. Infiltration previously detected at the external wall junction with the intermediate floor was still present.

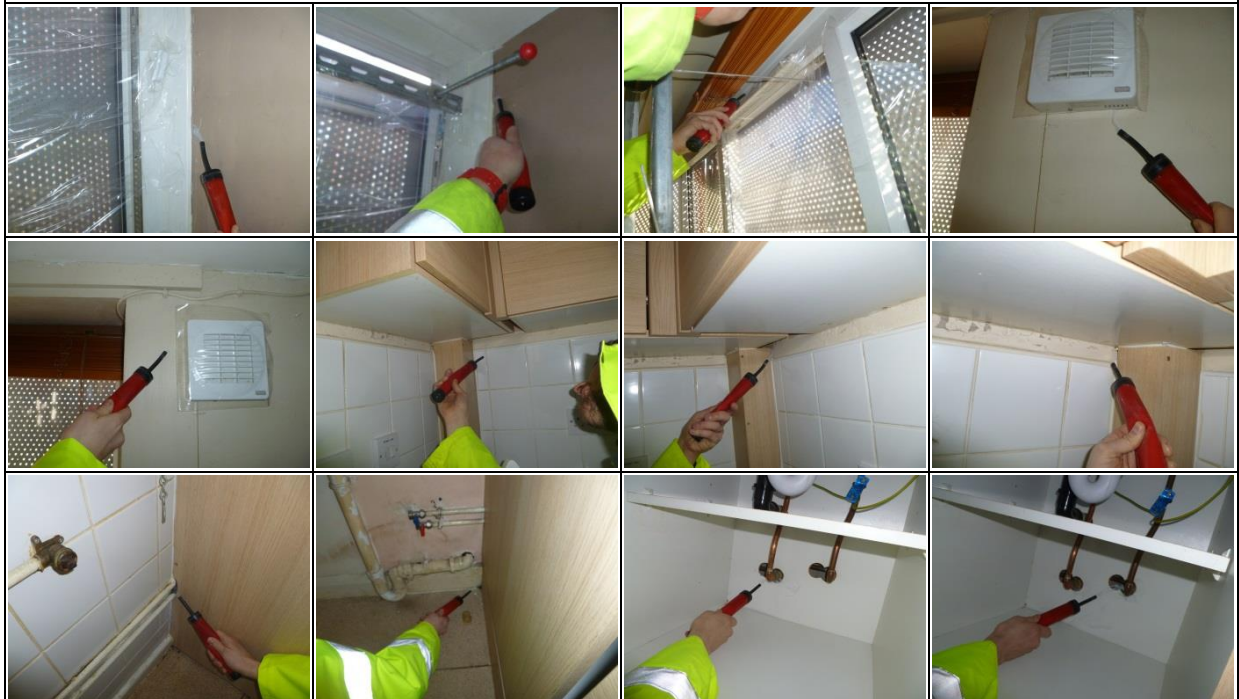
In the basement lobby air leakage was detected around the door frame, through visible cracks where it met both party and internal walls. The trickle vent in the kitchen window also performed poorly; although it closed reasonably effectively there was significant air movement between the clip-in vent and the window frame itself. The intermittent extract fan also permitted air movement between itself and the wall, even though the fan itself was temporarily sealed for the purpose of the test. The most substantial air leakage was detected into the voids behind the kitchen unit. This was observed at both wall and floor mounted units. As the basement is likely to be the main infiltration zone when the house is occupied, it is envisaged that cold air ingress from behind the units may not only have energy performance issues but may also result in discomfort to future occupants.

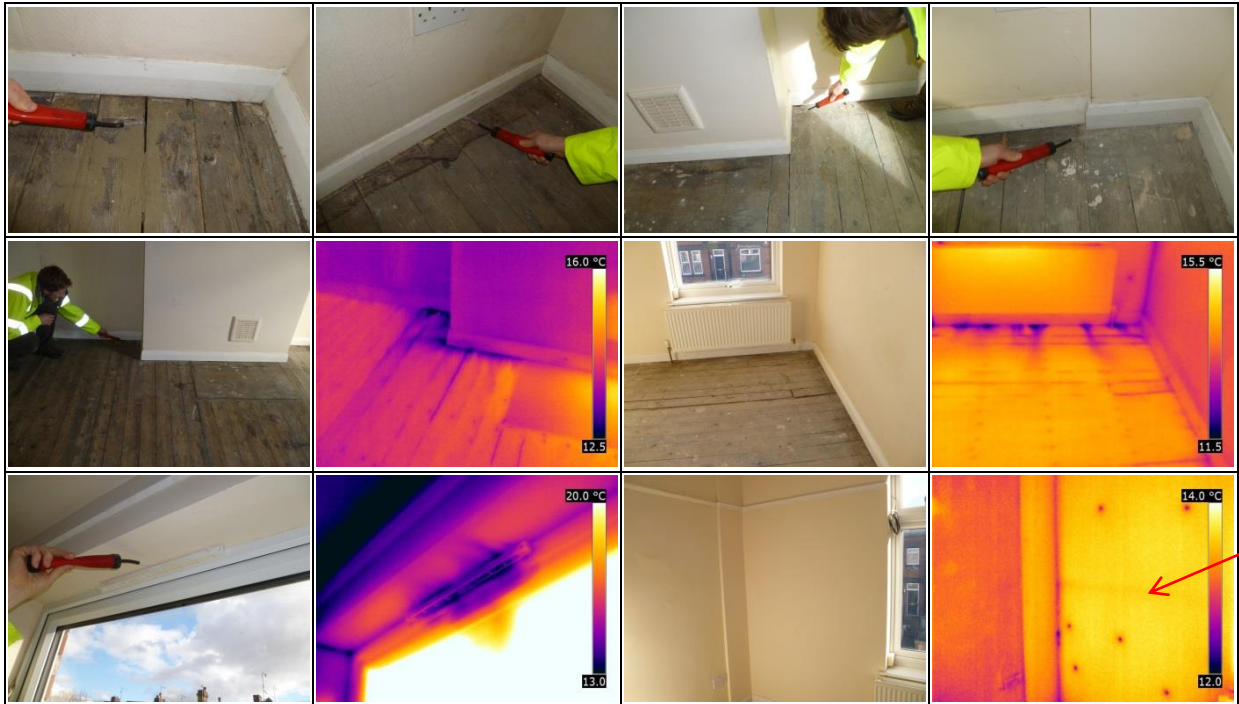
Even with a very small ΔT joints between the IWI panels were appearing to be detectable through thermography (arrowed), it would be interesting to see if this worsens as ΔT increases.

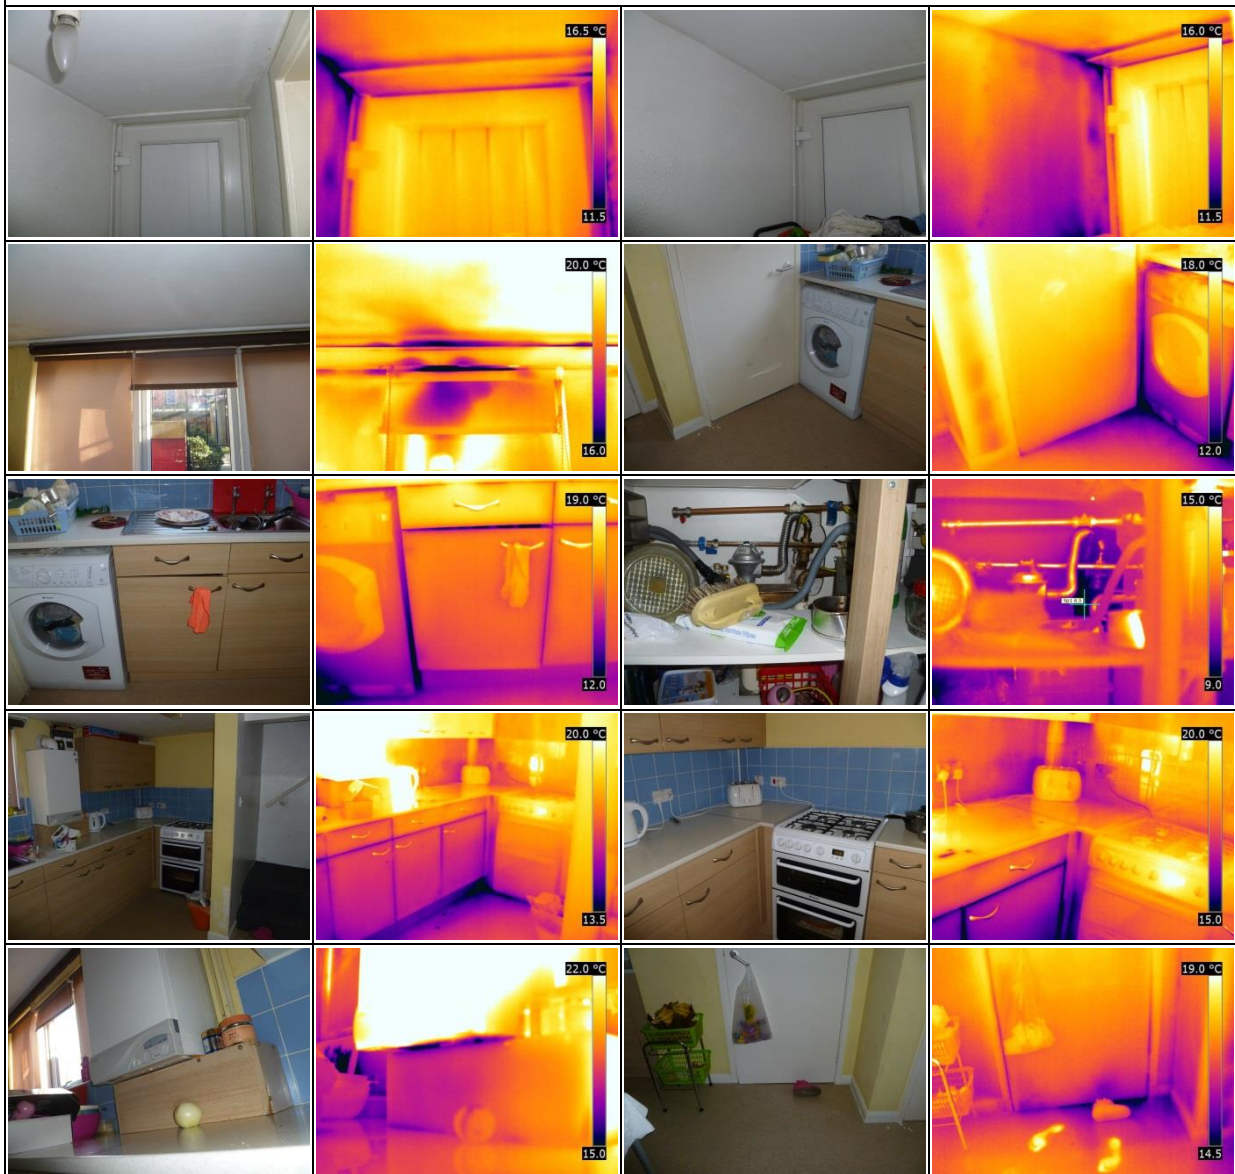
Cold air was observed emerging from the kitchen cupboard; however, it was not possible to determine whether this was air leakage or just that the air in the cupboard was cooler than that in the kitchen.

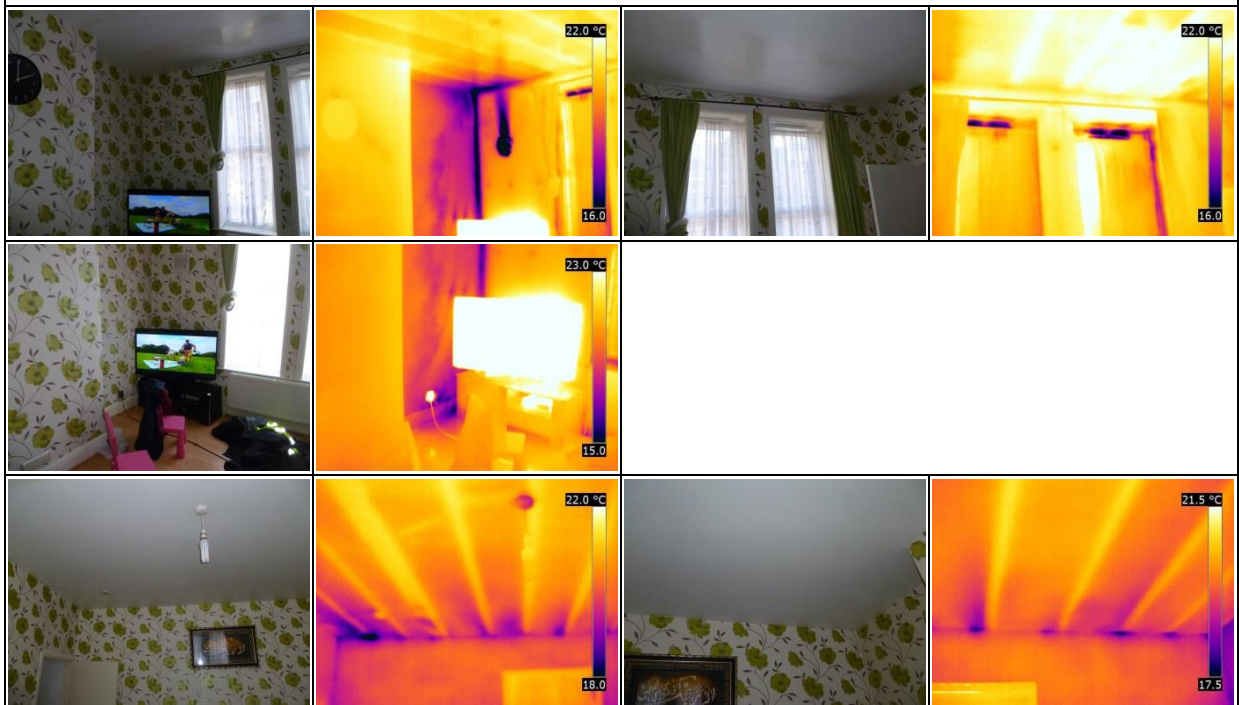
At the party wall junction with the external wall infiltration was detected around the IWI.
 Air leakage was also observed around the vent in the external wall.
 Leakage could be seen at the window at the trickle vents and to a lesser extent around the window frame.
 On the rear party wall, cooler air could be seen being drawn into the intermediate floor void around the built in joists.

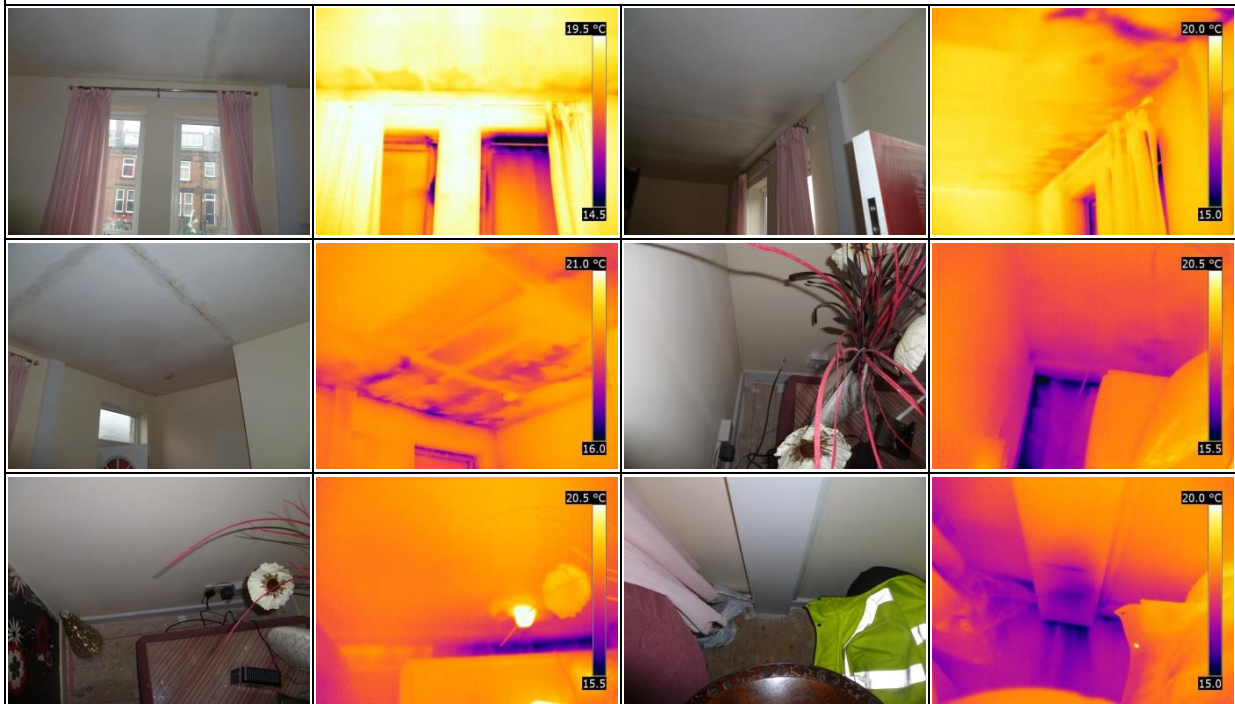
As in the basement, air leakage could be observed around the windows where the security screens had been removed, around the trickle vents and into the intermediate floor void. Significant air ingress was detected around the floor perimeter, most noticeably at the exposed floorboards and under the skirting and on the external wall at the junction of the floor and vertical plastic ducting.

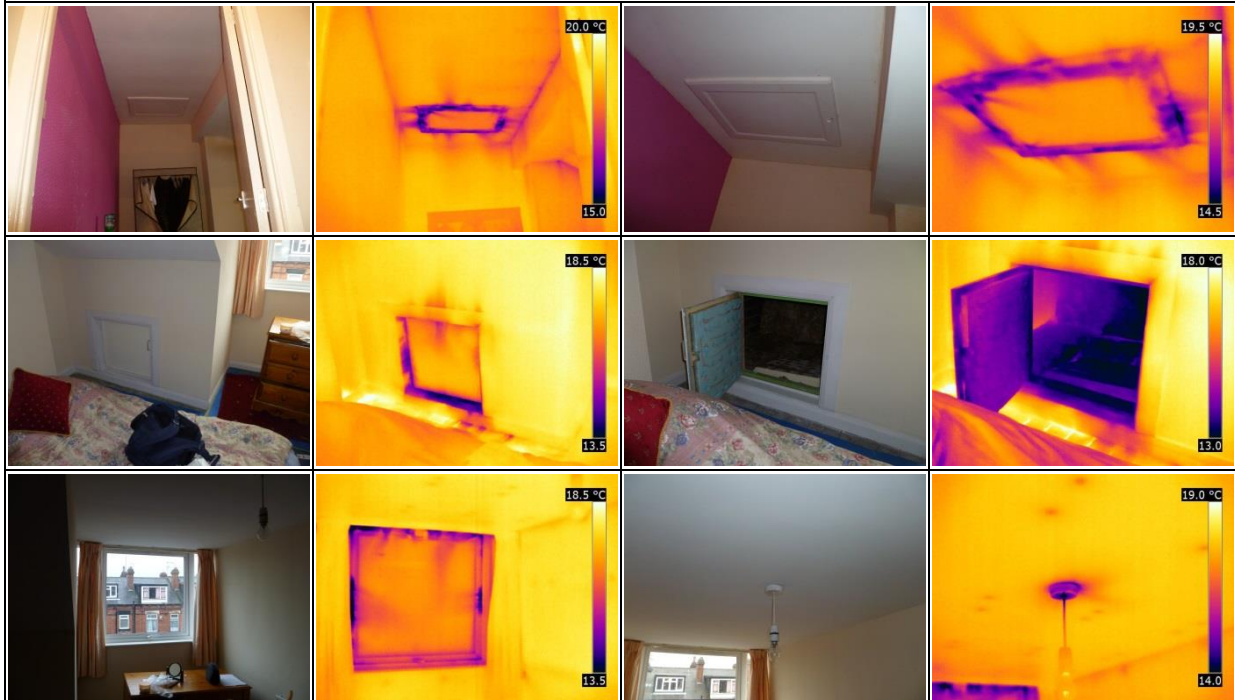
Other air paths included direct leakage at the window and central light fitting.

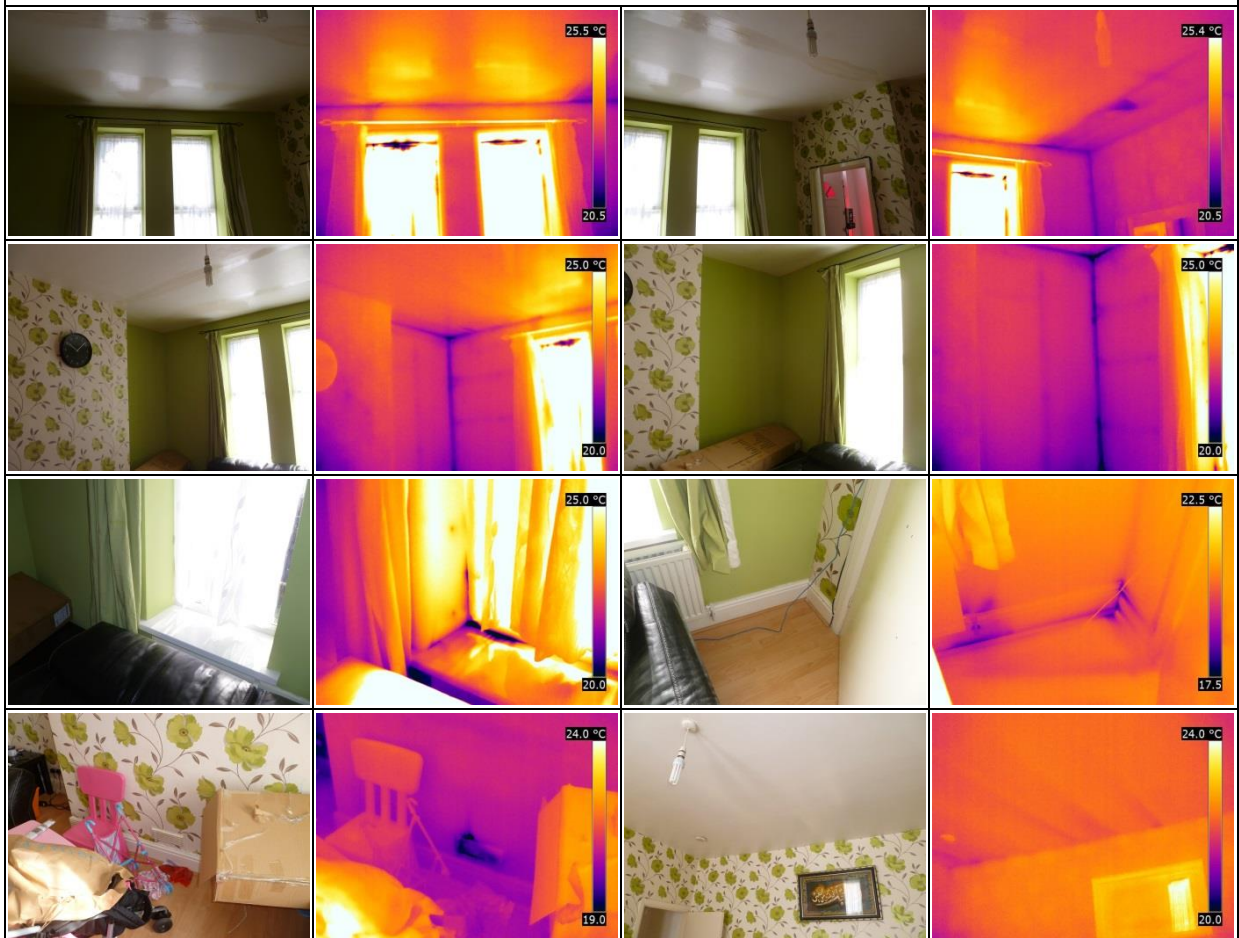
On the rear party wall, cooler air previously seen being drawn into the intermediate floor void around the built in joists had reduced significantly.

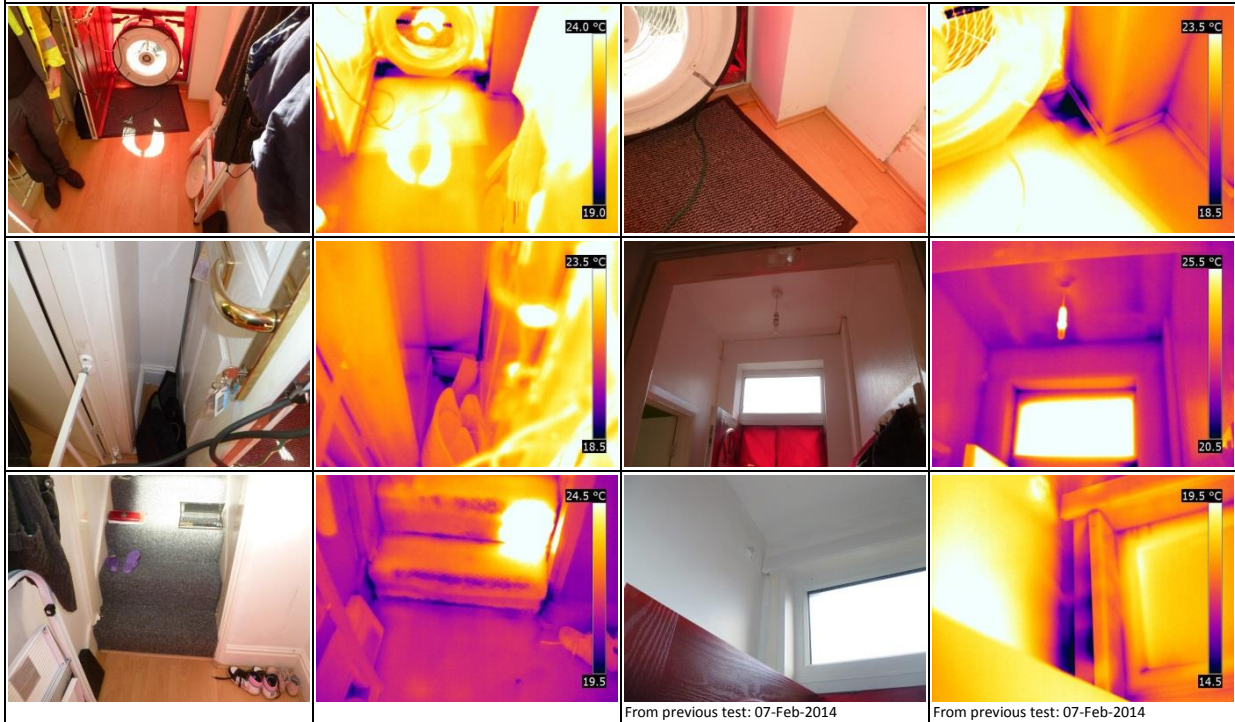
Around the front door and window there had been a noticeable improvement in airtight performance, but air movement into the intermediate floor void above the door appeared unchanged.

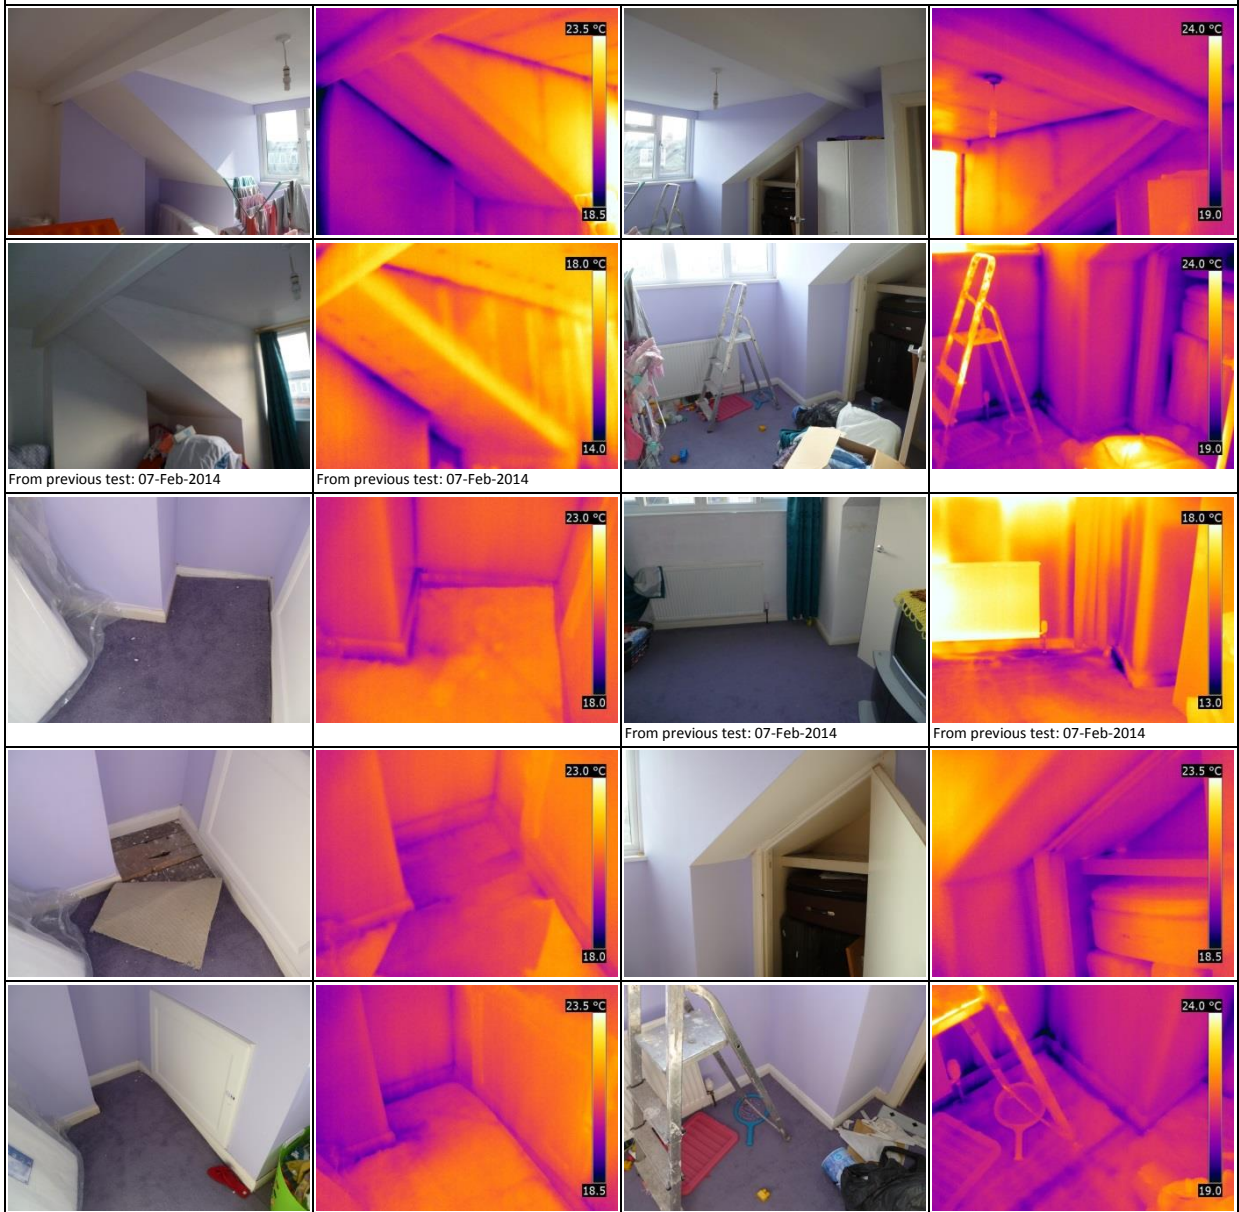
Air leakage through the intermediate floor actually appeared to be worse than previously observed; with the carpet lifting throughout the room, especially where there were holes in the floor, and joints between floorboards visible through the carpet. Along the rear wall junction with the floor the air emerging was still cool enough to show clearly in the thermal images.

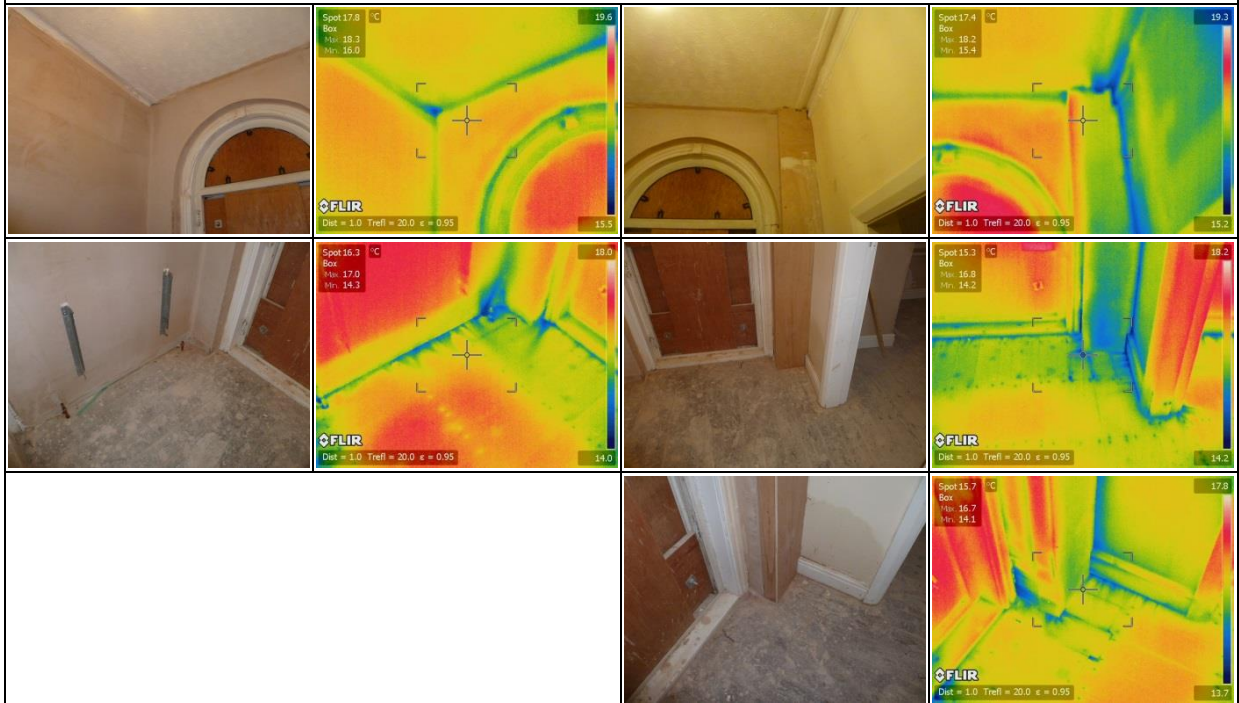
The ground floor perimeter appeared to be far more problematic, with noticeable infiltration at all floor/wall junctions and at the base of the stairs.
