SAFETY FLYER TO THE FISHING INDUSTRY

Fishing vessel *Ardent II* (INS 127), fire while alongside, 16 August 2016

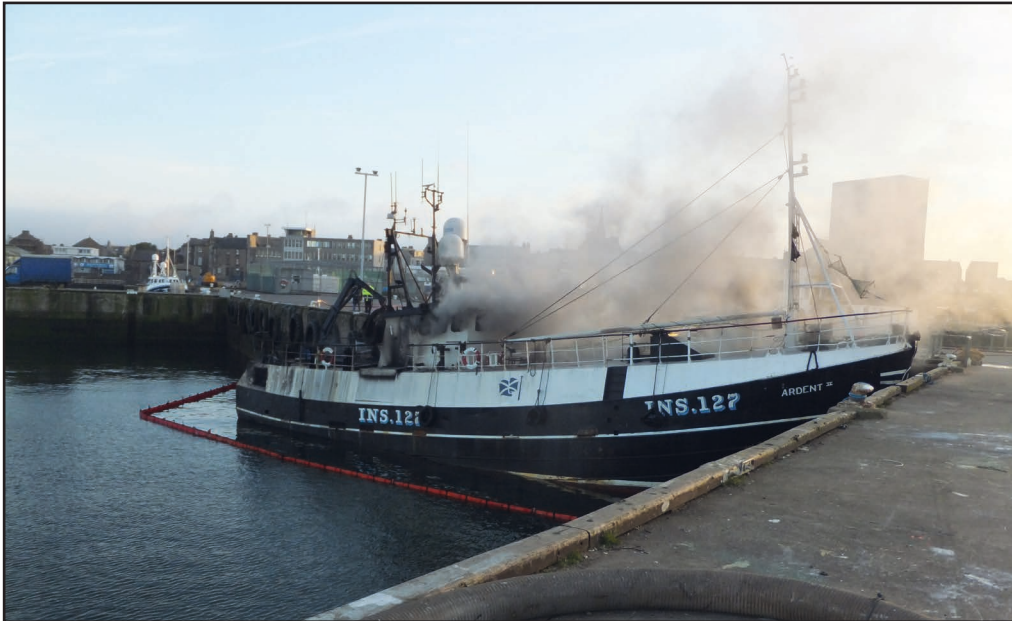
Figure 1: *Ardent II* on fire

At approximately 0500 on 16 August 2016, a fire started in the crew mess room of the fishing vessel *Ardent II* while alongside in Peterhead (**Figure 1**). The three crew sleeping on board escaped without injury but the vessel was extensively damaged.

At 0537, the emergency services were called after the three crew, who had escaped with none of their possessions, alerted the crew of a nearby fishing boat. Flames were seen emitting from the watertight doorway between the crew mess room and the aft net drum space. At 0546, the first fire appliance was on scene and the fire service continued to tackle the blaze until the following day. By this time, the vessel was extensively damaged and was later declared a constructive total loss.

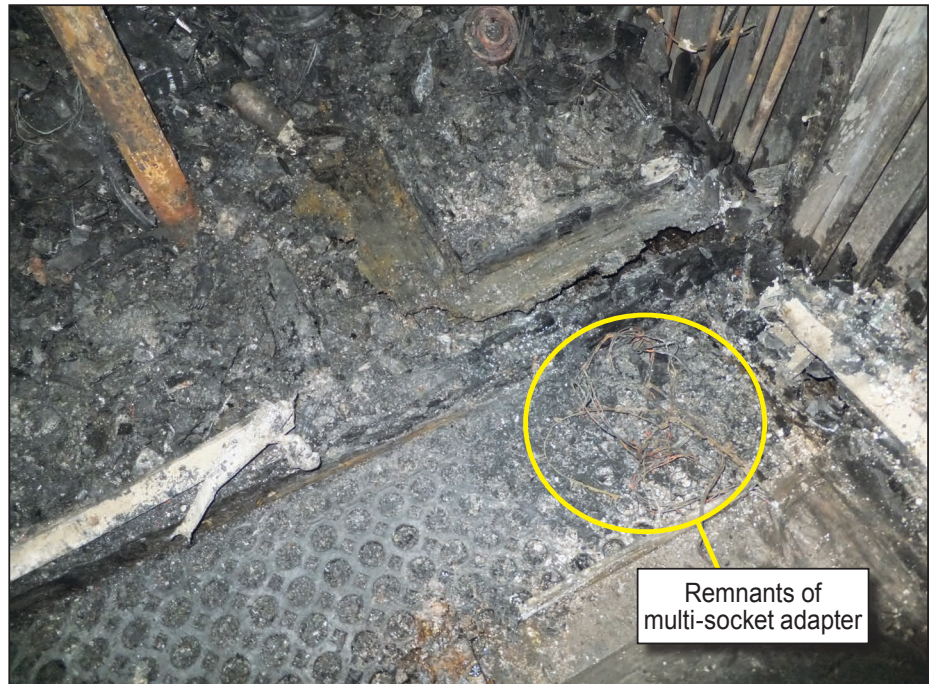
1. On examination, it was determined from the fire patterns and other evidence that the most likely source of the fire was an electrical multi-socket adapter (**Figure 2**), which supplied a domestic freezer in the crew mess room. Fishing vessel owners and skippers have a responsibility to ensure electrical equipment is maintained in a safe condition. Regular visual inspection of electrical equipment to check for bare wires, that appropriate fuses are in place, and for signs of burning, together with regular Portable Appliance Testing (PAT), would provide an effective means for reducing the risk of electrical fires.

Figure 2: Remnants of multi-socket adapter
