# Post-incident reporting for reservoirs

## Annual report 2016

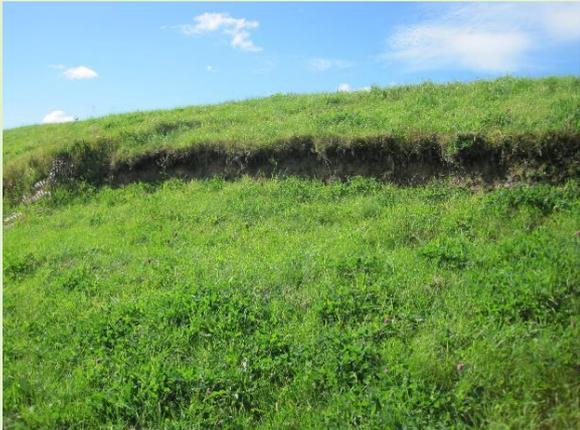
Incident 421	
<b>Dam type</b>	Earth embankment
<b>Reservoir legal status</b>	Statutory impounding reservoir
<b>Dam height (m)</b>	9
<b>Incident type</b>	Embankment instability
<b>Incident severity</b>	3
<p><b>Description</b></p> <p>A historical area of instability on the downstream face of an embankment dam was noted as having become reactivated as a tension crack was evident. A precautionary drawdown of the reservoir was completed to 1m below top water level. The area was monitored by installing vibrating wire piezometers. In 2016 works were carried out to remediate the slip area. Steel sheet piles were driven into the foundation at the downstream toe. When excavating the slip material, it was evident that the fill material was of poor quality and saturated. The reservoir was lowered by a further 3.85m before work continued. The slipped material was replaced by rockfill placed over a filter layer. The reservoir level was slowly restored to its normal level. The work was considered successful.</p> <p><b>Lessons learned</b></p> <p>The nature of fill materials in old dam embankments can vary over the length of the embankment leading to local instability. Areas of instability can become reactivated over time.</p>

<p>Photo 1: 2012 slip</p>

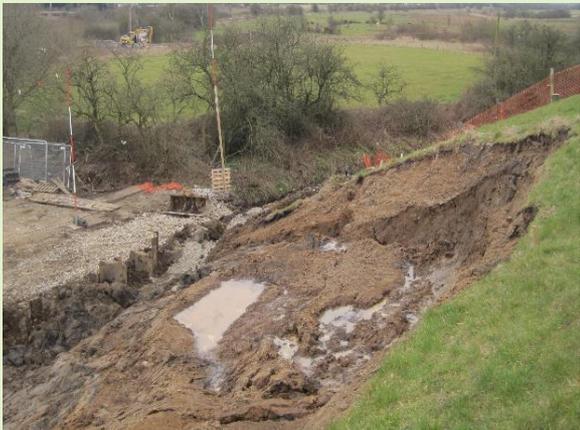
<p>Photo 2: saturated fill material during excavation March 2016</p>

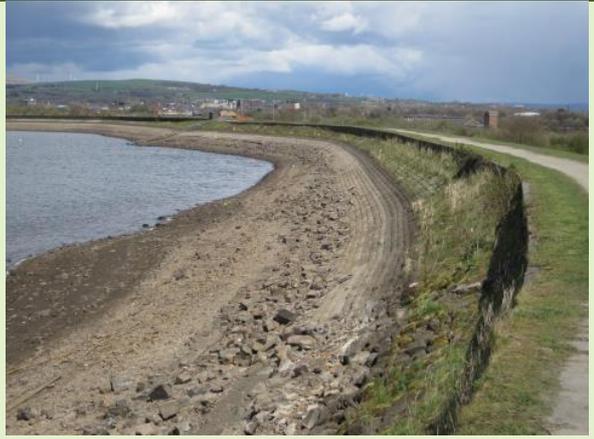
Photo 3: reservoir level reduced April 2016

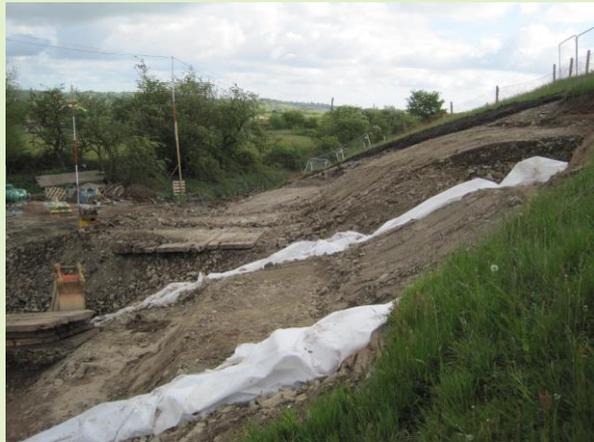
Photo 4: placing rock-fill May 2016

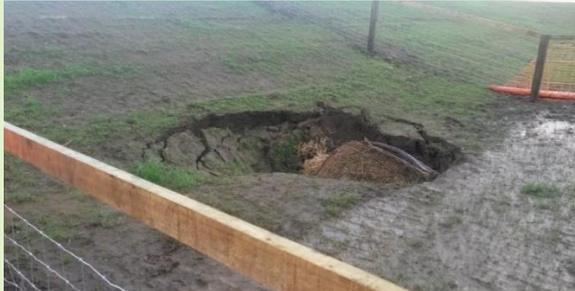
Incident 422	
<b>Dam type</b>	Earth embankment
<b>Reservoir legal status</b>	Statutory impounding reservoir
<b>Dam height (m)</b>	4
<b>Incident type</b>	Mining
<b>Incident severity</b>	2
<p><b>Description</b></p> <p>A 3m-diameter sink hole at the outer toe area of a flood storage reservoir embankment appeared. The area was excavated and the sinkhole was found to extend to a depth of 2m and connect with a horizontal cavity at the upper surface of the mudstone bedrock. The area was remediated by excavating the damaged area and infilling with free-draining material wrapped in a geotextile fabric. In the following month, three further sink holes appeared, one on the site of the first sink hole and two further sinkholes further from the embankment toe. Further remediation work was carried out and a 1.5m-high berm was added to the outer toe of the embankment to improve its stability. Investigations indicated that the depressions were related to deep coal mining activity. The embankment had recently been raised to offset the impact of settlement caused by the mining. A quantitative risk assessment was carried out and it is planned to further improve the stability of the affected embankment section by driving a row of steel sheet piles on the line of the crest into the bedrock. As the mining has now ceased it is hoped that further movement of the area will be not be significant.</p> <p><b>Lessons learned</b></p> <p>Subsidence due to coal mining can lead to fissuring of the ground surface and may materialise at the ground surface as a row of sinkholes. The movement can continue for many years after the mining has been completed and it can be difficult to anticipate where damage to surface structures might occur. Where safety-critical structures are located in the vicinity of a line of sub-surface movement it will often be prudent to take proactive measures to strengthen structures before the movement</p>

<p>Photo 1: sinkhole at toe of embankment</p>

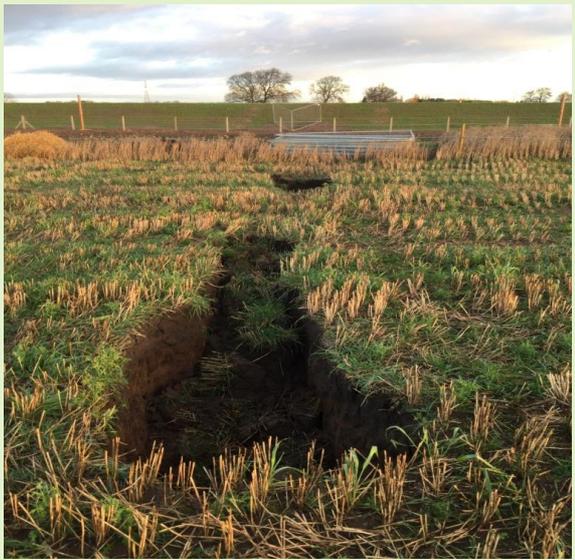
<p>Photo 2: sinkhole further from embankment toe</p>

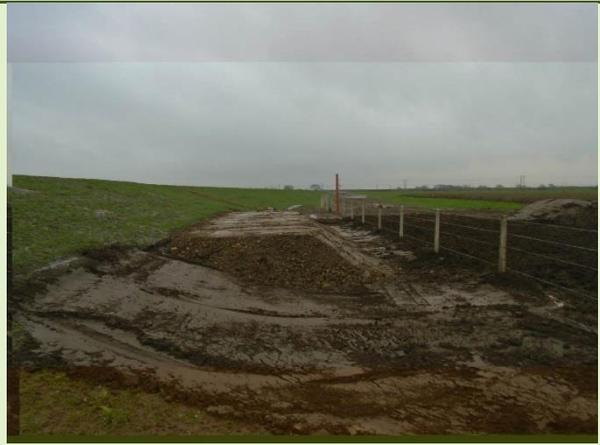
Photo 3: berm constructed to aid stability

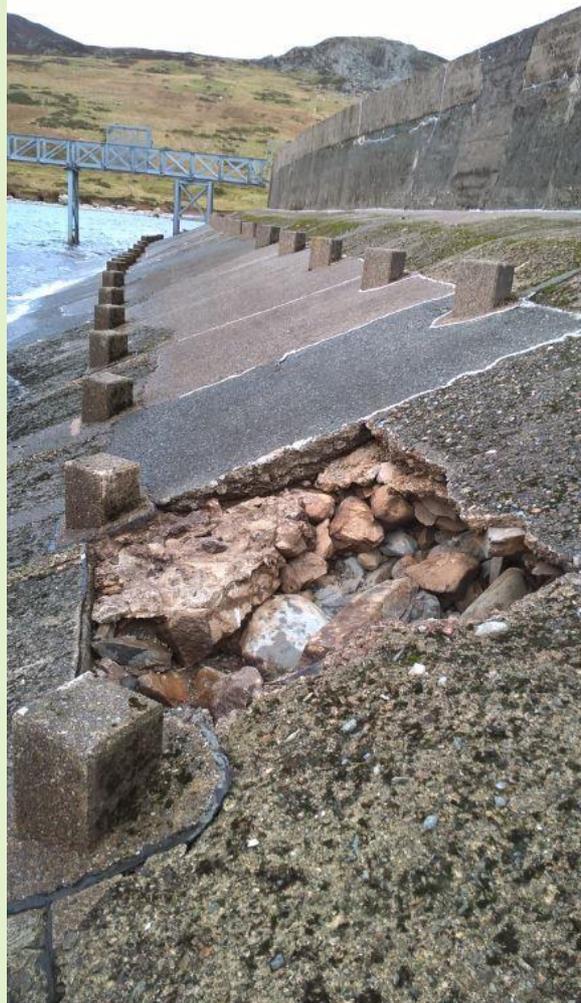
Incident 426	
<b>Dam type</b>	Earth embankment
<b>Reservoir legal status</b>	Statutory reservoir
<b>Dam height (m)</b>	25
<b>Incident type</b>	Wind, waves, deterioration of upstream face protection
<b>Incident severity</b>	2
<p><b>Description</b></p> <p>The upstream face of the embankment dam was protected from wave action by rip rap on the lower section of the face and rip rap overlain with a mass concrete slab on the upper section. Following a two-day period of unusually high water levels and wave action, a hole in the concrete slab was identified. Some material from underneath the slab had been washed out but the embankment fill had been protected by the underlying rip rap layer. It is believed that voiding under the slab had arisen due to settlement of the embankment and that a loss of support had contributed to the failure of the face protection. The reservoir was lowered to allow a repair to be completed.</p> <p><b>Lessons learned</b></p> <p>Rigid facing systems such as concrete slabs can be effective in protecting the upstream face of a dam from wave erosion. Problems can arise if the slab design cannot accommodate settlement of the underlying fill material combined with wave loadings.</p>

<p>Photo 1: hole in concrete slab</p>

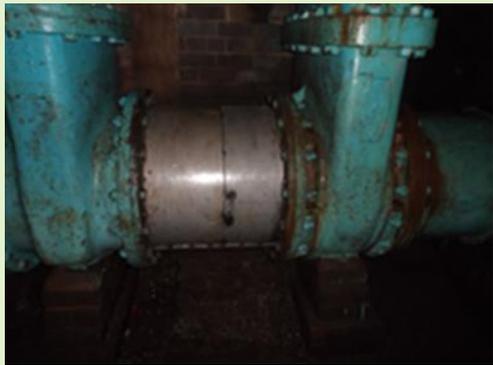
Incident 427	
<b>Dam type</b>	Rockfill
<b>Reservoir legal status</b>	Statutory reservoir
<b>Dam height (m)</b>	44
<b>Incident type</b>	Failure of draw-off pipe
<b>Incident severity</b>	3
<p><b>Description</b></p> <p>A review of the condition of the pipework and valves at a large concrete/masonry gravity dam identified a short section of steel pipe on two of the four low level scour mains within the dam body with inadequate pipe thickness. These sections warranted improvement works but could not be isolated from reservoir pressure as they are located downstream of the abandoned original guard valve and upstream of the replacement guard and duty valves. One of these pipe sections was successfully encapsulated with a collar and rendered safe. Due to further deterioration in the condition of the other pipe section it was considered too dangerous to the workforce within the confined space within the dam to complete a similar repair. It was therefore necessary to substantially lower the reservoir and use divers to install a temporary plug at the inlet to the scour main to provide adequate isolation and protection to the workforce in completing the repair work. Had either of the two pipe sections failed, it is unlikely that reservoir safety would have been compromised but the reservoir would have drained in an uncontrolled manner through the failed pipe section.</p> <p><b>Lessons learned</b></p> <p>This incident demonstrates the value of periodic asset condition surveys on pipes and valves within dams through non-destructive testing and visual assessments. Such surveys can inform asset planning to schedule improvement and remedial works to minimize the risk to reservoir safety, water supply and the safety of those tasked with undertaking the repair or improvement works. Isolation of the scour main was successfully completed using divers but this can be challenging and hazardous work and should be avoided as far as possible through effective asset management.</p>

<p>Photo 1: Short section of steel pipe on the scour pipe</p>

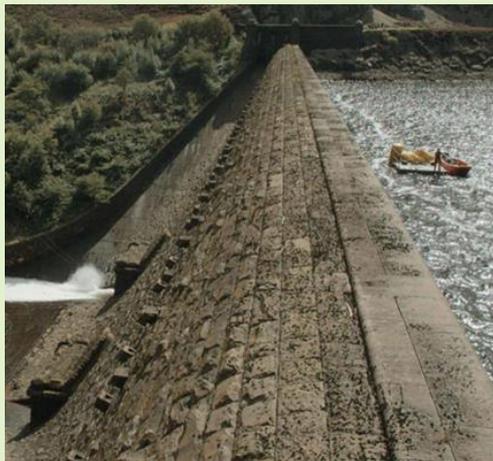
<p>Photo 2: upstream can be seen the diving platform and downstream can be seen one of the scour pipes discharging.</p>

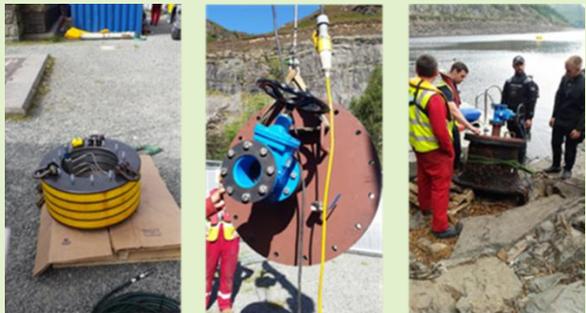
<p>photo 3: from left, inflatable plug, plate and bellmouth.</p>

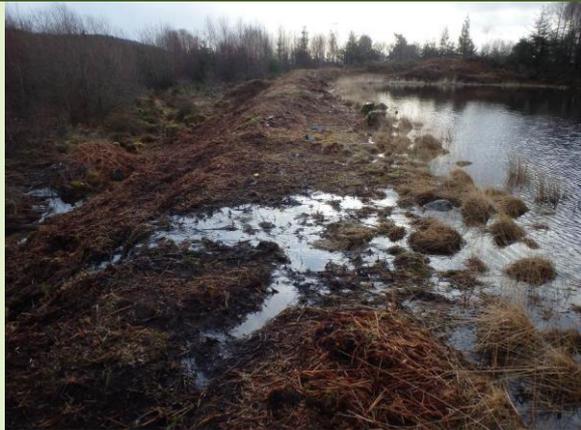
Incident 428	
<b>Dam type</b>	Earth embankment
<b>Reservoir legal status</b>	Statutory reservoir
<b>Dam height (m)</b>	4.5
<b>Incident type</b>	Inflow flood, erosion by overtopping
<b>Incident severity</b>	2
<p><b>Description</b></p> <p>A subsidiary dam embankment overtopped with floodwater following a period of very wet weather. Some erosion of the dam crest and downstream shoulder occurred at two locations either side of a small masonry overflow spillway. Emergency works were initiated to seal the eroded areas with sandbags, raise the elevation of the dam crest using sandbags and to provide temporary improvements to the spillway using plastic sheeting and sandbags. The reservoir does not feature any operational facilities for lowering the reservoir water level. The provisions for monitoring and surveillance were improved and studies and investigations are planned to improve the flood safety of the reservoir.</p> <p><b>Lessons learned</b></p> <p>The reservoir was not provided with sufficient spillway capacity and dam freeboard to prevent overtopping of an earth embankment dam in a moderately severe flood event. The event occurred at a reservoir which had only recently been registered under the Reservoirs Act 1975 and where earlier recommendations to improve the spillway capacity had not been completed. The Undertaker responded quickly to make temporary repairs to the eroded areas and to increase the dam freeboard until more permanent works could be completed to improve the flood safety of the reservoir.</p>

<p>Photo 1: Eastern breach location</p>

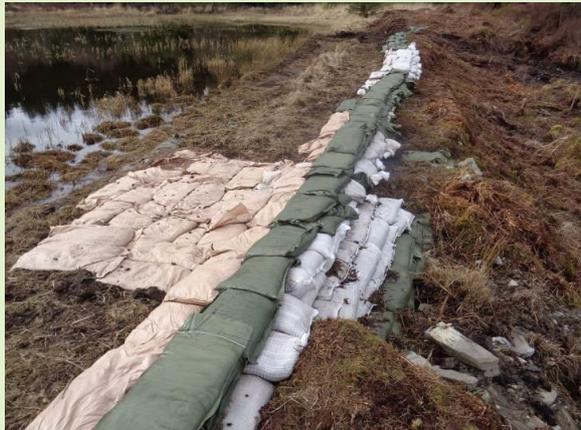
<p>Photo 2: western breach location, following works to seal the breach</p>
