# Trains struck a location cabinet door in Chipping Sodbury Tunnel, 20 February 2017

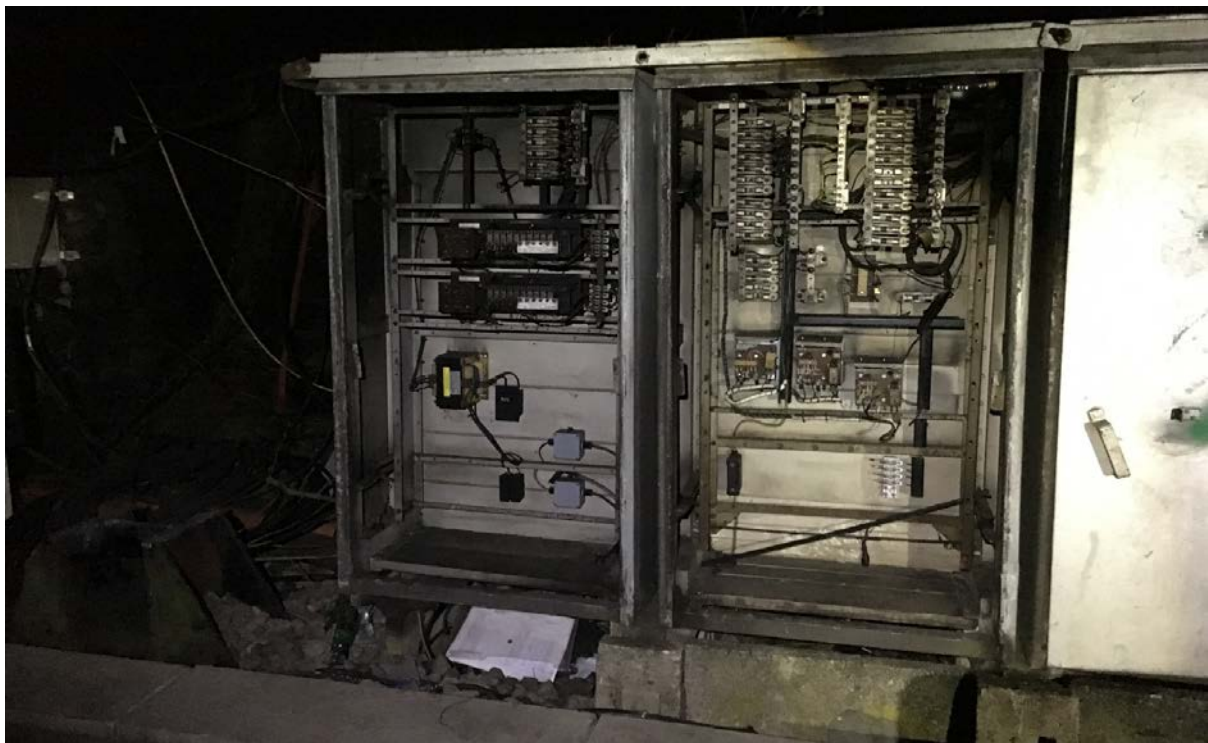
This accident occurred because the doors of two location cabinets near the eastern end of Chipping Sodbury Tunnel had not been secured following signalling work carried out during a possession the previous weekend, the 18 and 19 February 2017.

The location cabinets with missing doors (image courtesy of Network Rail)

There were delays to the work due to problems with the availability of plant, leading to insufficient time to remove these cabinets. Although staff have stated that the doors were closed when they finished work, an inspection following the accident found one door leaning against the back of the location cabinets. The remains of the other door (the one struck by the trains) were found just outside the tunnel. A padlock was found on top of one of the cupboards.
