# ***AAIB Bulletin***

***7/2017***

Spitfire IXT	G-LFIX	15-Sep-16	3
--------------	--------	-----------	---

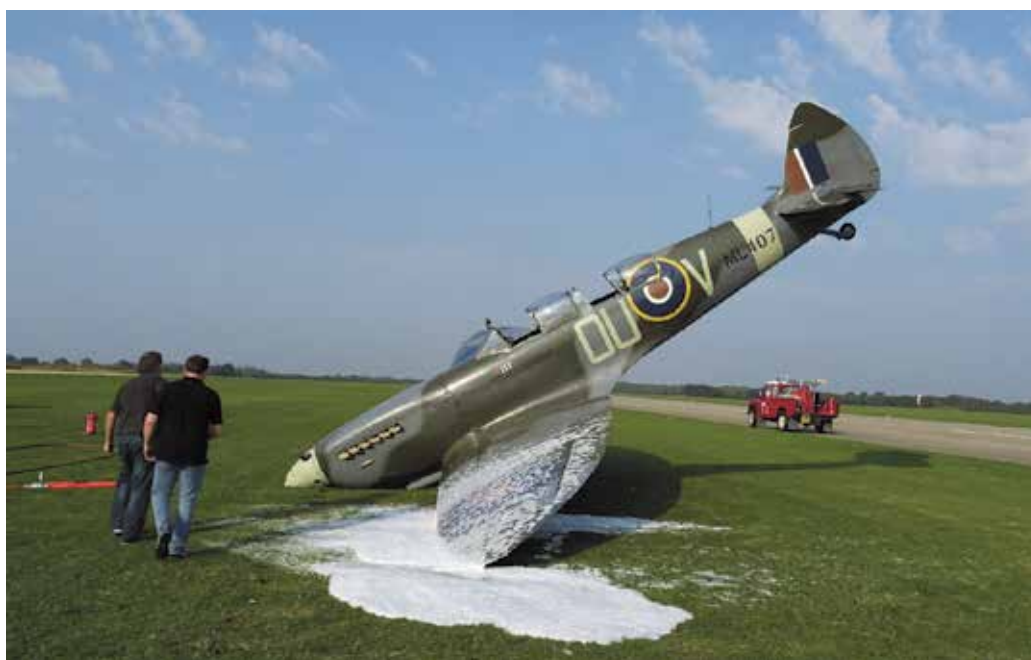
**Figure 1**

It was subsequently discovered that the left landing gear actuator seals had failed, preventing the actuator from achieving full extension.

G-LFIX after the landing gear collapse

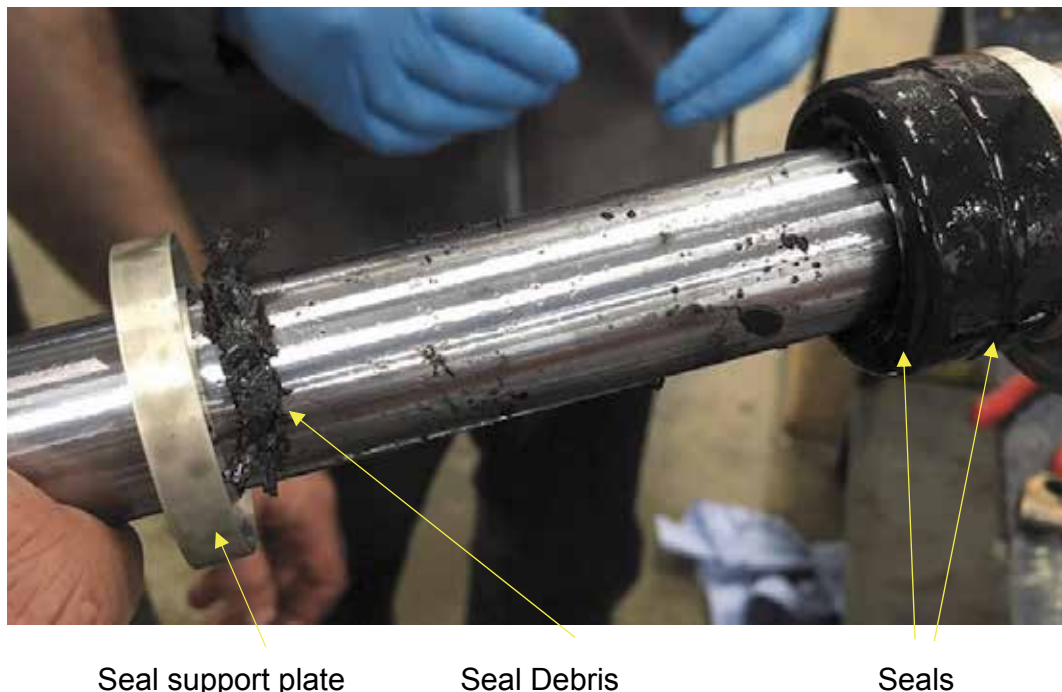
**Figure 3**

selector window. Further inspection revealed that the landing gear had failed to lock down because the landing gear actuator ram chevron seals had failed and pieces liberated from the seals had migrated between the actuator ram and the seal support plate, jamming the actuator ram before it reached its full extension (see Figure 3).

Seal debris on landing gear actuator ram

All the seals were passed to the AAIB. Examination under high powered optical microscopy confirmed that the failure of the seals had initiated in the region of the seal lip. The failure surfaces indicated that the seal lip material had been drawn between the seal and the actuator ram. Examination of the internal bore of the seals and the failure surfaces indicated that the seal failure had been progressive, with small amounts of material being liberated. The presence of this material between the seals and the hydraulic ram resulted in the release of further material which, over a number of operating cycles, produced sufficient material to jam the actuator ram within the seal pack.

The collapse of the left landing gear was caused by a failure of the landing gear actuator chevron seals, which jammed the actuator before the landing gear had reached the locked position.

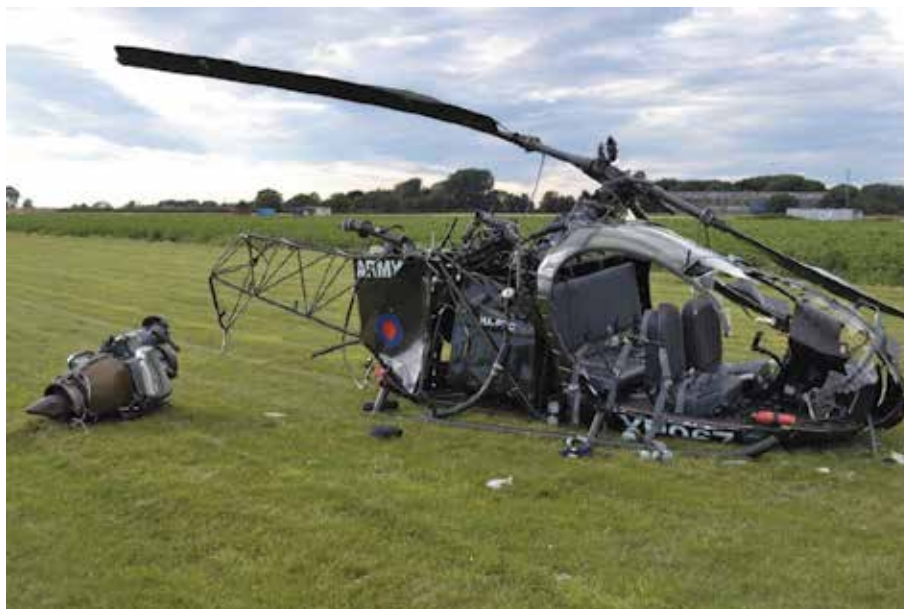
**Figure 1**

Helicopter wreckage

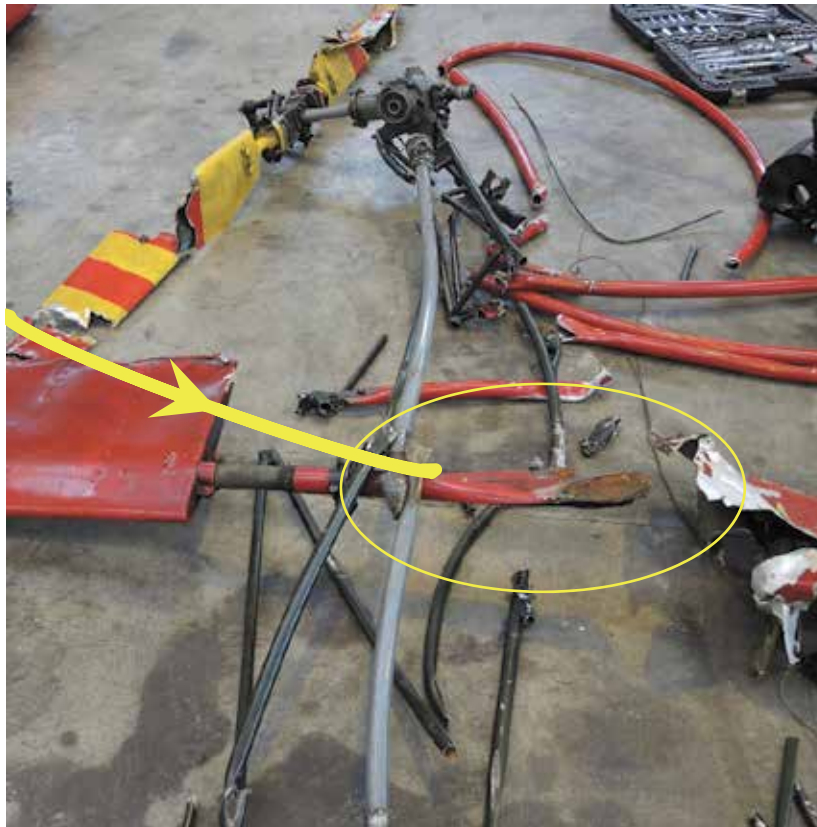
**Figure 3**

The helicopter component examination clearly shows that the main rotor disc came into contact with the tail boom structure. It is evident from the damage to the main rotor blades and their tips, along with the damage to the stabiliser and its cross tube, that the first impact was from the yellow blade closely followed by blue and the red blades in succession. The yellow blade tip missed the right stabiliser aerofoil but collided with the cross tube and on into the inboard trailing edge corner of the left stabiliser aerofoil. Figure 3 shows the damage to the stabiliser cross tube and path of the blade impact.

Damage to the stabiliser cross tube and path of the blade impact

This was the probable source of the “loud crack” described by the passengers and many of the witnesses. The tip fairing was crushed and detached and its deformation precisely matched the profile of the stabiliser trailing edge. In this initial impact, the cross tube was flattened and there is evidence that the yellow blade, whilst in contact with the cross tube, travelled underneath the tail rotor drive shaft and it is possible that it momentarily restricted

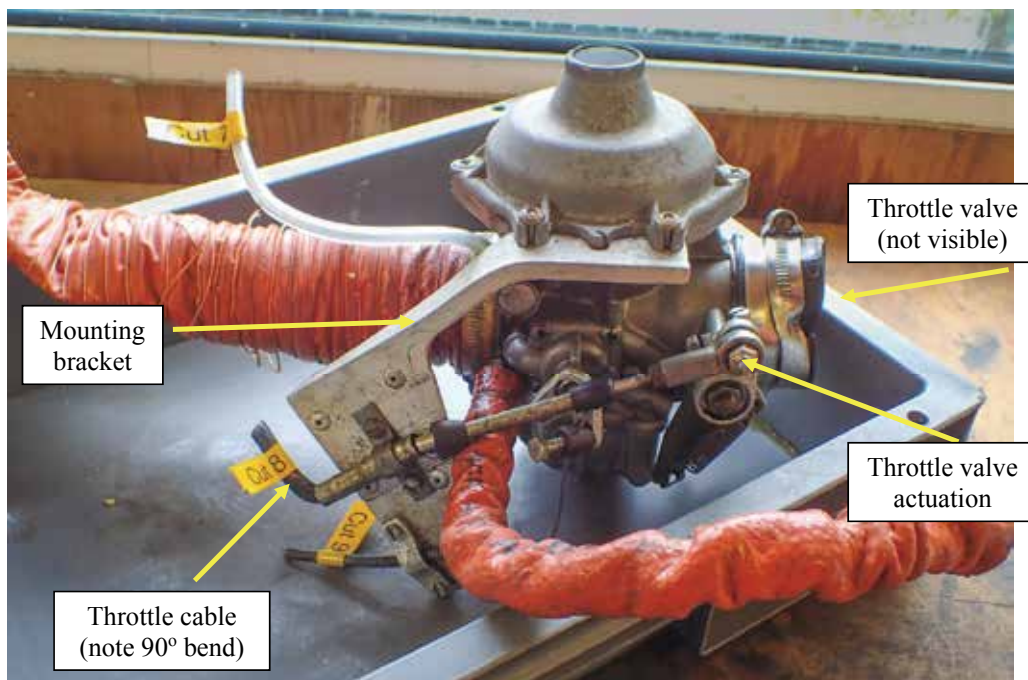
**Figure 7**  
The carburettor

The throttle cable terminated in a solid linkage which was mounted on a bracket attached to the carburettor. The throttle cable exhibited a 90° bend, caused by impact loads (Figure 7), and the mounting bracket was deformed. In order to confirm the pre-impact position of the throttle valve, the throttle linkage was detached from the mounting bracket and the bracket was straightened. When the throttle linkage was re-mounted on the bracket, its position corresponded to the butterfly valve being fully closed. This indicated that the throttle was closed at impact.

Examination of the carburettor confirmed that the choke was in the OFF position. There was a small amount of fuel in the carburettor fuel bowl and some small particles of debris. Some corrosion was evident on the main jet holder and, when examined under a microscope, solidified oily residue was evident on the internal bore. However, the main needle jet itself was clean and free from debris. The idle jet also exhibited some oily residue; this is not uncommon as oil can seep into the carburettor when the engine is shut down. The rubber of the inlet manifold and fuel inlet hoses had lost all its flexibility, consistent with age-related degradation.

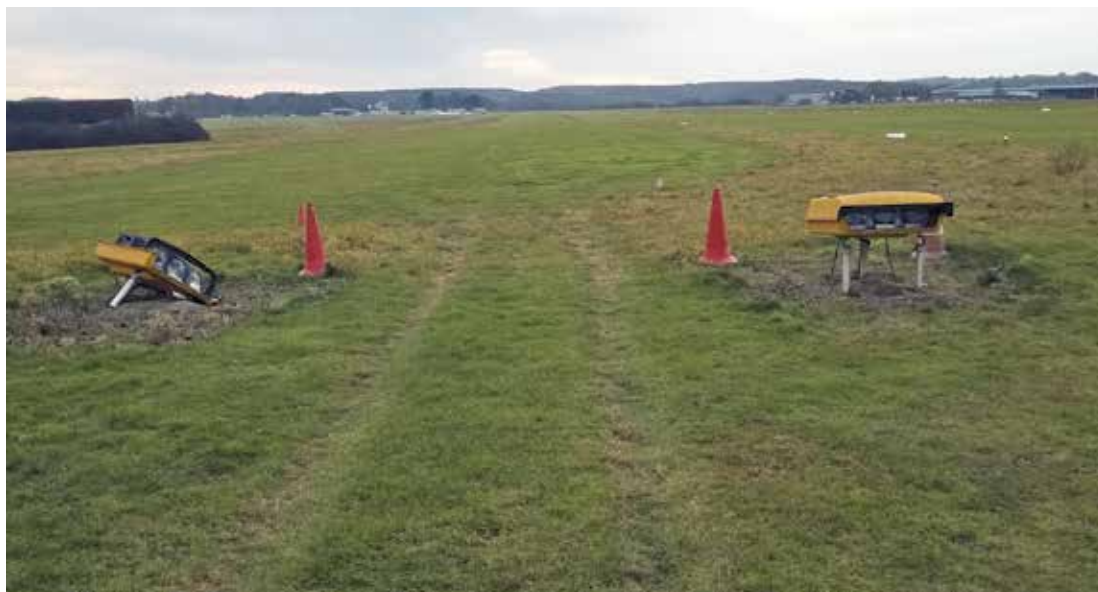
**Figure 1**

APAPI units showing damage to the left unit, in a view looking along Runway 20L from the undershoot. The units are installed for Runway 20R which is on the right of the photograph
