# Woodbarn Farm

(/A404//13.10//) SMIS Structure Key: 18761

**Principal Inspection**

**20 January 2014**

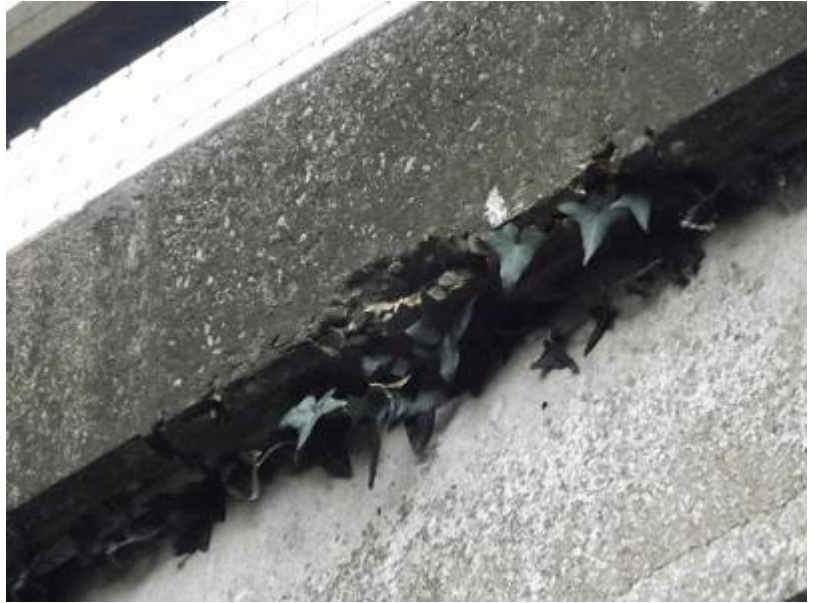
<b>Components</b>	Centre Deck - West Parapet Plinth, Centre Deck - East Parapet Plinth
<b>Defect Type</b>	ER - Exposed reinforcement
<b>Extent</b>	SC - Defect present in 5% to not more than 20% of area or length of element
<b>Severity</b>	D3 - Moderate: Defect is probably causing damage to element or structure, or is likely to do so in the near future
<b>Priority</b>	Medium
<b>Comments</b>	Exposed reinforcement to east and west parapet edge beams due to low cover

Exposed reinforcement to west edge beam, north end 20.1.14

<b>Maintenance Object</b>	Expansion Joint	<b>Maintenance Action</b>	Provide
<b>Estimated Cost</b>	£6,000	<b>Recomm. Action Date</b>	01/08/2010
<b>Priority Category</b>	3	<b>Risk Score</b>	78
<b>Comments</b>	Saw cut above buried joints and insert bituminous filler		
<b>Maintenance Object</b>	Concrete Deck	<b>Maintenance Action</b>	Repair
<b>Estimated Cost</b>	£20,000	<b>Recomm. Action Date</b>	01/01/2013
<b>Priority Category</b>	3	<b>Risk Score</b>	25
<b>Comments</b>	Repair exposed reinforcement to west parapet edge beam

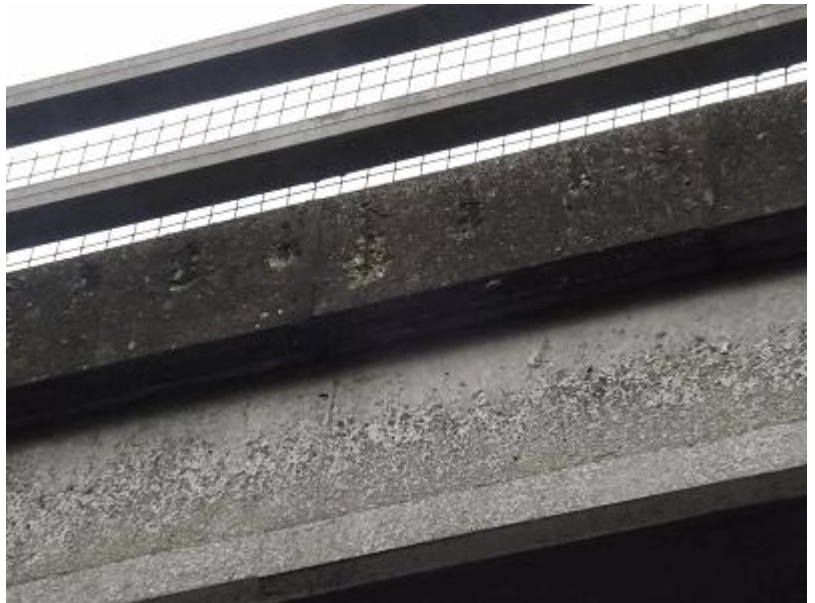
Exposed reinforcement to west edge beam elevation 20.1.14

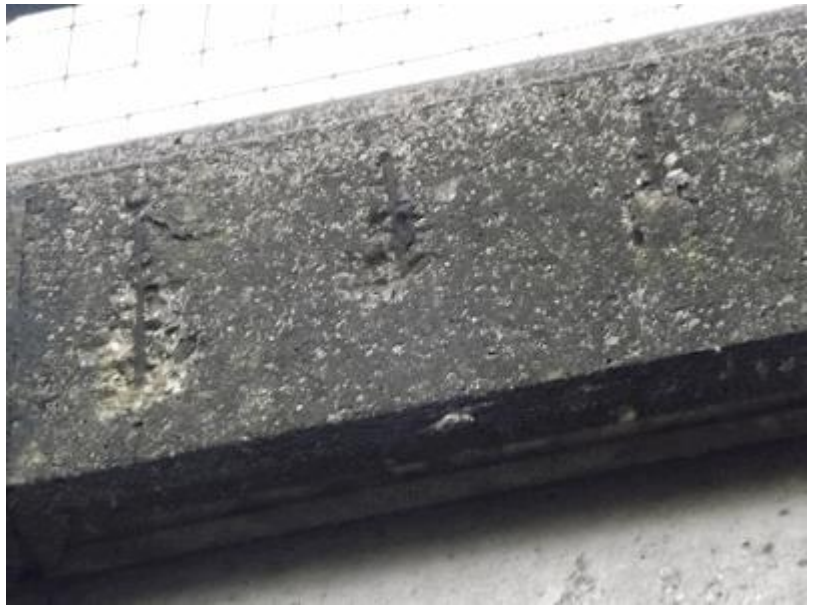
Exposed reinforcement to west  
edge beam elevation 20.1.14

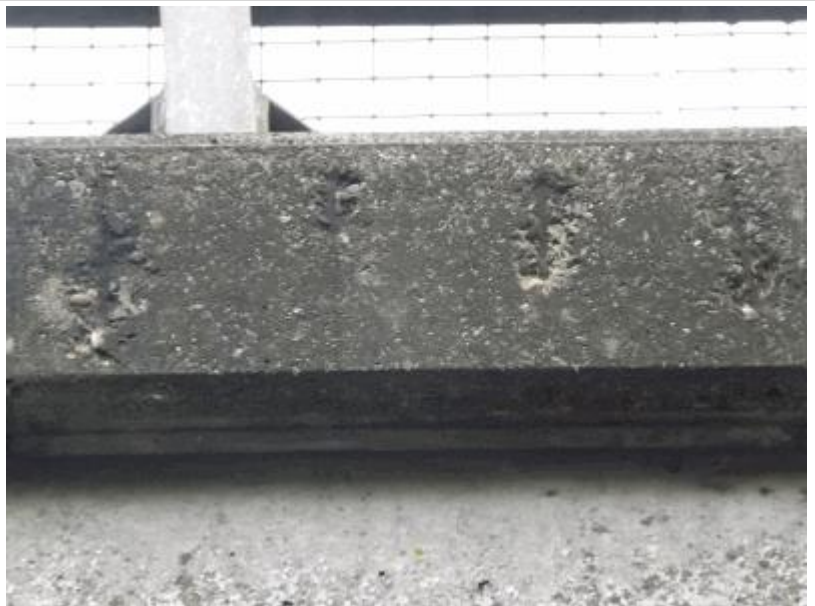
Exposed reinforcement to west  
edge beam elevation 20.1.14

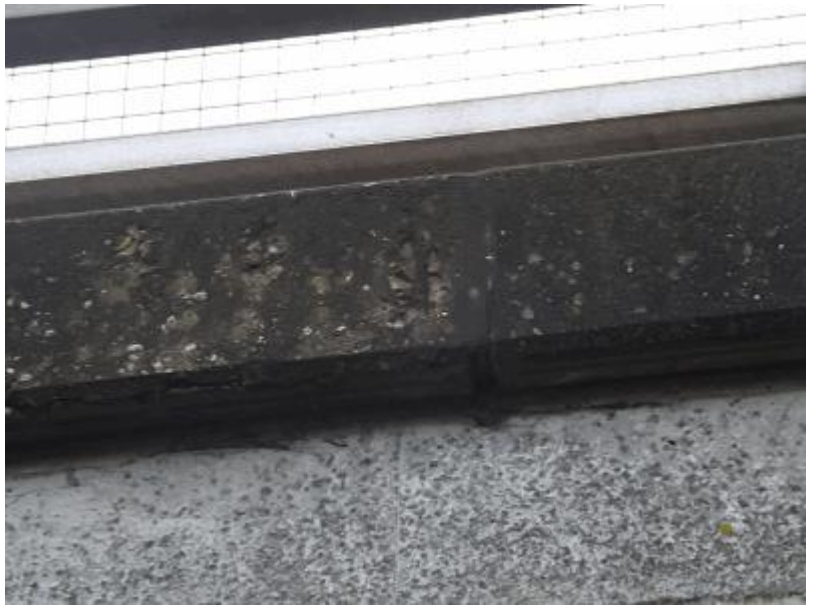
Exposed reinforcement to east edge  
beam elevation 20.1.14

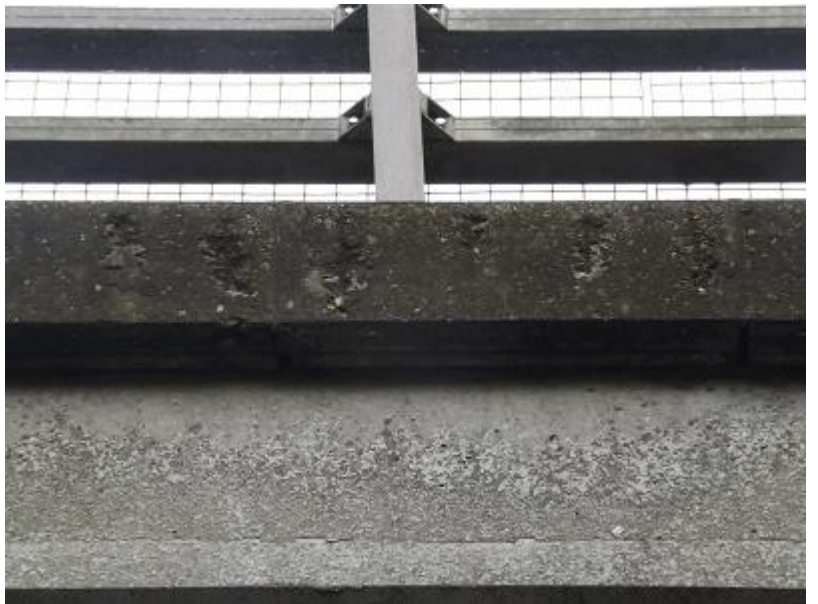
Exposed reinforcement to west  
edge beam elevation 20.1.14

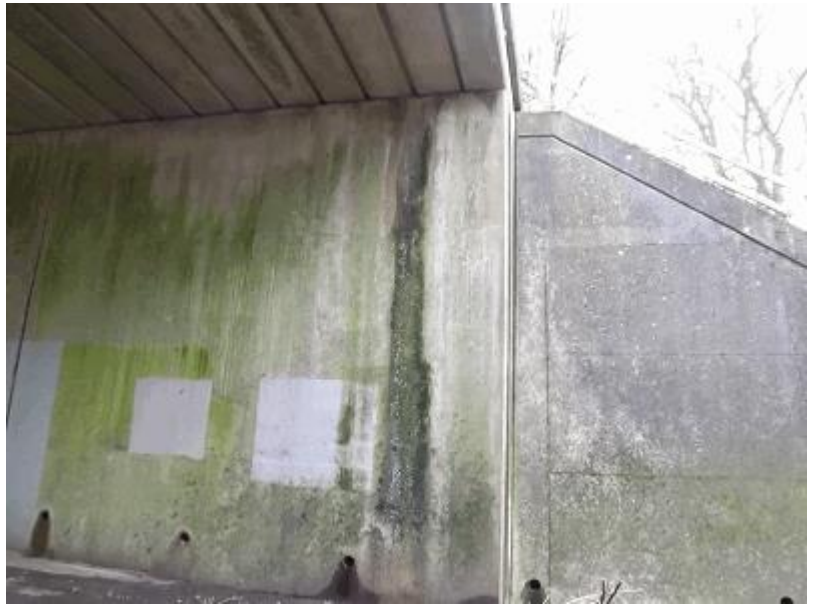
<b>Extent</b>	SB - Defect present in not more than 5% of area or length of element
<b>Severity</b>	D3 - Moderate: Defect is probably causing damage to element or structure, or is likely to do so in the near future
<b>Priority</b>	Medium
<b>Comments</b>	Running water and water staining to south abutment west end

Water staining to south abutment, west end 20.1.14

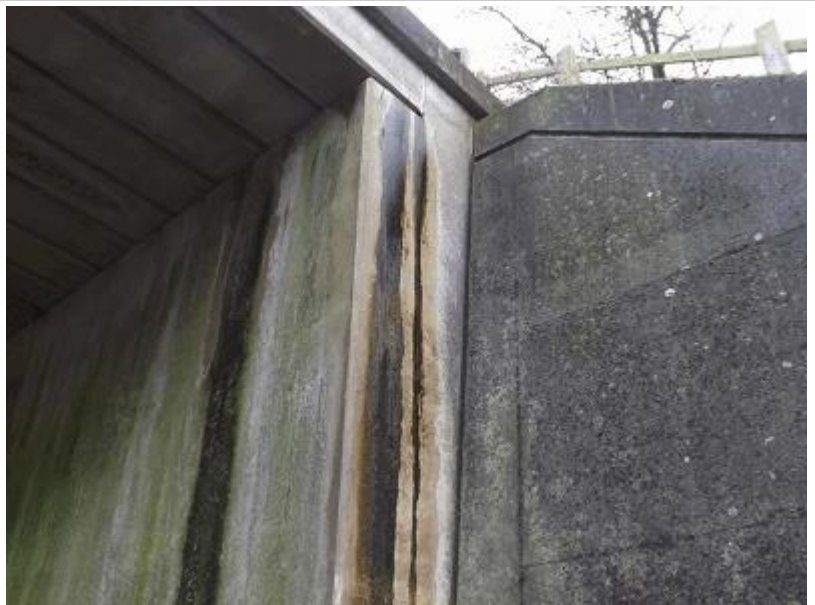
Running water to south abutment west end return 20.1.14

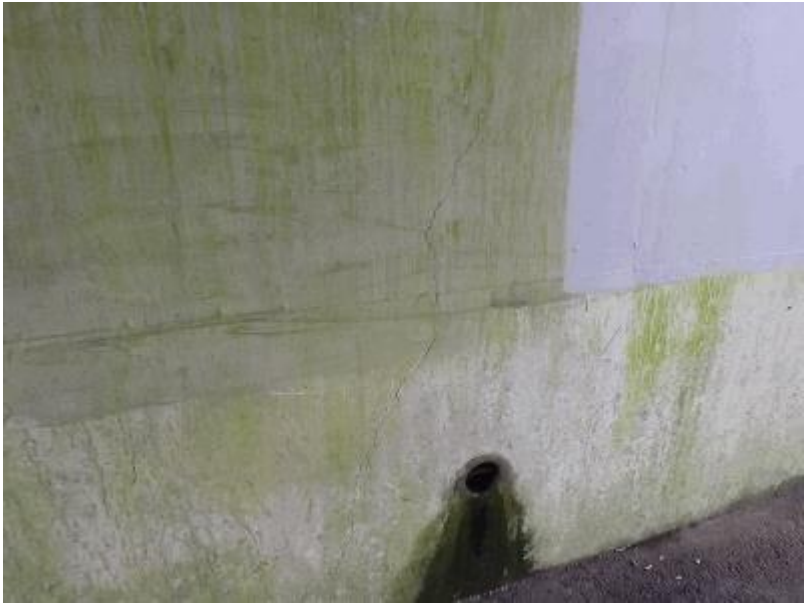
<b>Components</b>	South Abutment - Abutment Wall for South Abutment, North Abutment - Abutment Wall for North Abutment
<b>Defect Type</b>	DSCr - Drying shrinkage crack
<b>Extent</b>	SB - Defect present in not more than 5% of area or length of element
<b>Severity</b>	D2 - Minor: Defect is unlikely to be causing damage to the element or structure now or unlikely to do so in the near future
<b>Priority</b>	Low
<b>Comments</b>	Minor cracking to abutment walls
Vertical cracking to north abutment 20.1.14

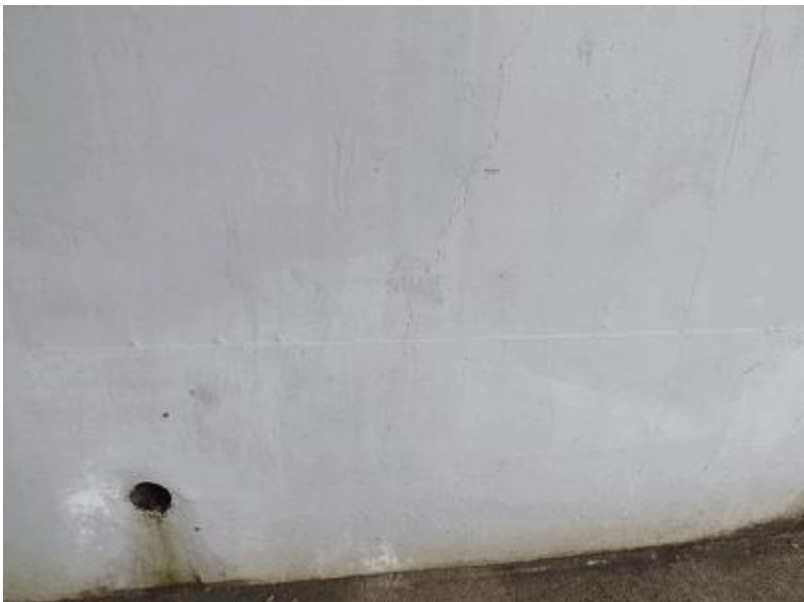
Vertical cracking to north abutment 20.1.14

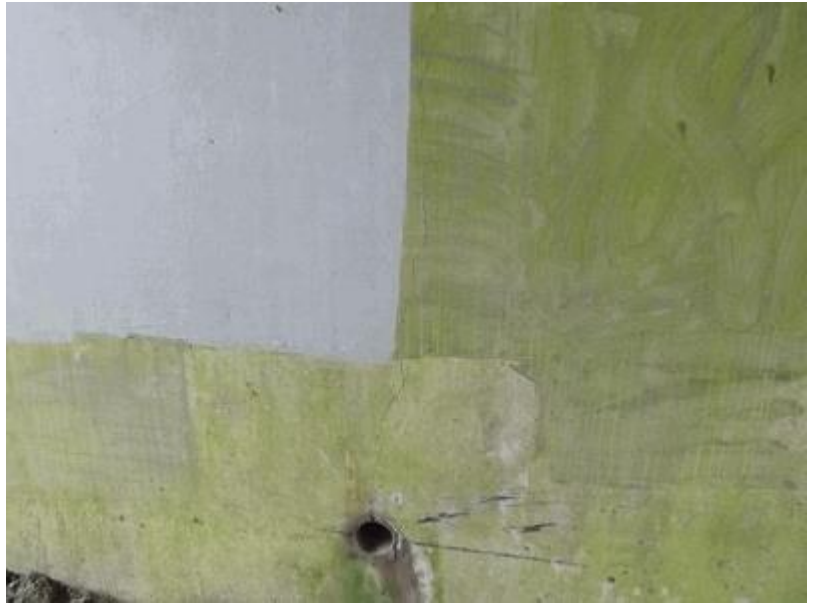
Vertical cracking to south abutment  
20.1.14

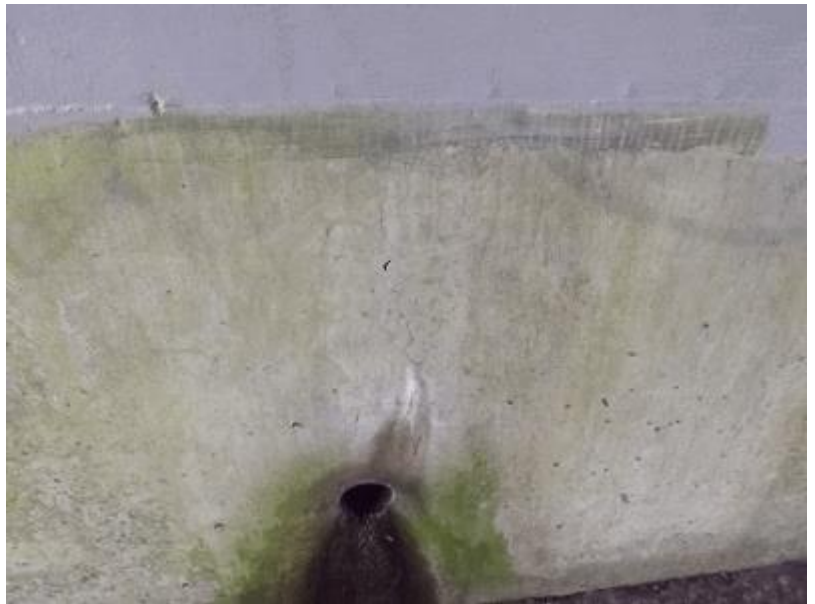
Minor vertical cracking to north  
abutment from weep hole 20.1.14

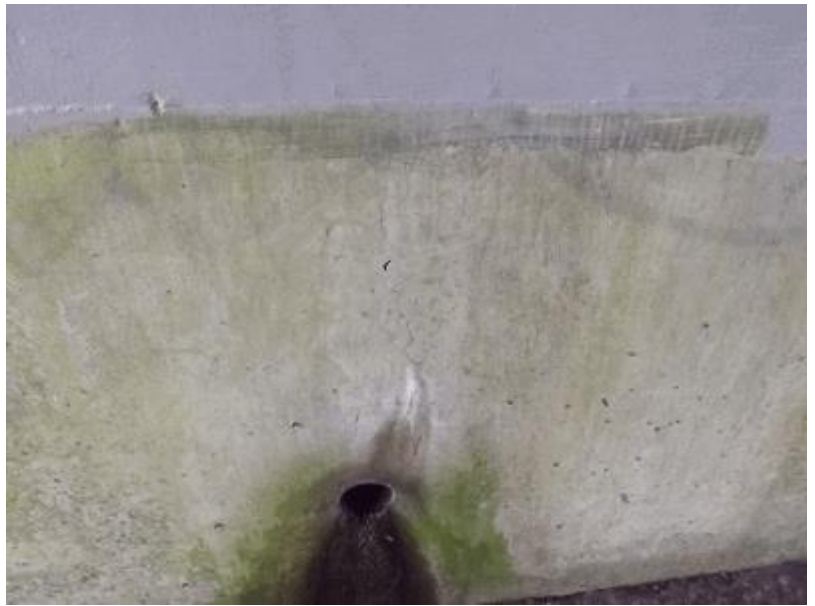
Minor vertical cracking to north abutment from weephole 20.1.14

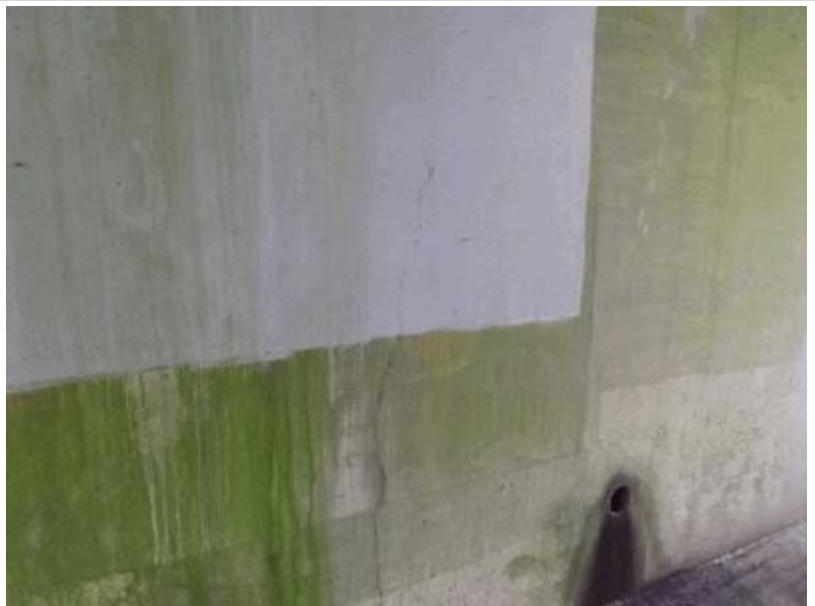
Vertical cracking to south abutment 20.1.14

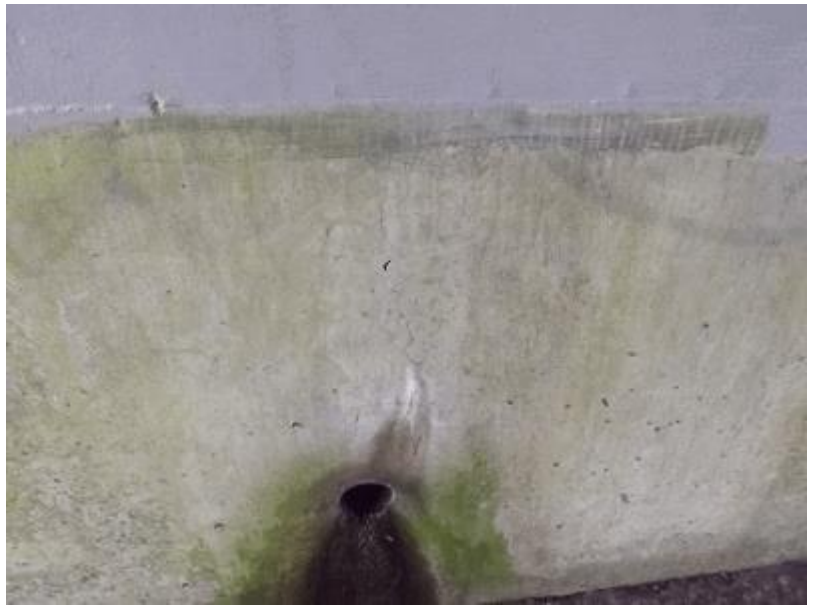
<b>Components</b>	North Abutment - Abutment Wall for North Abutment
<b>Defect Type</b>	CLe - Calcite Leaching
<b>Extent</b>	SB - Defect present in not more than 5% of area or length of element
<b>Severity</b>	D2 - Minor: Defect is unlikely to be causing damage to the element or structure now or unlikely to do so in the near future
<b>Priority</b>	Low
<b>Comments</b>	Minor leachate through cracking to north abutment

Minor leachate through cracking to north abutment 20.1.14

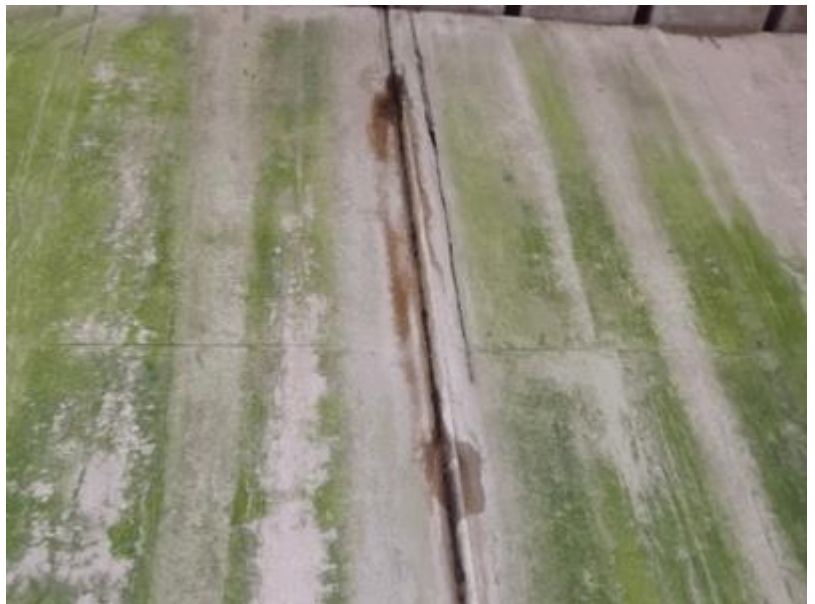
**Severity** D2 - Minor: Defect is unlikely to be causing damage to the element or structure now or unlikely to do so in the near future

**Comments** Water staining to south abutment centre construction joint

Minor water staining to south abutment centre at construction joint 20.1.14

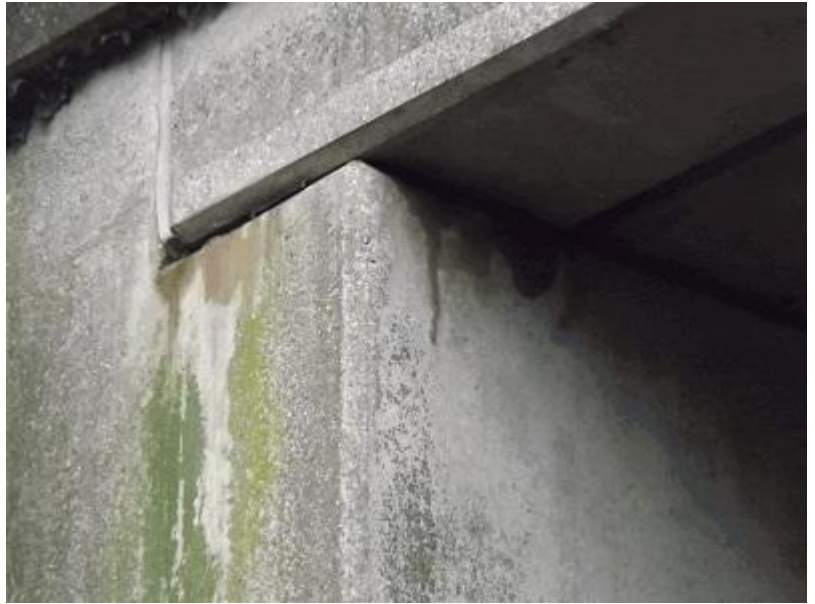
**Severity** D2 - Minor: Defect is unlikely to be causing damage to the element or structure now or unlikely to do so in the near future

**Comments** Water staining at top of north abutment, west end

Water staining at top of north abutment, west end 20.1.14

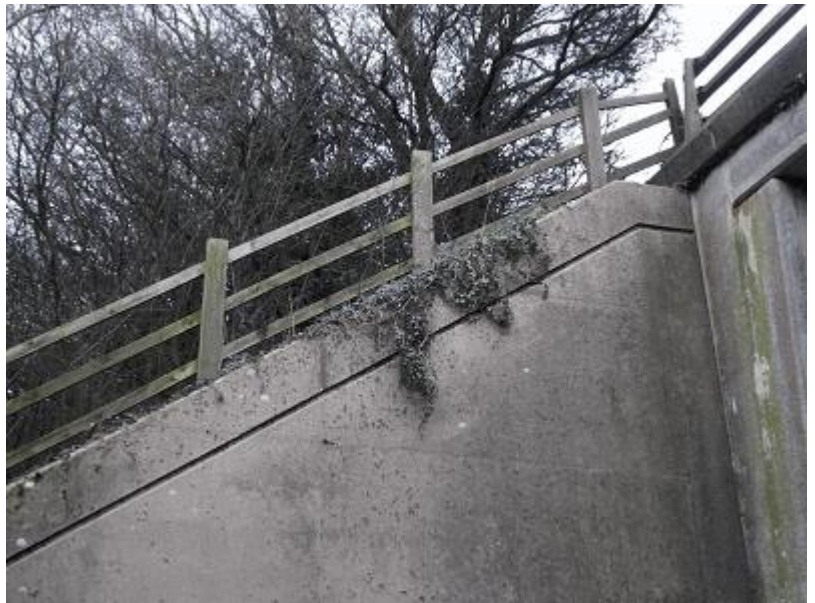
**Severity** X2 - Defects unlikely to affect condition of adjacent elements now or in the near future

**Comments** Vegetation along top of north west wing wall

Vegetation along top of north west wing wall 20.1.14

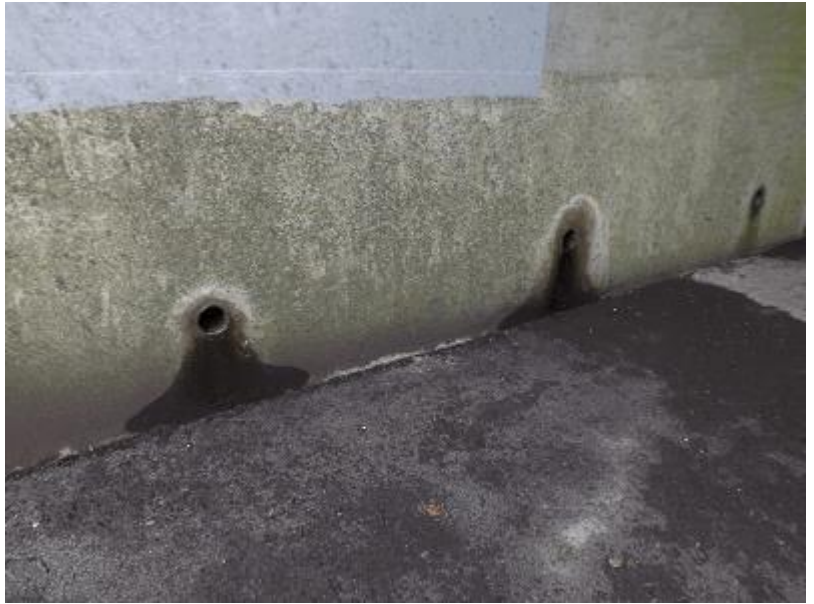
**Comments** Minor water staining to abutments due to active weepholes

Active weepholes to north abutment  
20.1.14

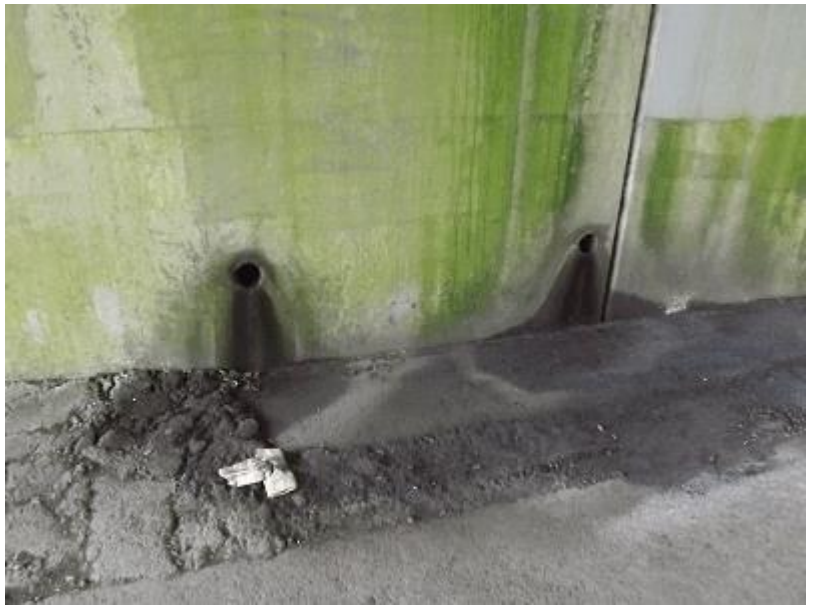
Active weepholes to south abutment  
20.1.14

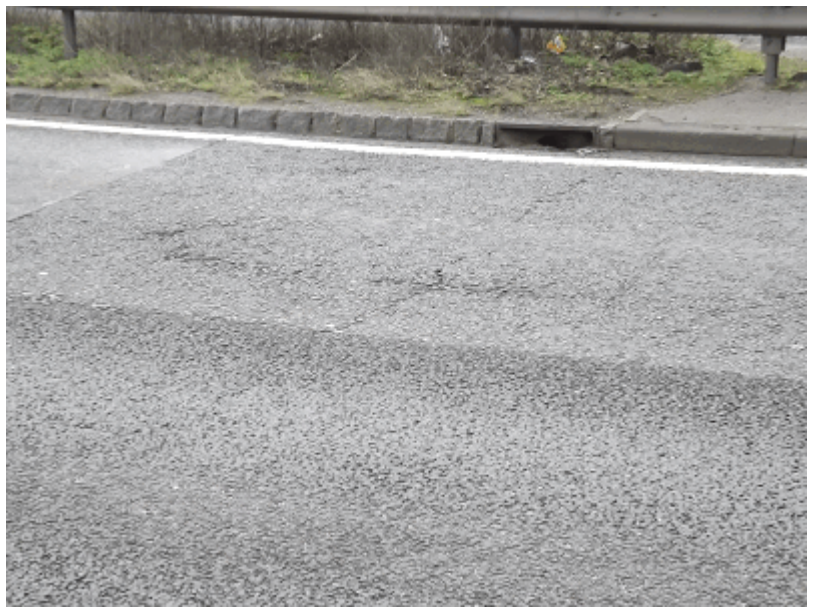
<b>Extent</b>	SB - Defect present in not more than 5% of area or length of element
<b>Severity</b>	D3 - Moderate: Defect is probably causing damage to element or structure, or is likely to do so in the near future
<b>Priority</b>	Medium
<b>Comments</b>	Cracking across northbound and southbound carriageway surfacing above buried joints due to lack of provision for movement

Cracking across southbound lane 2, south end 20.1.14

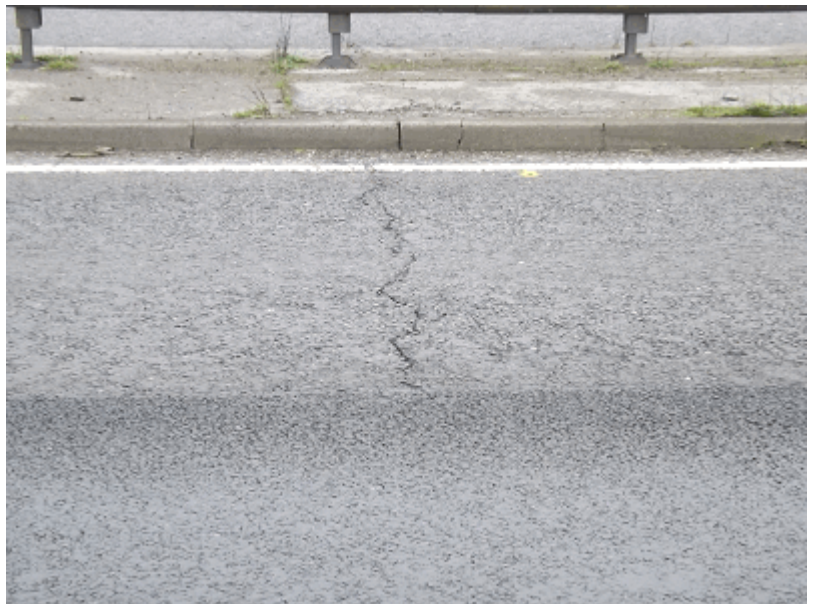
Major cracking across northbound lane 2 towards north end 20.1.14

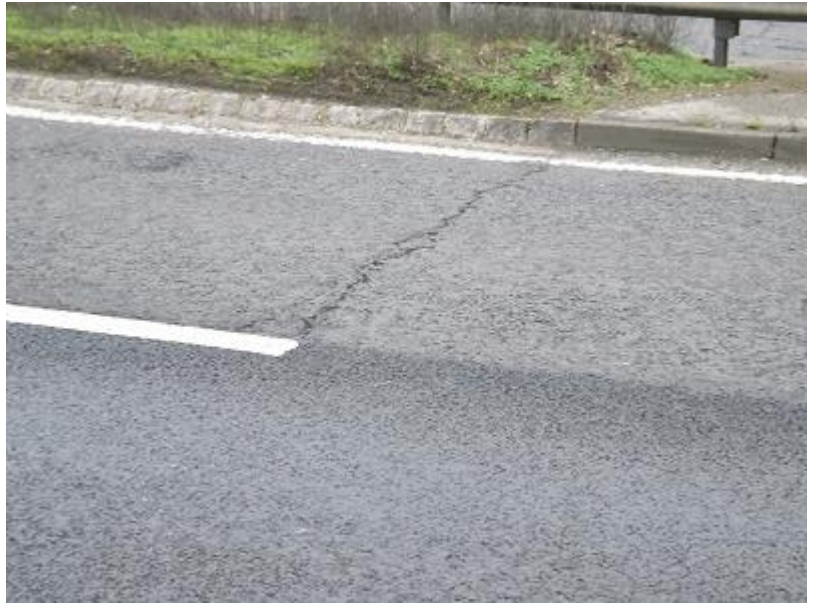
Major cracking across northbound lane 2, north end 20.1.14

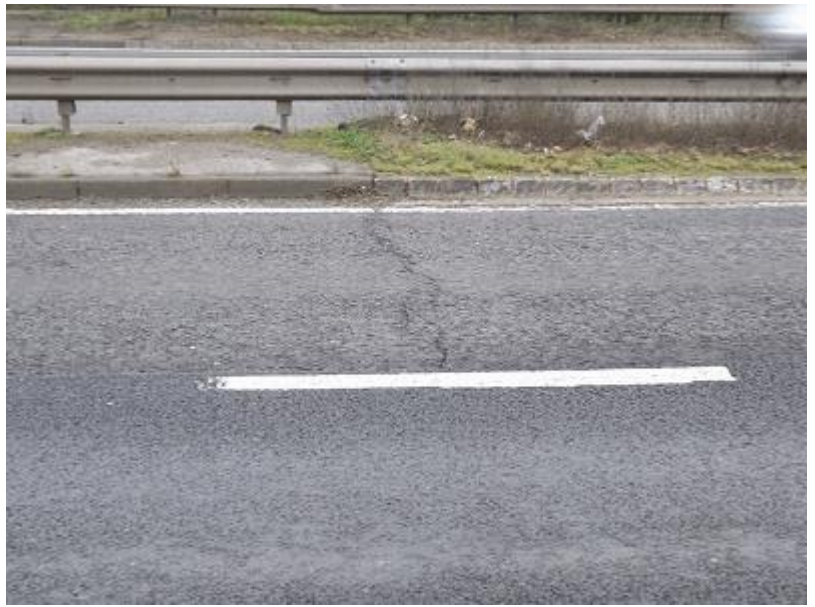
Cracking across northbound lane 2, south end 20.1.14

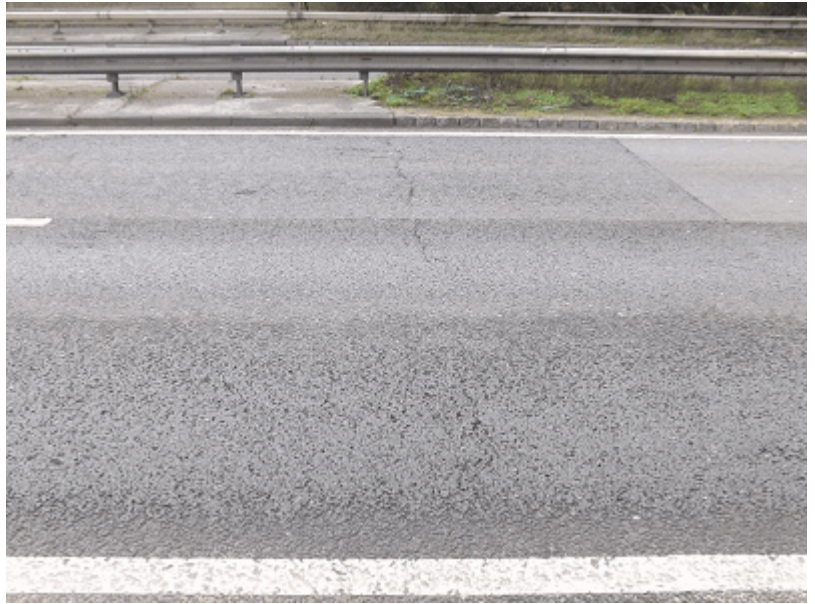
Cracking across southbound lane 2, north end 20.1.14

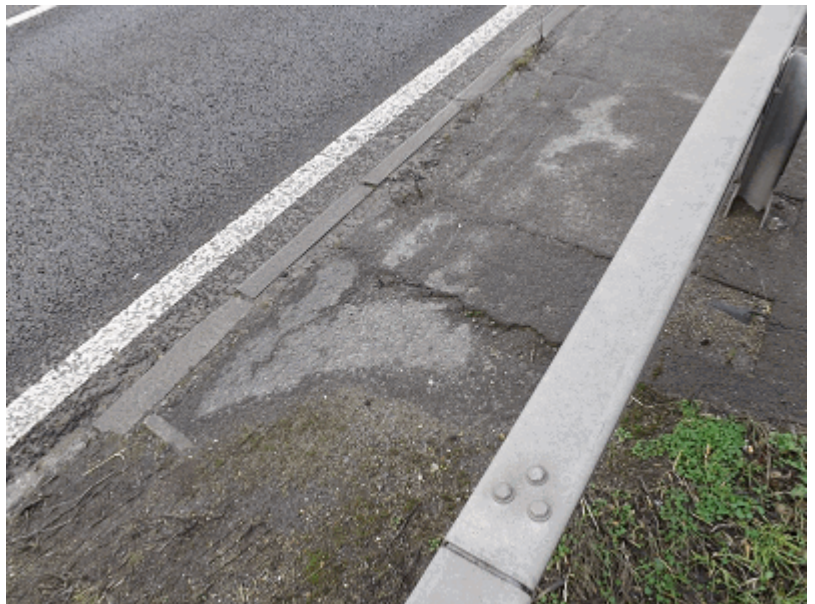
**Comments** Minor cracking to deck verges

Cracking to east verge, south end 20.1.14

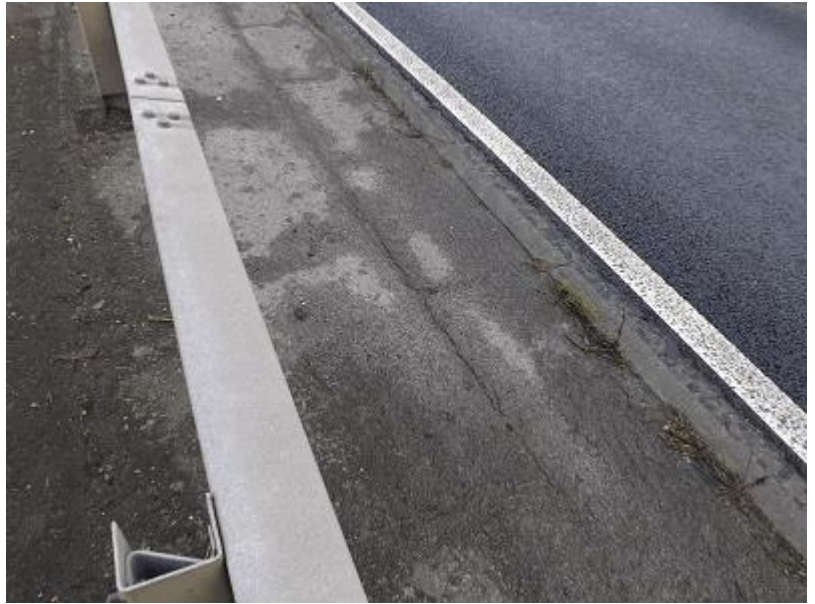
Cracking along west verge 20.1.14

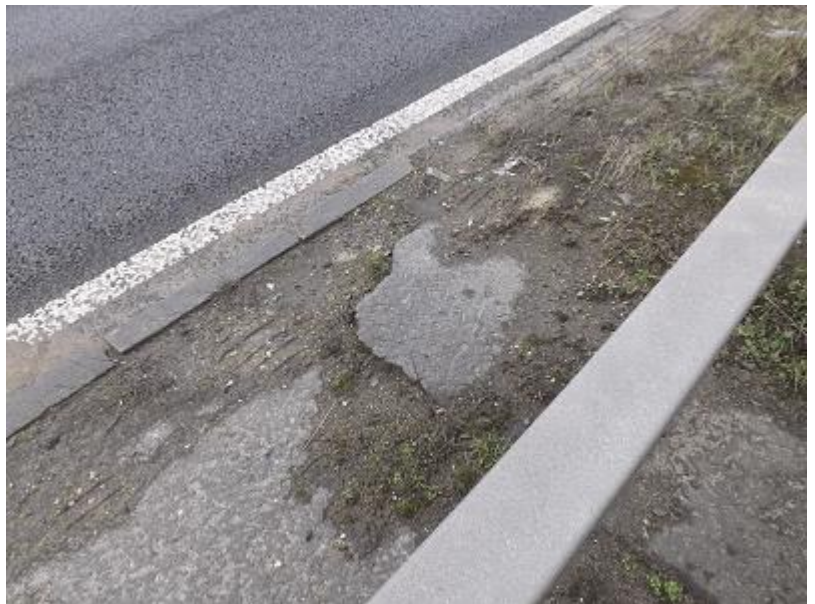
**Comments** Displaced east verge kerbstone, north end

Displaced east verge kerbstone, north end 20.1.14

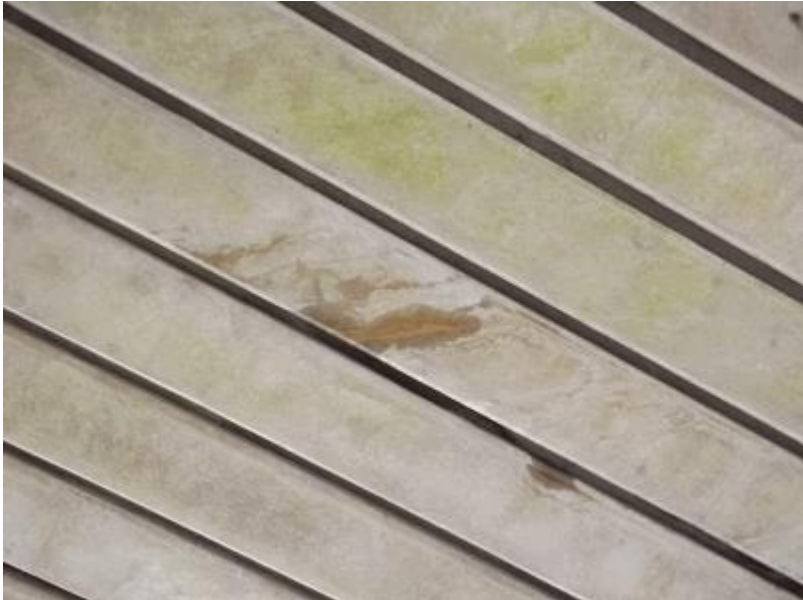
<b>Components</b>	Centre Deck - Main Slab, Longitudinal Beams - Longitudinal Beams West edge 1, Centre Deck - Longitudinal Beams	
<b>Defect Type</b>	Cr - Crack of uncertain origin or a combination of causes	
<b>Extent</b>	SB - Defect present in not more than 5% of area or length of element	
<b>Severity</b>	D2 - Minor: Defect is unlikely to be causing damage to the element or structure now or unlikely to do so in the near future	
<b>Priority</b>	Low	
<b>Comments</b>	Cracked edge beam at east side of south abutment	
<b>Components</b>	Longitudinal Beams - Longitudinal Beams 23, Longitudinal Beams - Longitudinal Beams 22	
<b>Defect Type</b>	WS - Water stain	
<b>Extent</b>	SB - Defect present in not more than 5% of area or length of element	
<b>Severity</b>	D2 - Minor: Defect is unlikely to be causing damage to the element or structure now or unlikely to do so in the near future	
<b>Priority</b>	Low	
<b>Comments</b>	Minor water staining to main beam soffit near mid span

Minor water staining to main beam soffit near mid span 20.1.14
