AAIB Bulletin

2/2017

| S1/2017 Sikorsky S-92A | G-WNSR | 28-Dec-16 | 3 |

| ATR 72-212 A | G-COBO | 04-Mar-16 | 11 |

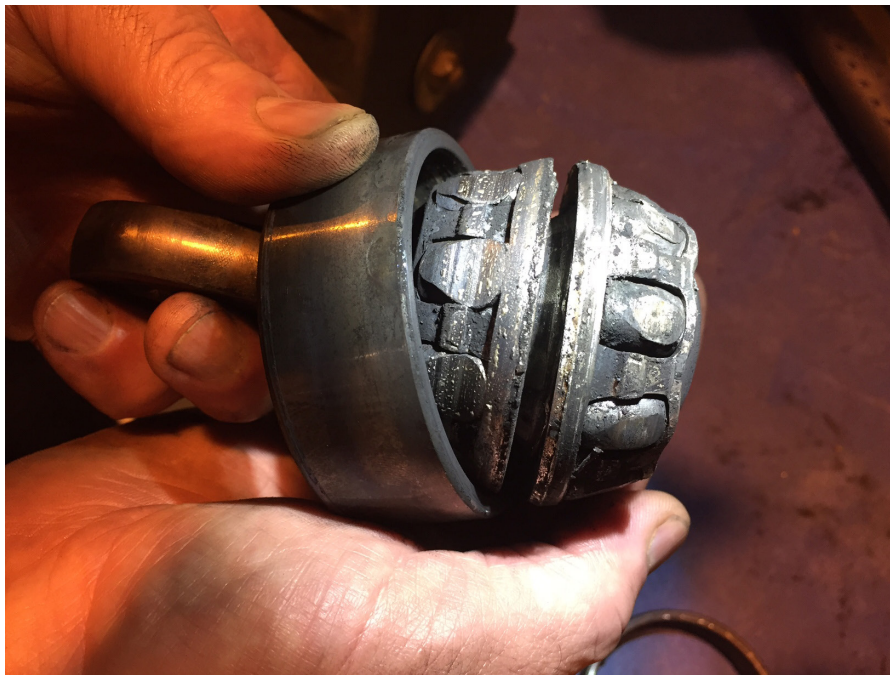
Figure 1

The technical investigation focussed on the tail rotor and associated components. Once the panels were removed it was immediately apparent that the tail rotor servo piston was damaged. The servo was removed and revealed that the tail rotor pitch change shaft (TRPCS) double row angular contact bearing was in a severely distressed condition (Figure 1).

TRPCS double row angular contact bearing from G-WNSR

Further disassembly and examination of the components found signs of severe overheating with extreme wear on the inner and outer thrust races and barrel shaped rollers of the bearing. It was found that the roller bearings seized to the inner member. The outer race roller had excessive axial play (0.5 in), such that the tail rotor driveshaft imparted a torsional load to the tail rotor servo. This torsional load caused the primary piston rod to fracture inside the servo. Due to the failure of the primary piston, the secondary piston sleeve separated axially from the primary piston adjacent to the link fitting, with the consequential total loss of control of the tail rotor.

The components were shipped to the helicopter manufacturer for forensic analysis. Initial findings indicate that the failure of this specific bearing was rapid; a period of 4.5 hours had elapsed from the first exceedance of the relevant bearing condition indicator recorded on the operator's Health and Usage Monitoring System (HUMS) to the point of failure.

The operator has subsequently introduced a number of measures to further strengthen the ability to detect impending bearing degradation. These include: a review of all HUMS data to ensure no anomalies, fleet-wide borescope inspections, a requirement for HUMS to be serviceable before flight and the time between HUMS download/analysis reduced to a maximum of 5 hours. The operator has also reviewed their HUMS processes and analytical procedures and introduced a requirement to carry out an additional assurance check.

This was followed by an Alert Service Bulletin (ASB) issued by the manufacturer on 10 January 2017. ASB 92-64-011 introduces a one-time inspection of the TRPCS and bearing assembly for ratcheting, binding, or rough turning. The manufacturer has recommended that compliance is essential and is to be accomplished prior to the next flight from a maintenance facility; three flight hours are allowed in order to return directly to a maintenance facility. Concurrent with the release of ASB 92-64-011, the manufacturer published Temporary Revision 45-03 to require operators to use S-92 HUMS ground station software to review Tail Rotor Gearbox energy analysis Condition Indicators for alert conditions on a reduced flight hour interval. Records in excess of published alert levels require inspection of the pitch change shaft and bearing.

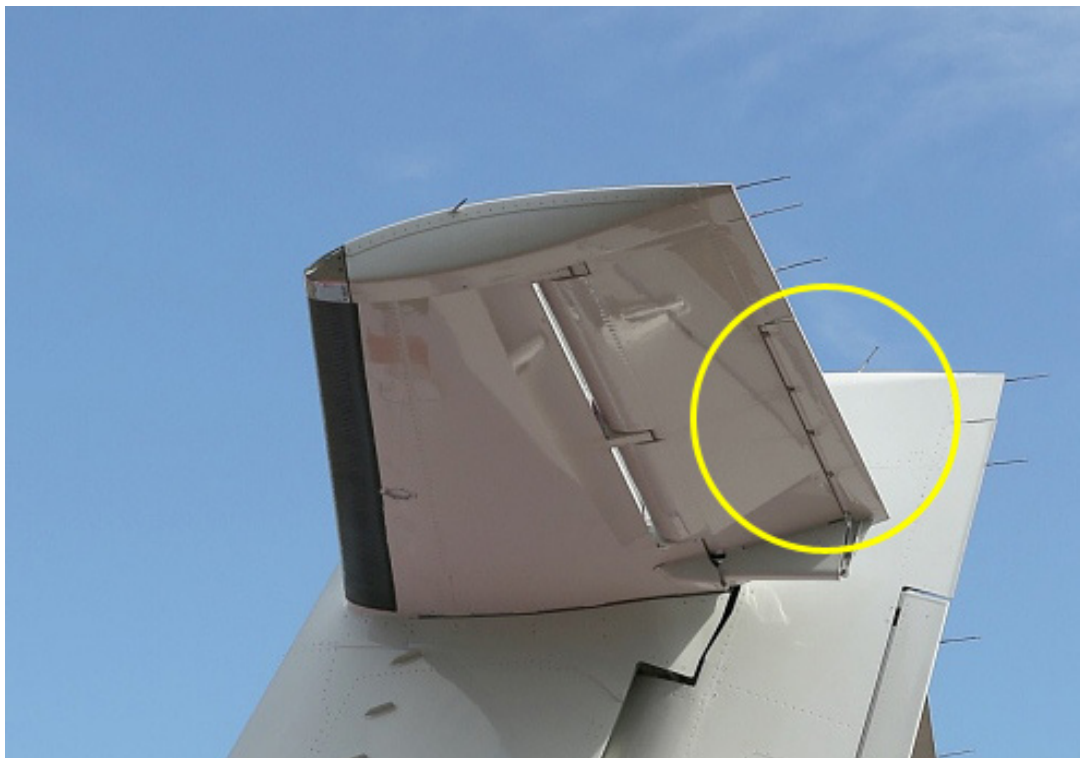
Figure 2

Left side of tailplane assembly showing trim tab (circled) on left elevator

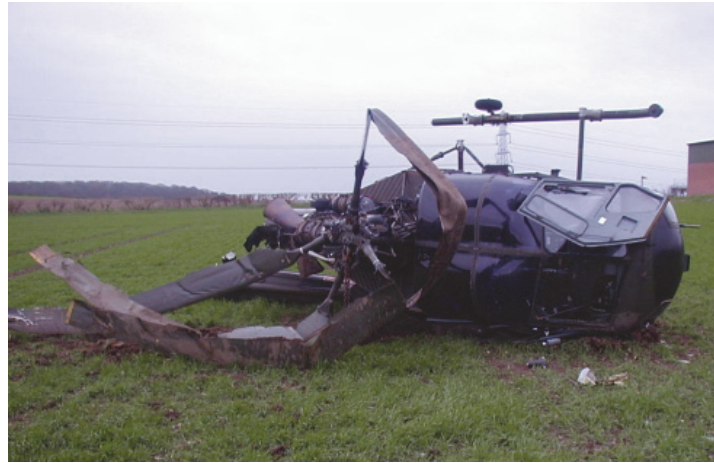
Figure 1

Position of helicopter after the accident
