# Collision between a passenger train and trolleys near Clapham, North Yorkshire, 25 August 2017

## 2. Summary of the accident

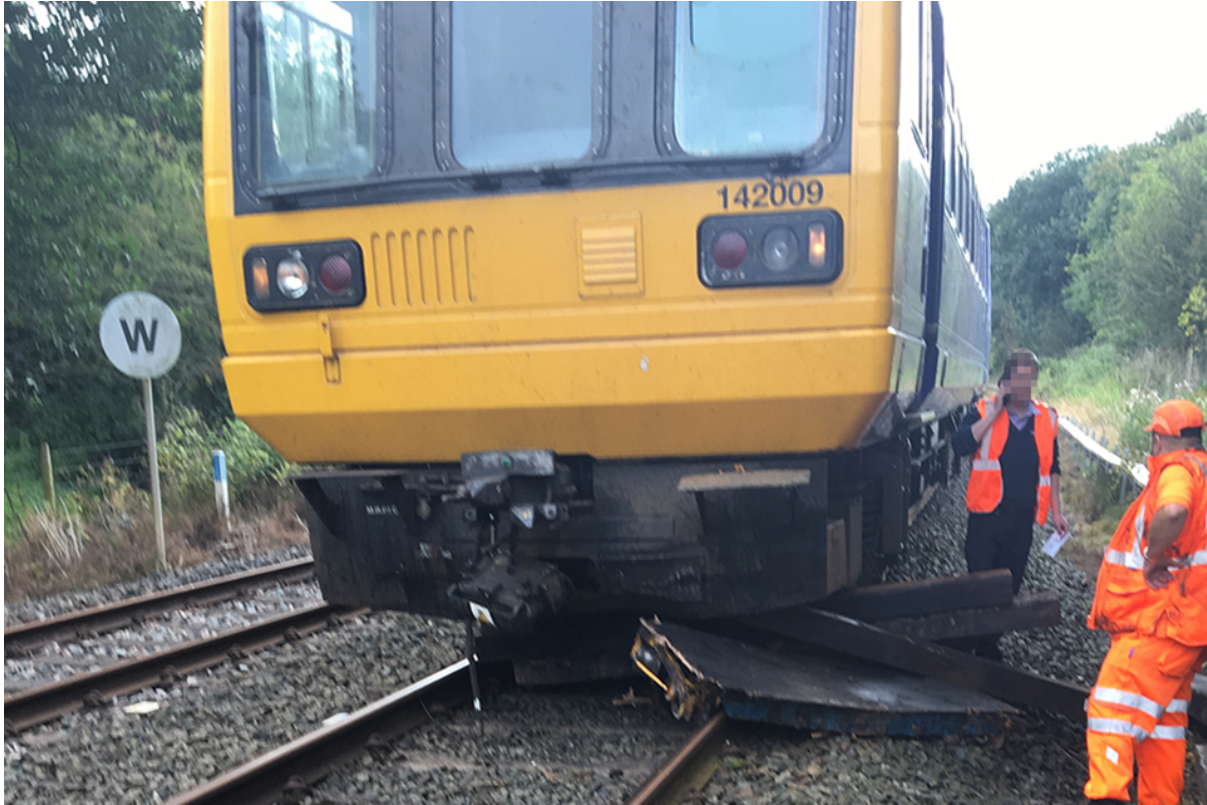
The collision caused damage to the train, trolleys, sleepers and track. No staff, passengers or crew were injured.

View of the front of train after collision with the trolleys

The train struck the trolleys and sleepers. One trolley and several sleepers became wedged underneath the front of the train. The train came to a stop 108 metres beyond the point of collision.

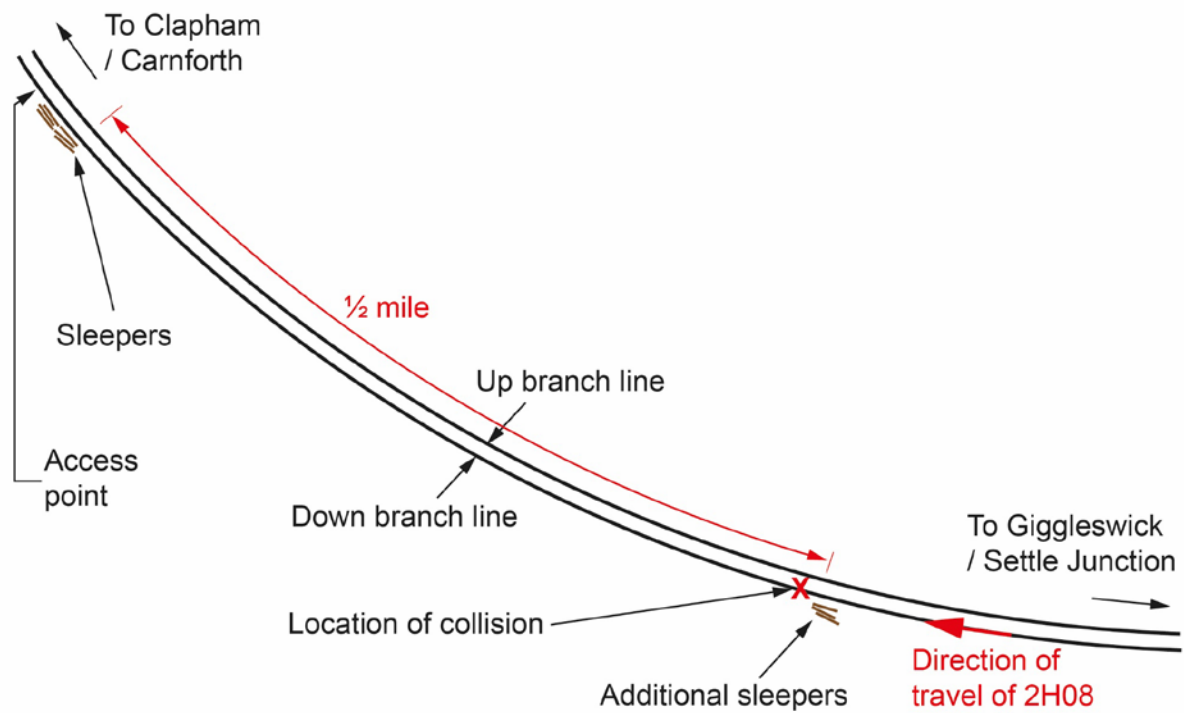
Schematic diagram of the area showing the locations of the access point and the collision
