BRE Global Client Report

BS 8414-1:2015 + A1:2017 Test referred to as DCLG test 7.

Prepared for: DCLG
Date: 18th August 2017 (Issue 1.0)
12th September 2017 (Issue 2.1)
Report Number: B137611-1037 (DCLG test 7) Issue: 2.1

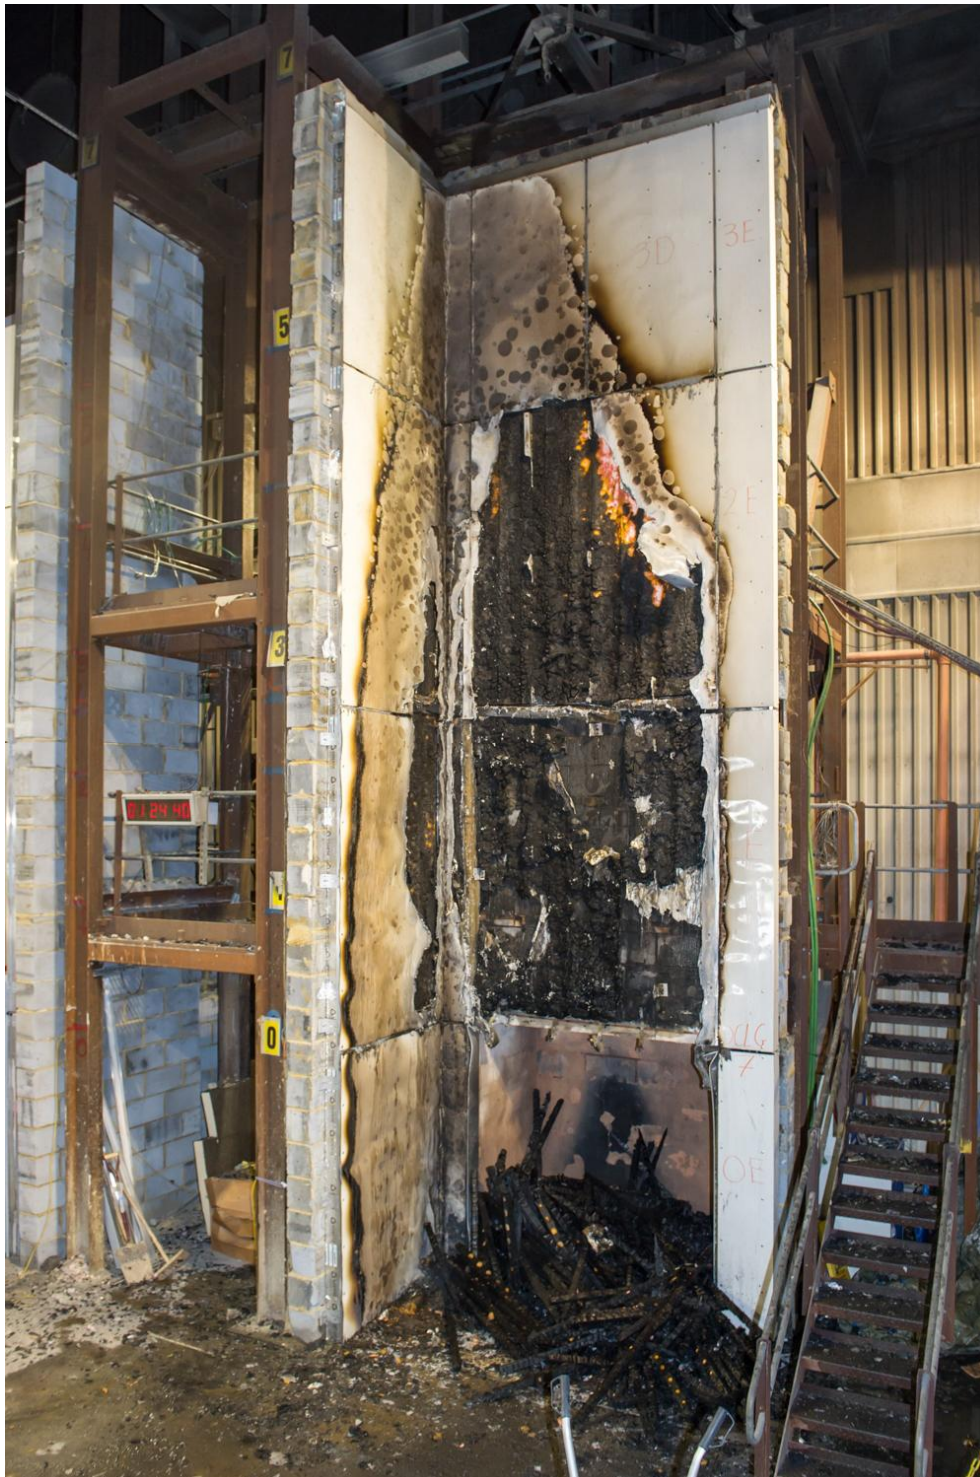
The cladding system was significantly damaged up to the height of the third horizontal cavity barrier – see *Figures 22-34*. The extent of the damage increased from discolouration of the ACM panels at the edges of the flame damage zone to complete consumption of panels, rail substructure, substantial charring and detachment of the insulation across the full width of the combustion chamber opening up to a height of approximately 5000mm – see *Figures 22-34*.

Figure 22. Full height photograph of system post-test – general.

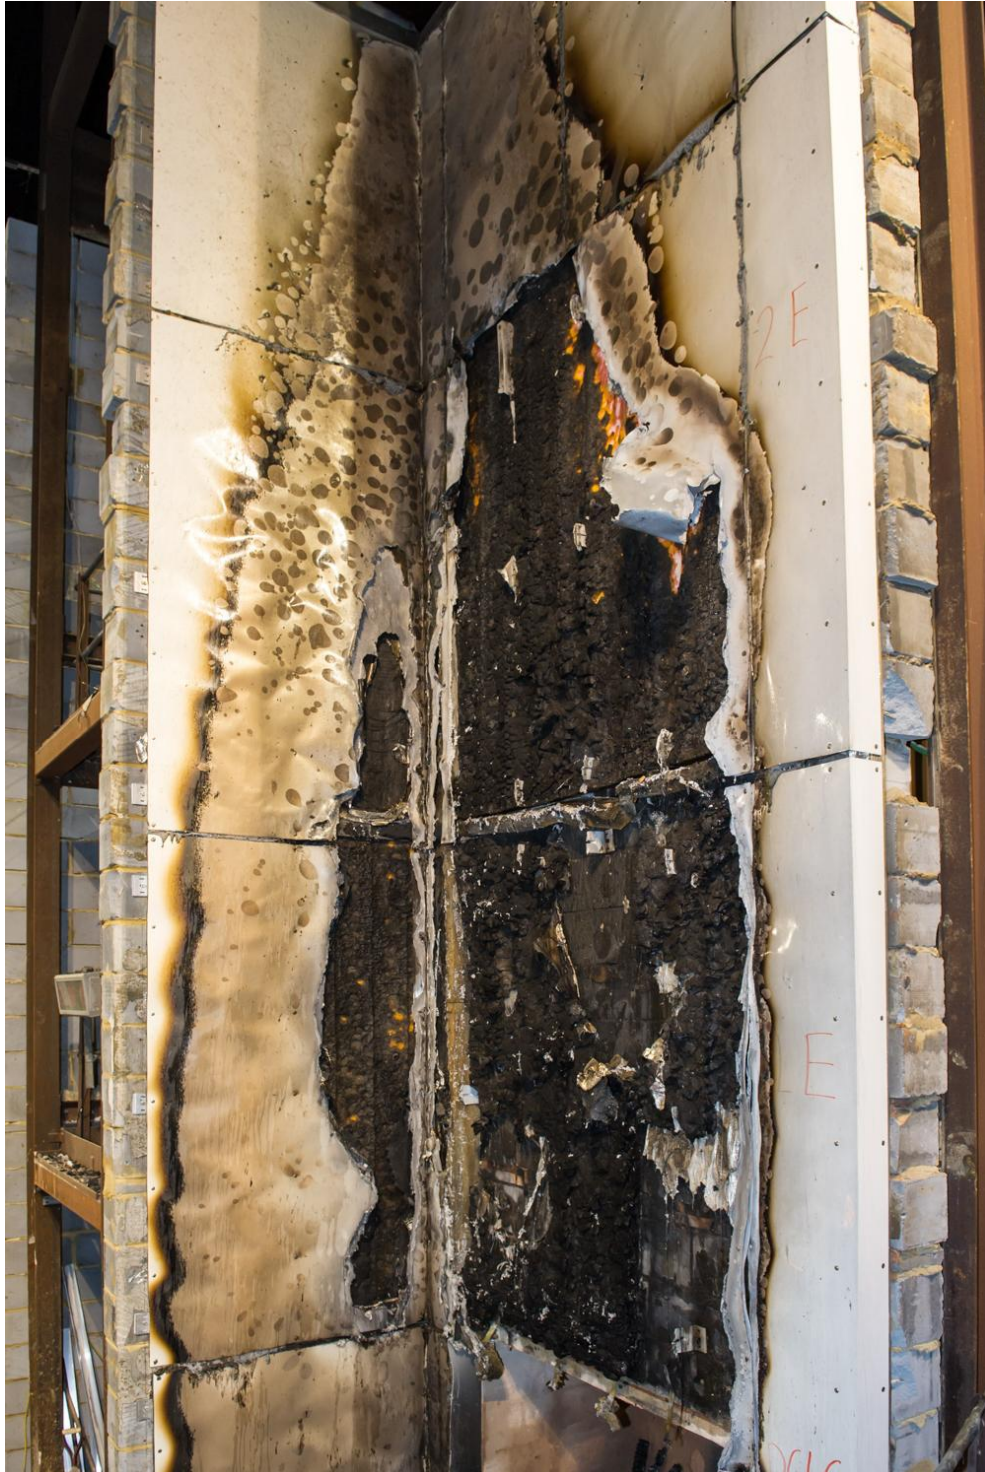
The wing wall was less severely damaged than the main wall with insulation charring adjacent to the main wall up to a height of approximately 4500mm above the combustion chamber (second fire break). Above the second fire break there was an area of damage where the foil was no longer present and there was surface charring of the insulation (approx 700mm high x 300mm wide at the base) consisting of one, and significant panel discolouration and distortion below the height of the third cavity barrier which reduced in severity towards the top of the cladding system – see *Figures 24-35*.

Figure 23. Photograph of system post-test – wing wall.

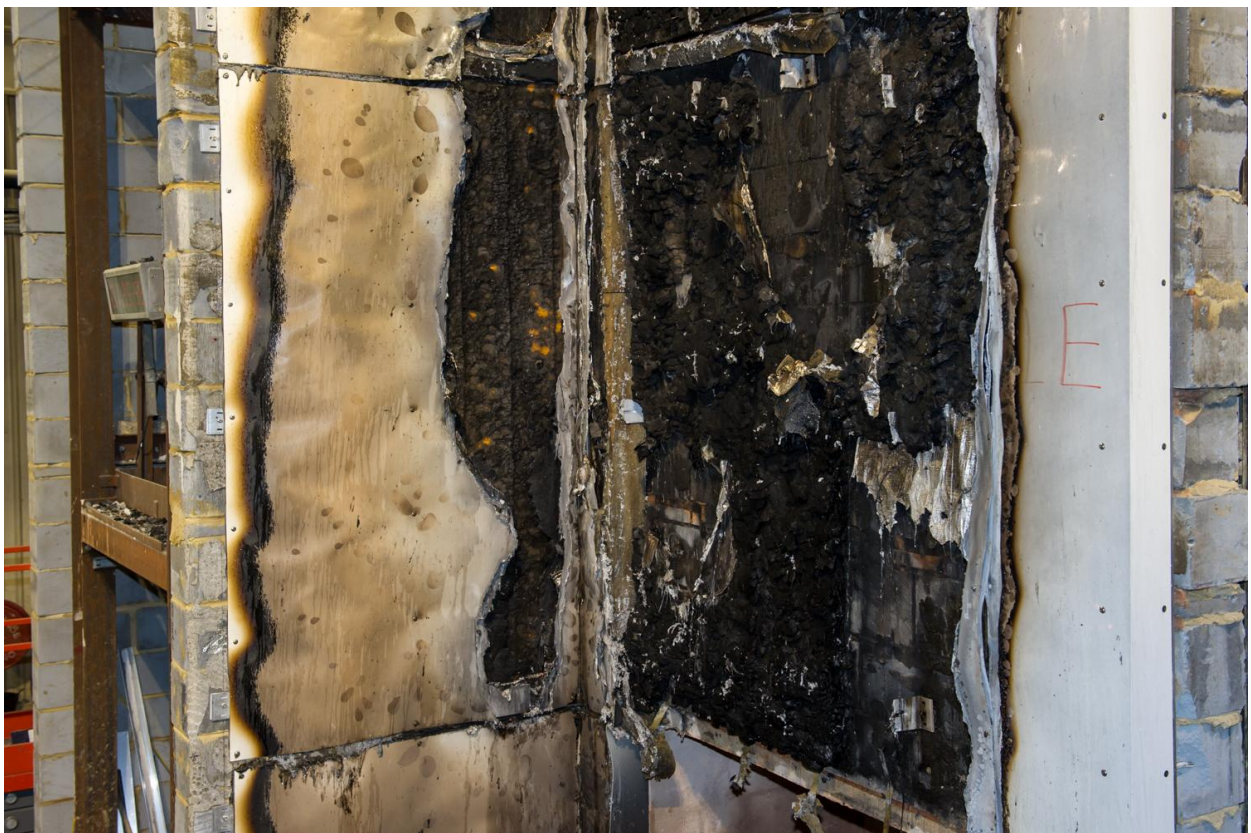
- Panel 0B. Distorted and surface discolouration of panel
- Panel OE. Largely undamaged.
- Panels 1C and 1D. 100% consumption of panels
- Panel 1B. 60% consumption of panel 1B. Panel 2B approximately 30% of the panel consumed
- Panel 2C. 90% consumption of panel.
- Panel 2D. 50% consumption of panel.
- Panel 2E. Surface discolouration extending for approximately 1m vertically from the base of the panel at the vertical joint between panels 2D & 2E
- Panel 3B. Panel in place. Discoloration across the full face of the panel. The panel was distorted.
- Panel 3C. Panel in place. Delamination of bottom edge of panels observed. Discolouration across 90% of the panel.
- Panel 3D. Panel in place. Some surface damage to the panels in the bottom left hand corner of the panel and heat distortion of the panel was observed.
- Panel 3E. Panel in place and largely undamaged.

Figure 24. First row ACM panels (directly above combustion chamber).

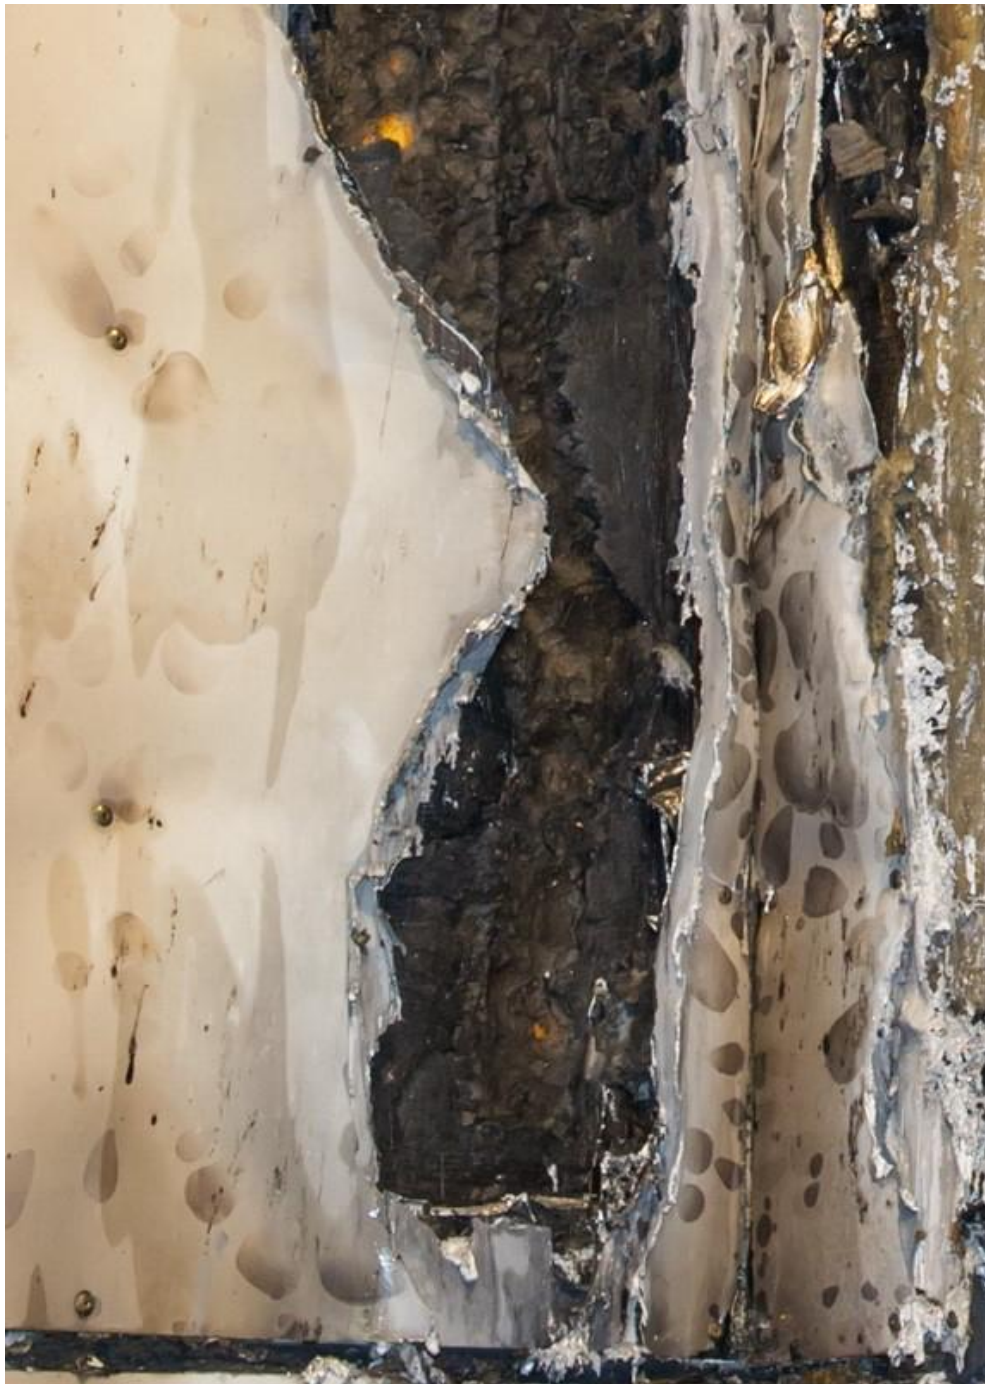
- Panel OA. Panel in place. Distortion and heat damage to the panel. A section of panel adjacent to panel OB approximately 700mm high and 150mm wide was consumed.
- Panel 1A. 30% of the panel consumed in a vertical strip adjacent to panel 1B exposing the insulation beneath. A small section of panel remained in place at the base of this panel. The remaining panel was in place.
- Panel 2A. A section of panel adjacent to panel 2B, approximately 300mm wide x 1000mm high was completely consumed exposing the insulation beneath. The outer aluminium above this for approximately 300mm was consumed leaving the inner layer of aluminium in place. The remaining panel was in place.

Figure 25. Close up view of partial panel consumption on the wing wall.

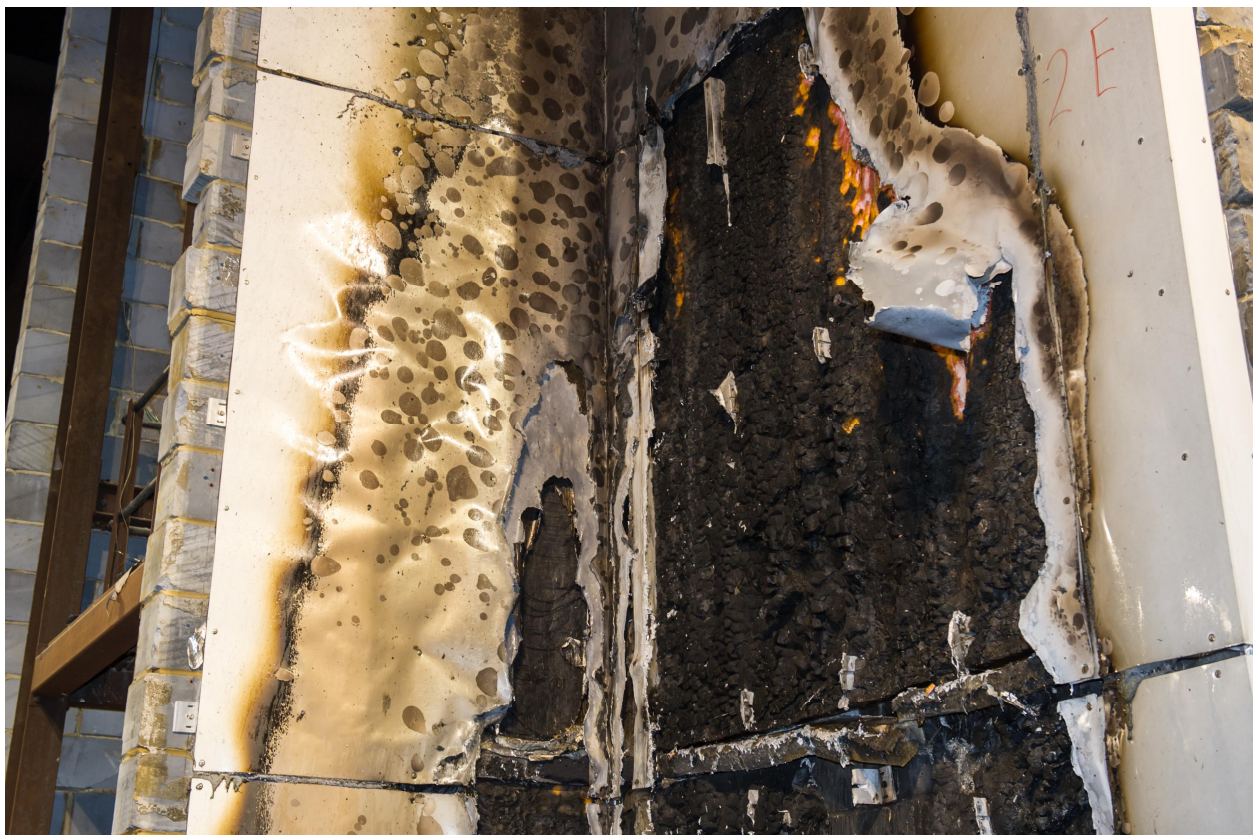
Figure 26. Second row ACM panels

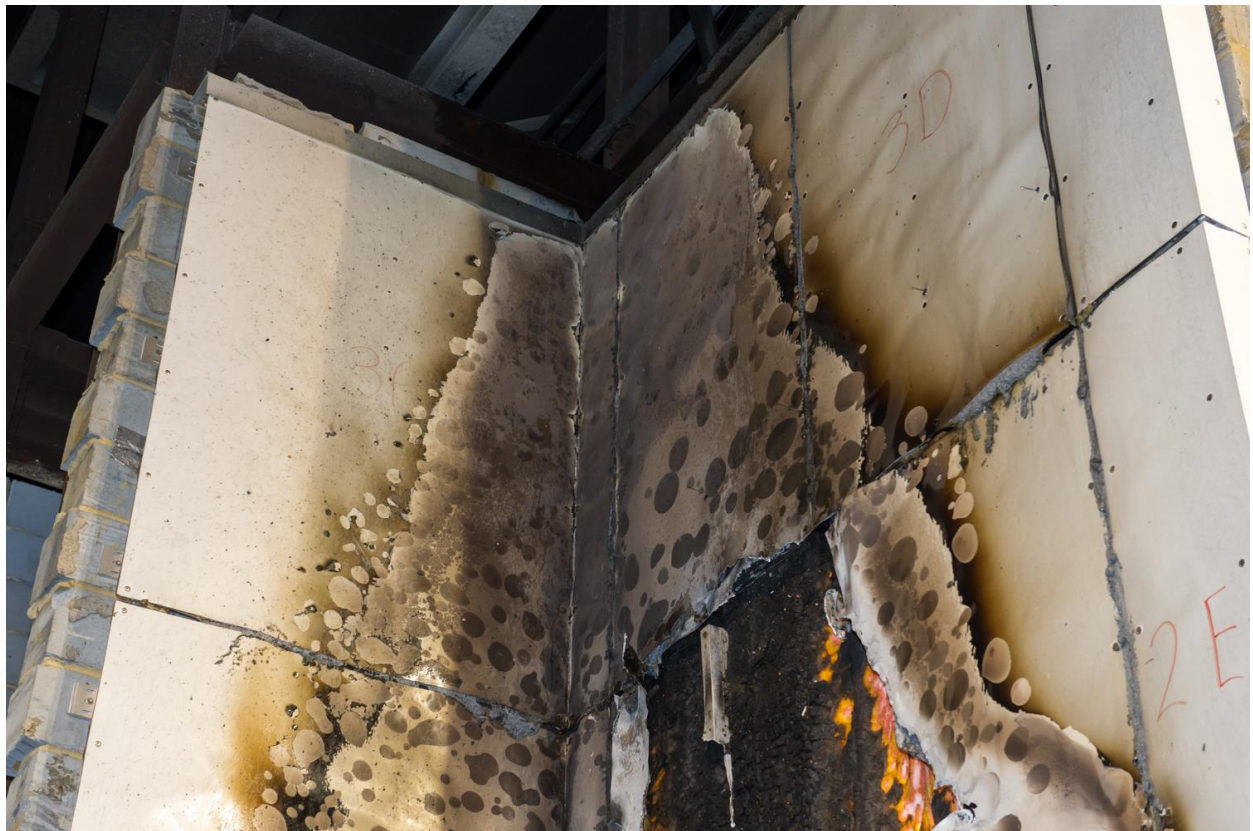
- Panel 3A. Distortion and discolouration of the panel extending the full height of the panel. The area of damage was approximately 1000mm wide at the base and 200mm wide at the top. The panel was in place.

Figure 27. Third row ACM panels (approximately 4600mm-6500mm above combustion chamber).

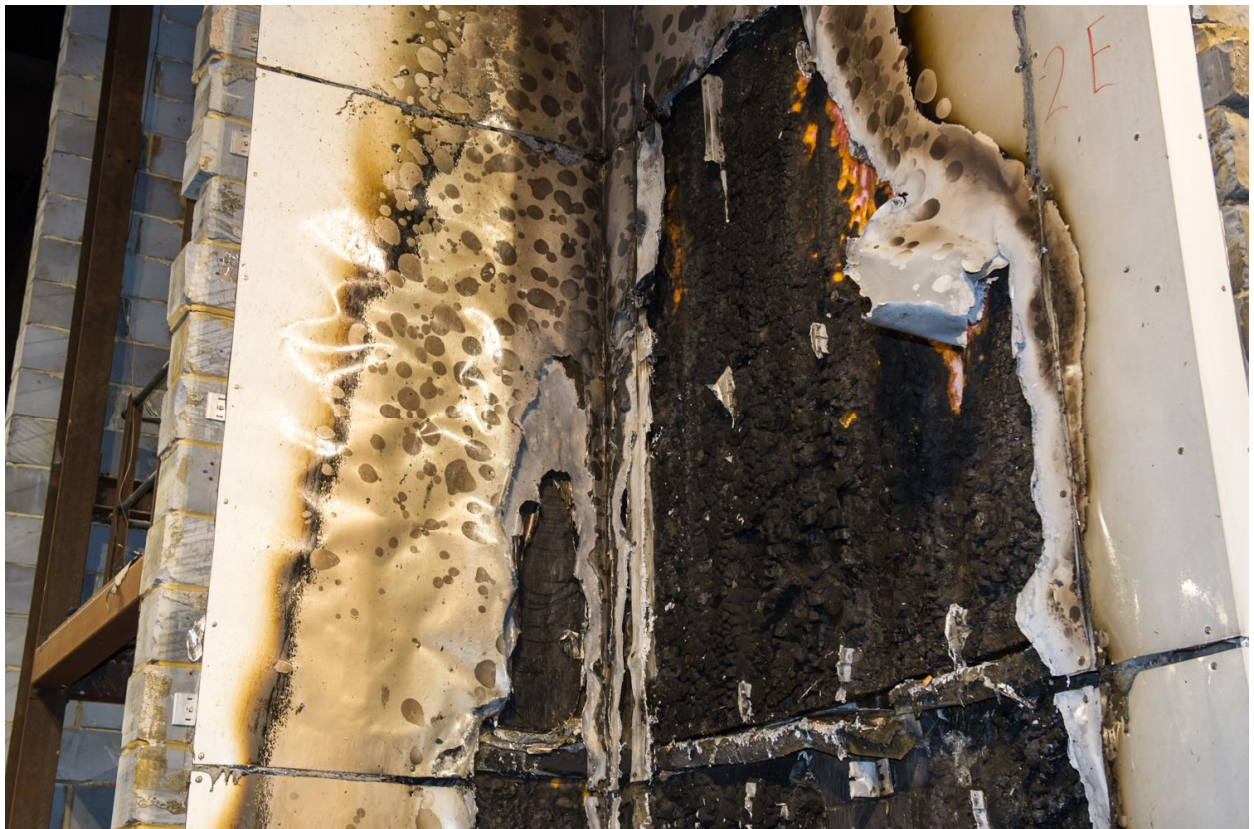
Figure 28. Distortion and damage to panel 2A– note delamination of the panel.

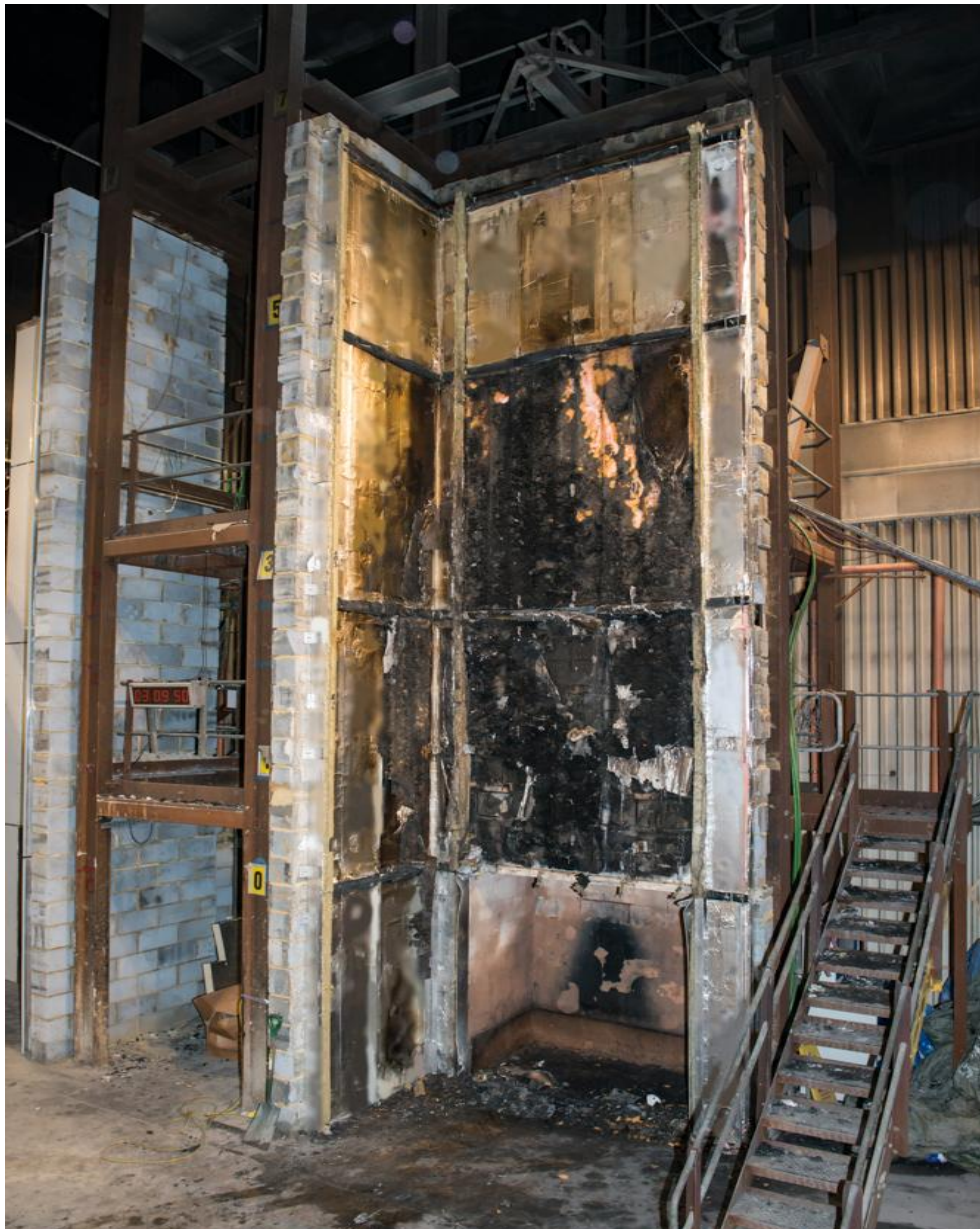
Figure 29. Full height photograph of system following removal of ACM panels.

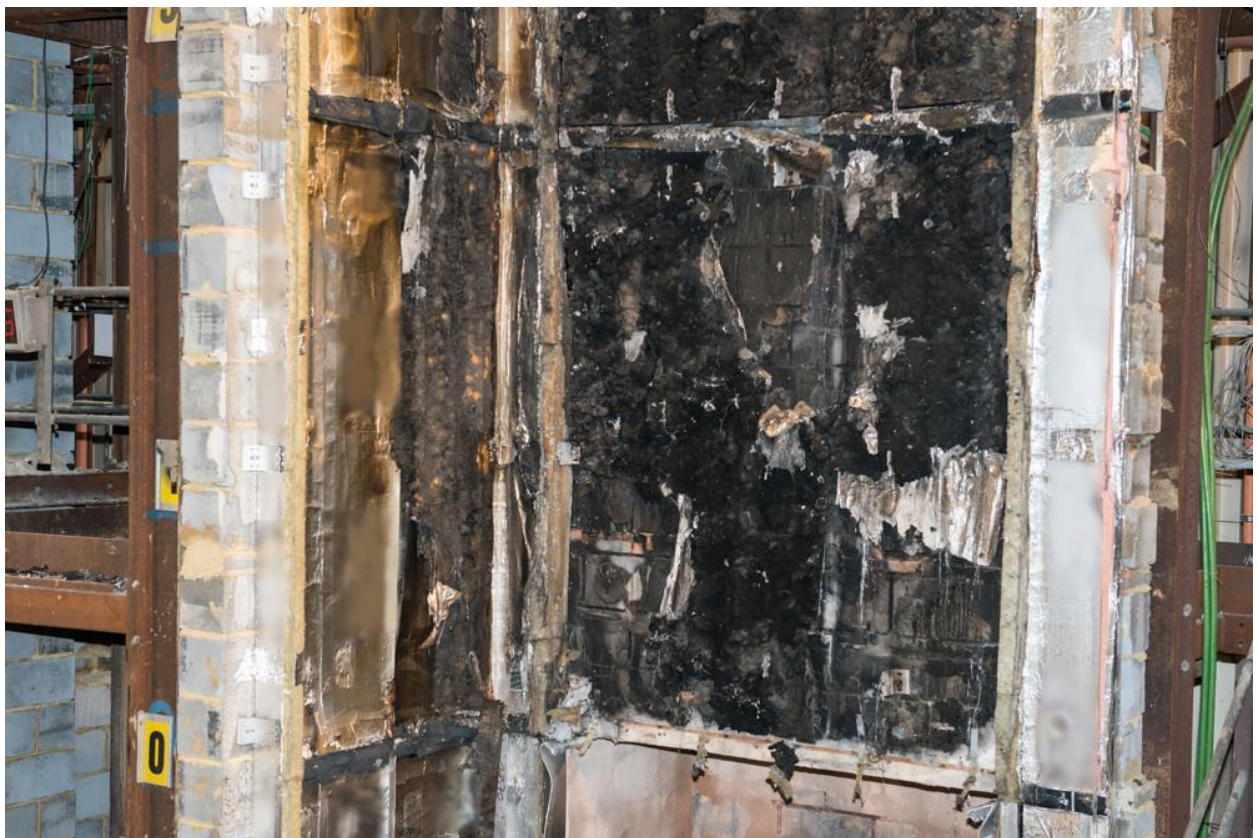
- 1C&1D, Approximately 50% of the insulation detached or consumed exposing the blockwork behind. Remaining insulation heavily charred. Some remains of foil facing.
- 1E. Insulation largely undamaged. Foil facing of insulation intact.
- 2C, charring of the insulation occurred in decreasing severity between the second and third cavity barrier. No foil facing was visible upon removal of the ACM panels.
- 2D, charring of the insulation occurred in decreasing severity between the second and third cavity barriers mirroring the damage to the ACM panel above.
- 2E Insulation largely undamaged with the foil facing intact.
- 3B Discolouration of the foil facing.
- 3C Discolouration of the foil facing
- 3D Discolouration of 50% of the foil facing.
- 3E Insulation undamaged.

Figure 30. Damage to cladding system beneath ACM panels directly above combustion chamber.

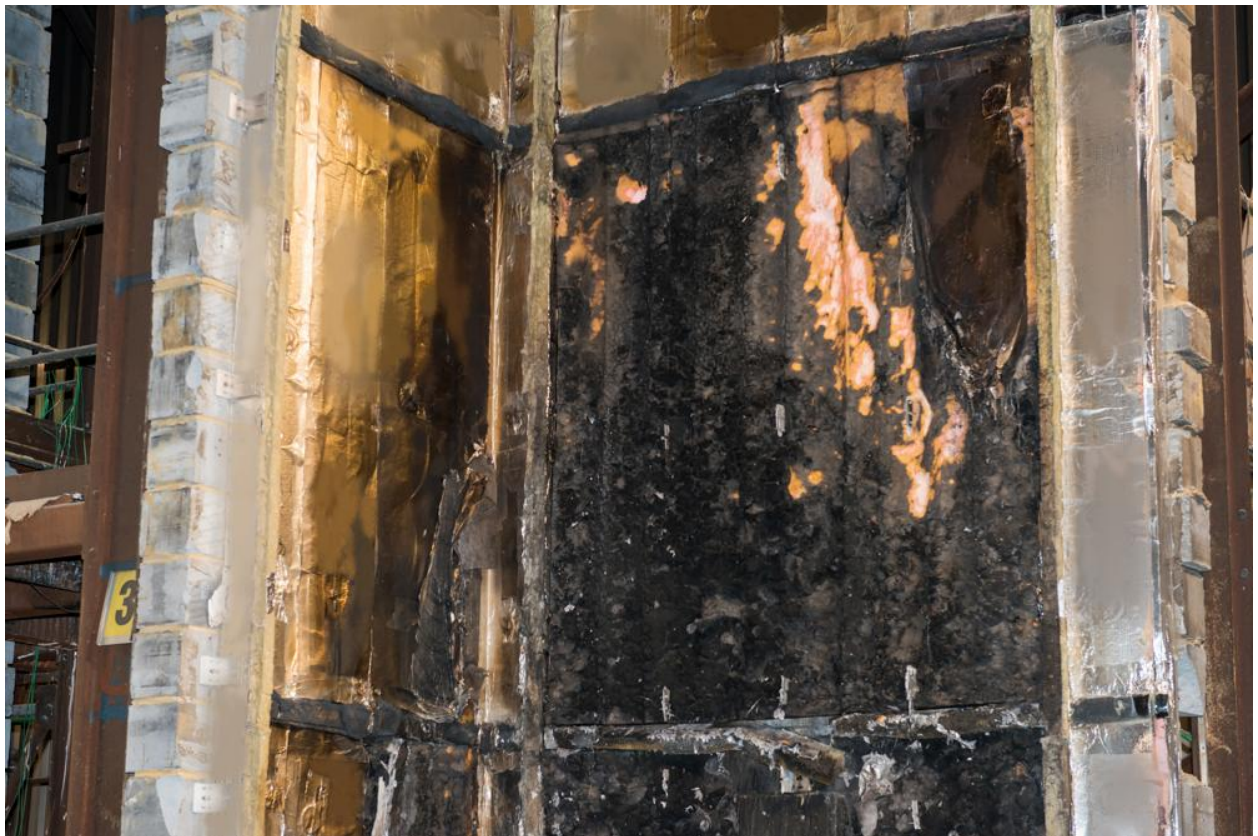
Figure 31. Damage to cladding system beneath ACM panels between the second and third horizontal cavity barrier .

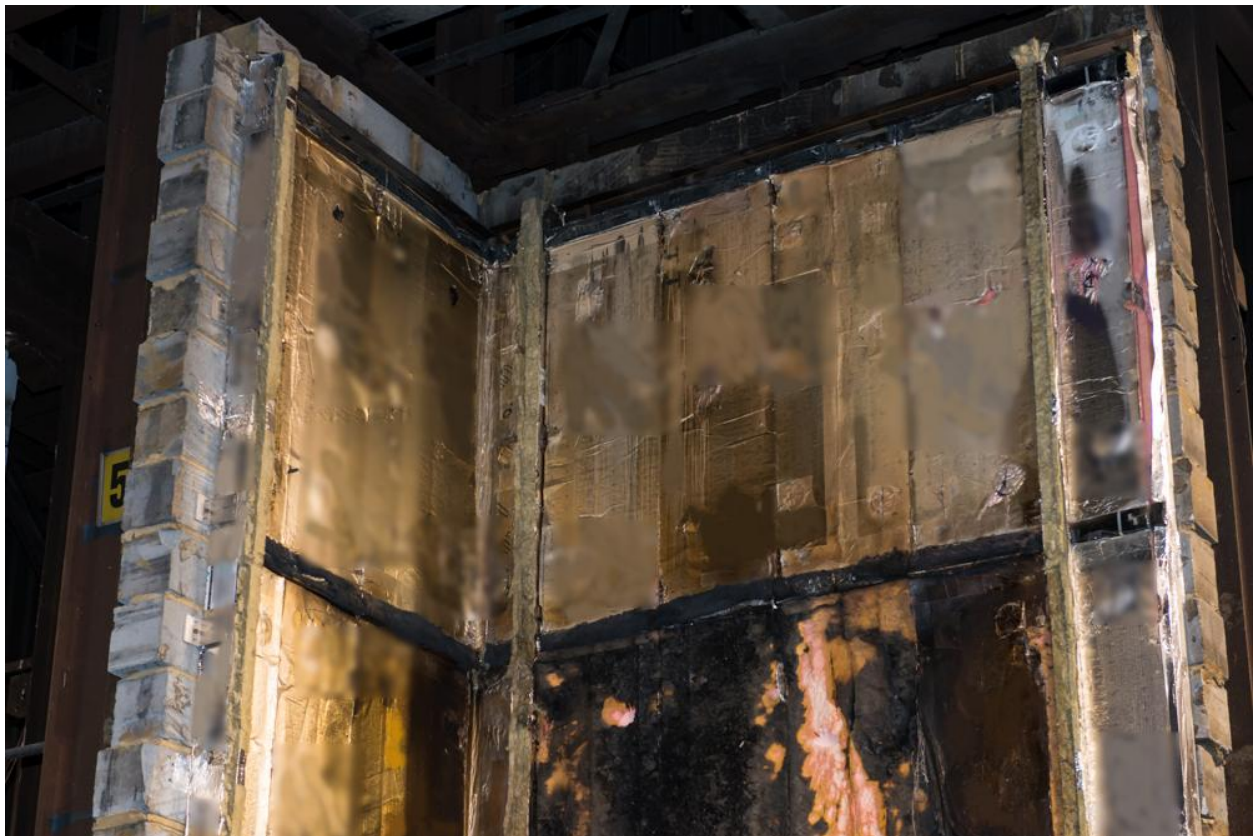
Figure 32. Damage to cladding system beneath ACM panels between the third and fourth horizontal cavity barrier

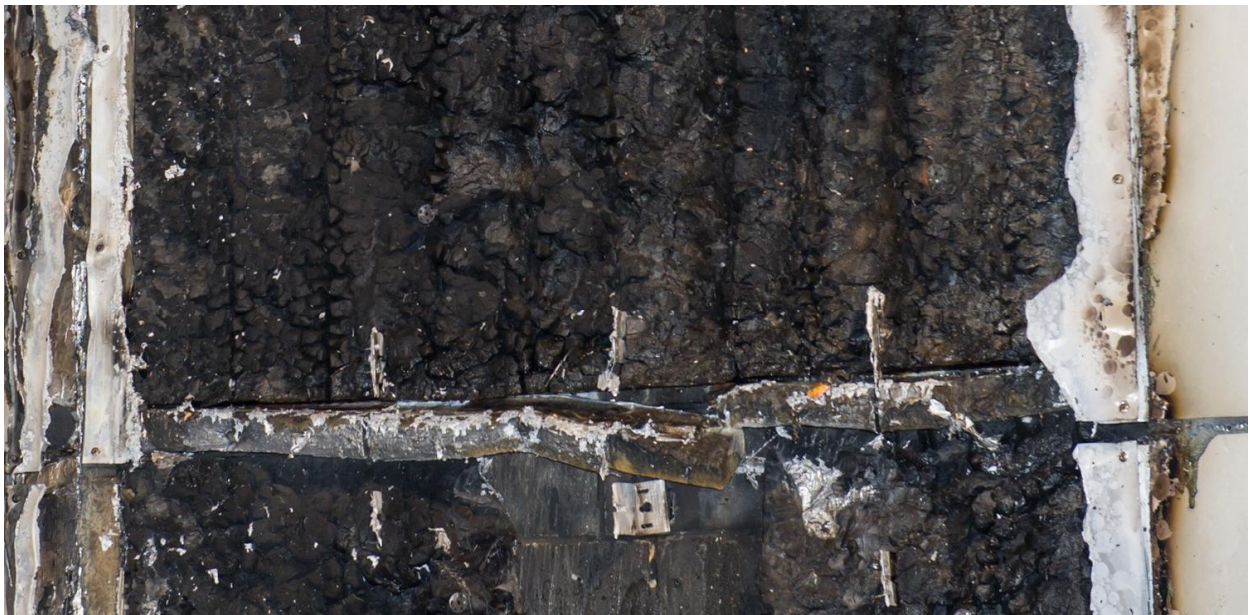
Figure 33. Close up of second cavity barrier in line with the combustion chamber opening.

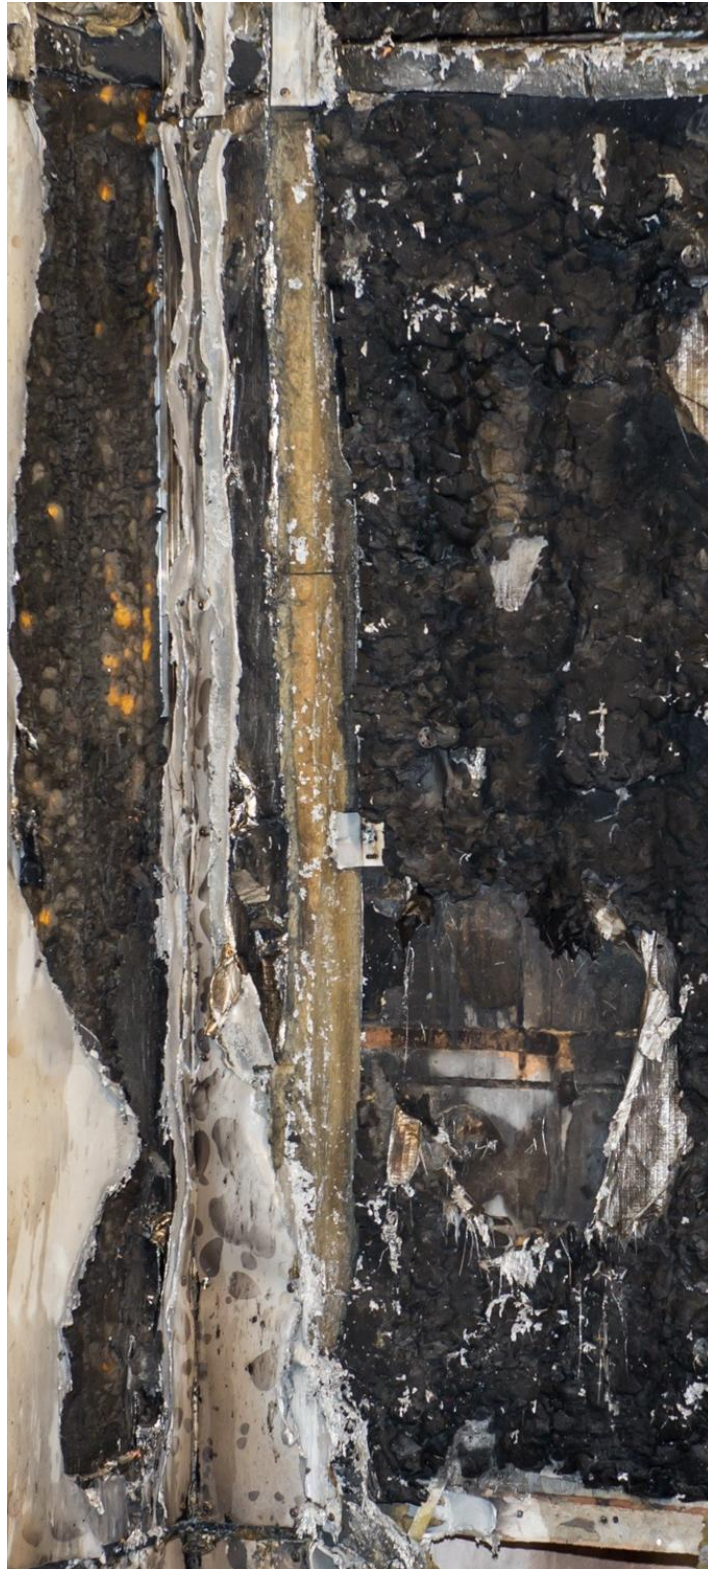
- 0A. The foil facing on the insulation remained intact.
- 1A. Insulation charred to the full height between the fire breaks on approximately 50% of the insulation adjacent to panel 1B. The foil facing on the remaining insulation was intact.
- 2A, A small section of the insulation was charred (approx. 300mm wide at the base and 800mm high). The foil facing remained intact on the rest of the insulation.
- 3A, minor discolouration to the foil facing – see *Figure 34*.

Figure 34. Close up of vertical cavity barrier adjacent to the wing wall directly above the combustion chamber –post test.
