Ministry
of Defence

Ref. FOI2017/02886

Property UPRN **2214791**

Date of Inspection: 05/01/2017
 Surveyor: [Redacted]

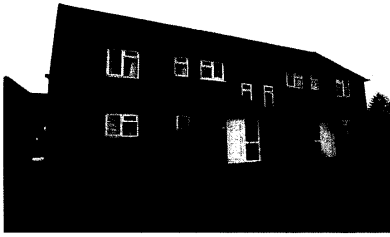
Front elevation (LHS property)

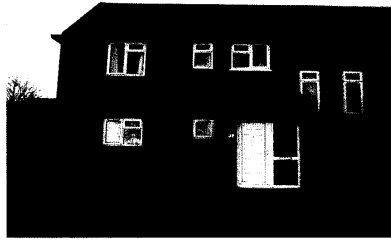
Front elevation

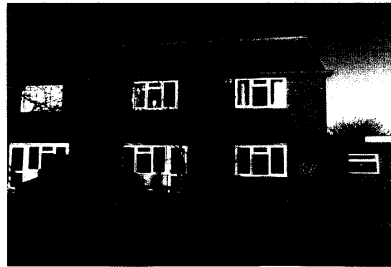
Rear elevation

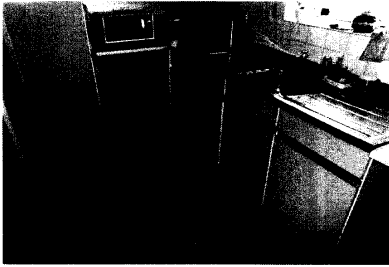
Early 80's kitchen units

- replace 30yr old kitchen (backs on new carcasses preventing food coming into contact with wall)

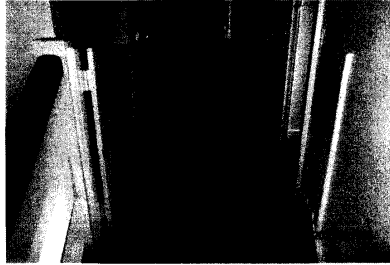
Child gate at top of stairs reducing risk to stairs
