AAIB Bulletin

8/2017

Published 10 August 2017

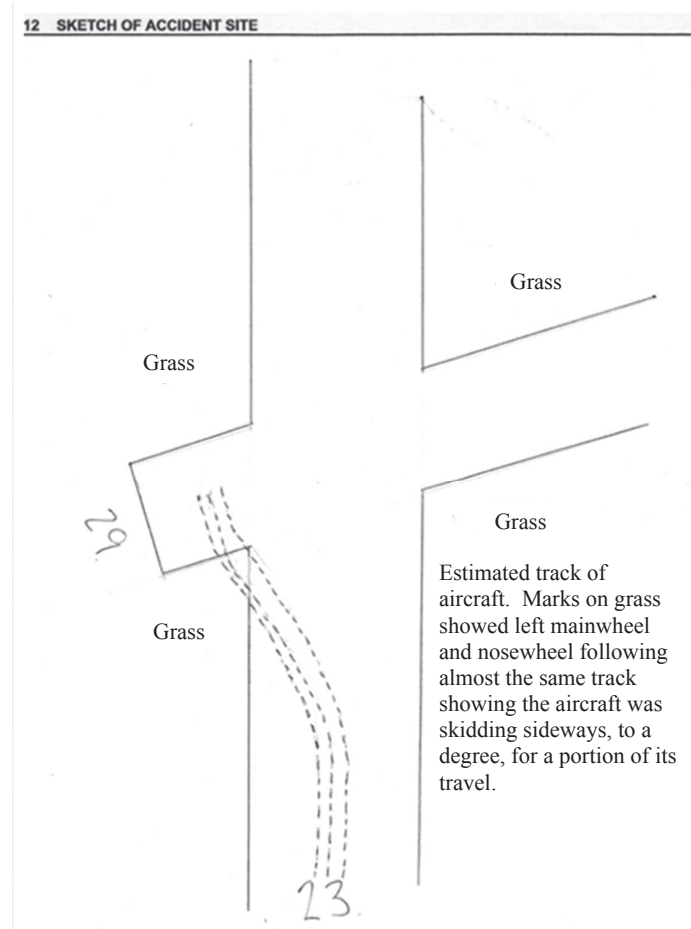
After shutdown, the captain accompanied airfield operations personnel while they checked the incident site. It became apparent that the aircraft had departed the paved area and crossed the grass (Figure 1). Consequently, the aircraft was taken out of service and remained at Tiree until an engineering inspection confirmed that there was no damage.

Figure 1
Commander's sketch of incident site

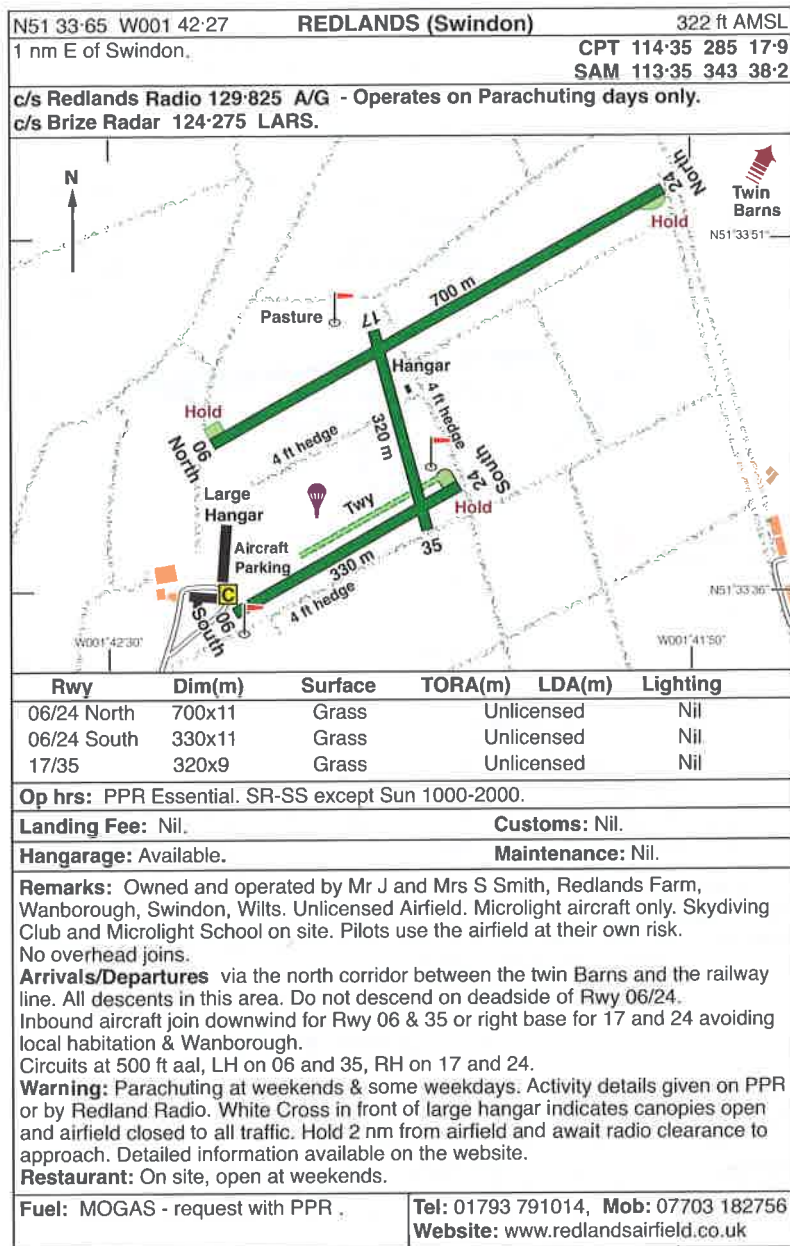
The aircraft stopped close to a hedge, which has a gap through which the runway passes at approximately its mid-point, see Figure 1 for a layout of the airfield. There was some

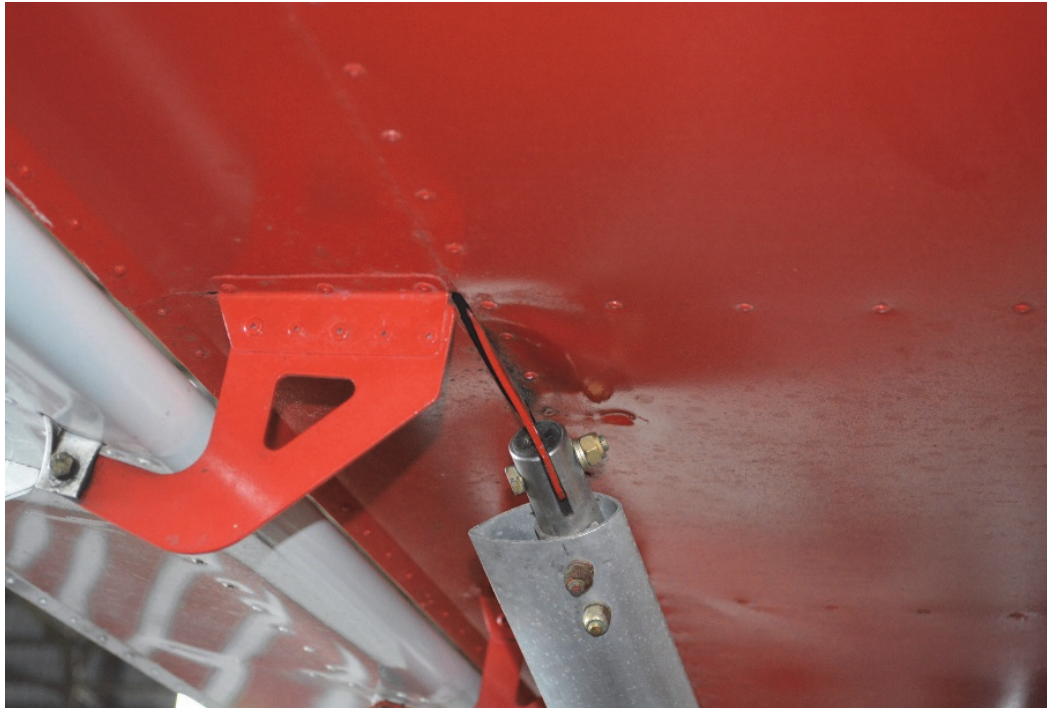
Figure 1

With the weather continuing to deteriorate, he curtailed the flight and landed at his home airfield. Two days later, when he moved the aircraft out of the hangar, he observed that the right rear lift strut attachment bracket was bent forwards. It was apparent that the uppermost attachment bolt had contacted the lower surface of the wing, leaving a clear indentation (Figure 1).

Distorted lift strut attachment
