ACCIDENT

Aircraft Type and Registration:	Cessna 402C, N603AB
No & Type of Engines:	2 Continental TSIO-520-VB piston engines
Year of Manufacture:	1997 (Serial no: 402C0603)
Date & Time (UTC):	11 February 2017 at 2004 hrs
Location:	Virgin Gorda Airport, British Virgin Islands (BVI)
Type of Flight:	Commercial Air Transport (Passenger)
Persons on Board:	Crew - 1 Passengers - 8
Injuries:	Crew - None Passengers - None
Nature of Damage:	Extensive damage to the landing gear and aircraft structure
Commander's Licence:	Commercial pilot's licence (FAA)
Commander's Age:	29 years
Commander's Flying Experience:	5,458 hours (of which 809 were on type) Last 90 days - 225 hours Last 28 days - 80 hours
Information Source:	AAIB Field Investigation

Synopsis

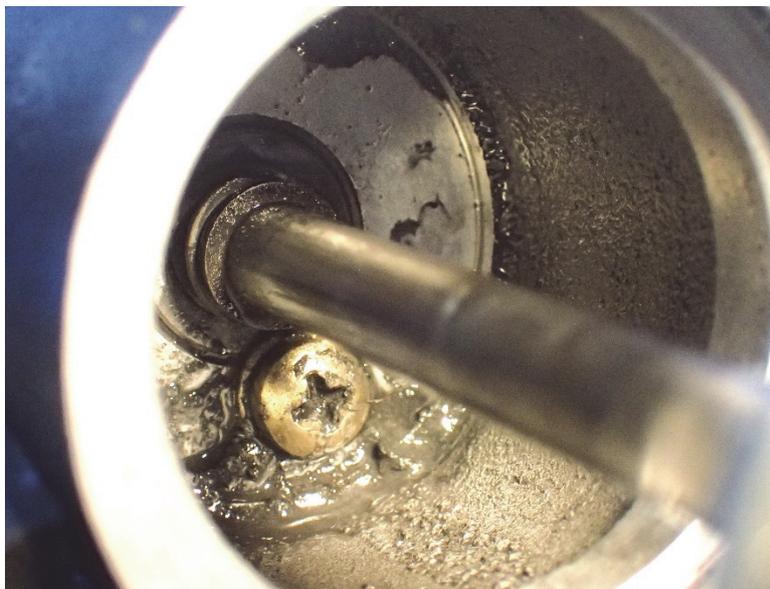
Figure 4

Debris and contamination inside the oil reservoir was analysed and identified to be general environmental dirt and aluminium flakes (Figure 4).

Debris in the left master cylinder oil reservoir

A basic functional test of the master cylinders established they could generate and hold pressure but subsequent strip examination identified several anomalies, some of which could have a significant detrimental effect on braking performance. The omission of the filler plugs created an entry point for debris and contaminants that were found in the oil reservoirs of both master cylinders. Analysis established that the debris was a combination of general environmental dirt and aluminium flakes; the latter most likely originating from the internal wall of the oil reservoir. The aircraft manufacturer considered that the presence of debris, if trapped between the sealing faces, could compromise the quality of the seal. This would have an adverse effect on braking performance but the symptoms would only be apparent whilst the debris remained trapped.

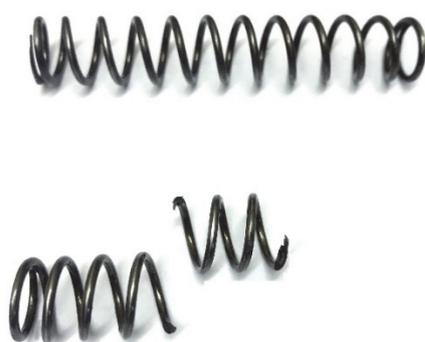
Figure 5

The piston rod and return spring were removed, revealing two pieces of a broken return spring in the lowest section of the housing bore. The broken pieces, when placed end to end, had a combined length that was approximately half a complete spring (Figure 5). The coil was wound in the opposite direction to the intact spring.

The intact piston return spring and the remains of the broken spring

The omission of the rubber ring seal from the left master cylinder would have had no effect on braking performance but was indicative of a shortfall during maintenance. The remains of a broken spring in the left master cylinder was unlikely to have interfered with system operation but they also were indicative of a shortfall during maintenance. The operator did not know when the spring failure occurred and considered the omission to remove the broken parts to be an error on their part.
