ACCIDENT

Aircraft Type and Registration:	DH110 Sea Vixen FAW Mk 2, G-CVIX	
No & Type of Engines:	2 Rolls-Royce Avon Mk 208 turbojet engines	
Year of Manufacture:	1963 (Serial no: 10125)	
Date & Time (UTC):	27 May 2017 at 1655 hrs	
Location:	RNAS Yeovilton, Somerset	
Type of Flight:	Private	
Persons on Board:	Crew - 1	Passengers - None
Injuries:	Crew - None	Passengers - N/A
Nature of Damage:	Hydraulic pump disintegration, overload fuel tanks destroyed, and fuselage and accessory gearbox abrasion	
Commander's Licence:	Airline Transport Pilot's Licence	
Commander's Age:	60 years	
Commander's Flying Experience:	8,690 hours (of which 58 were on type) Last 90 days - 34 hours Last 28 days - 11 hours	
Information Source:	Aircraft Accident Report Form submitted by the pilot and inquiries made by the AAIB

Synopsis

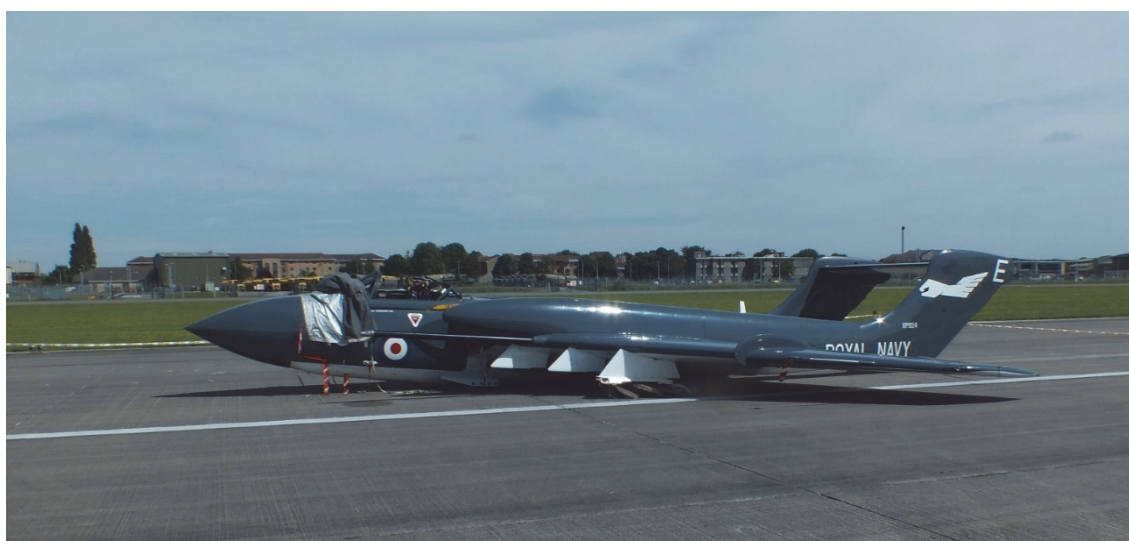
Figure 1
G-CVIX on the runway prior to recovery

There was no fire or fuel leakage but the aircraft had sustained significant damage to its fuselage underside, particularly in its engine bay area including the accessory gearbox casing. Figure 1 shows the aircraft on the runway.

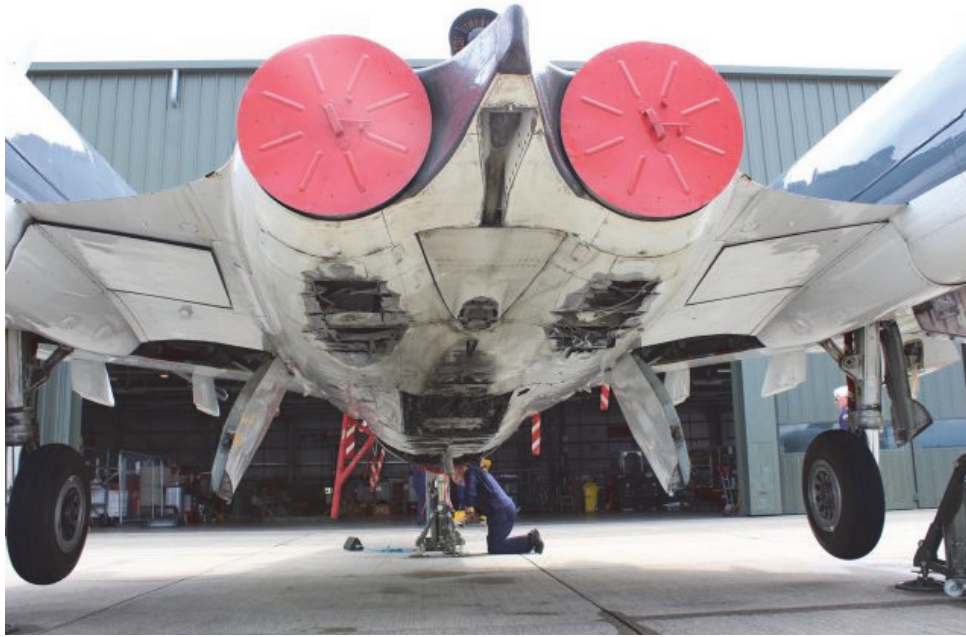
The surface of the runway had caused severe abrasion through the aluminium alloy fuselage skin, stringers and frames and into the casing of the accessory gearbox, to the extent that some of the gear train was exposed. The reinforced section, which attaches the drop tanks to the pylons, was all that remained of the left and right drop tanks still attached the aircraft. The canopy and its frame sustained damage consistent with being ejected from the aircraft whilst still at speed and landing behind the aircraft. There was no fuel leakage or fire during the landing. Figure 2 shows the damage to the underside of the aircraft.

Damage to the underside of G-CVIX.

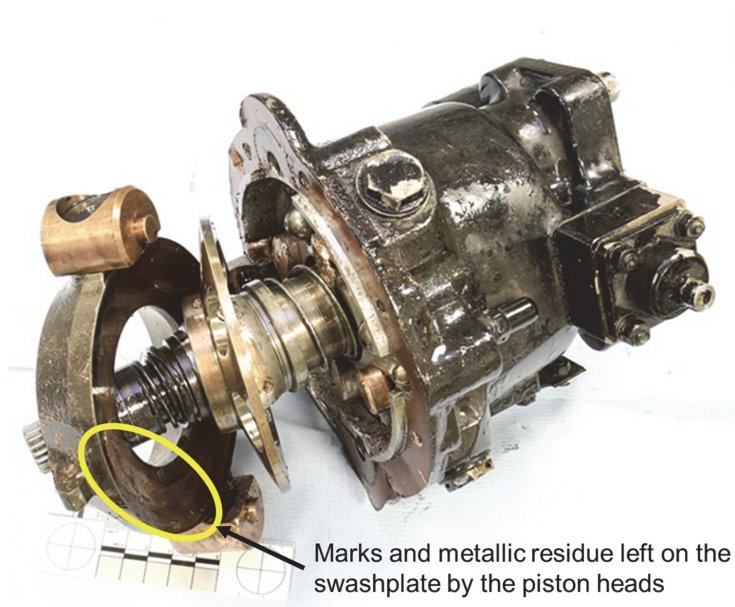
Figure 3

The Red pump was disassembled first and although it showed no outward signs of damage or malfunction, there was metallic debris present in the supply and return pipe connections. The disassembly revealed that the outer casing, cover plate and piston carrier were damaged internally with substantial amounts of non-ferrous material of various sizes throughout the pump. All seven of the pistons were present, but most of them were seized in the piston carrier. The swashplate piston track had significant metal scuffing and pick-up from the piston heads on its surface (Figure 3). Otherwise the swashplate, its pivot blocks and piston

The Red pump shown with its cover plate removed

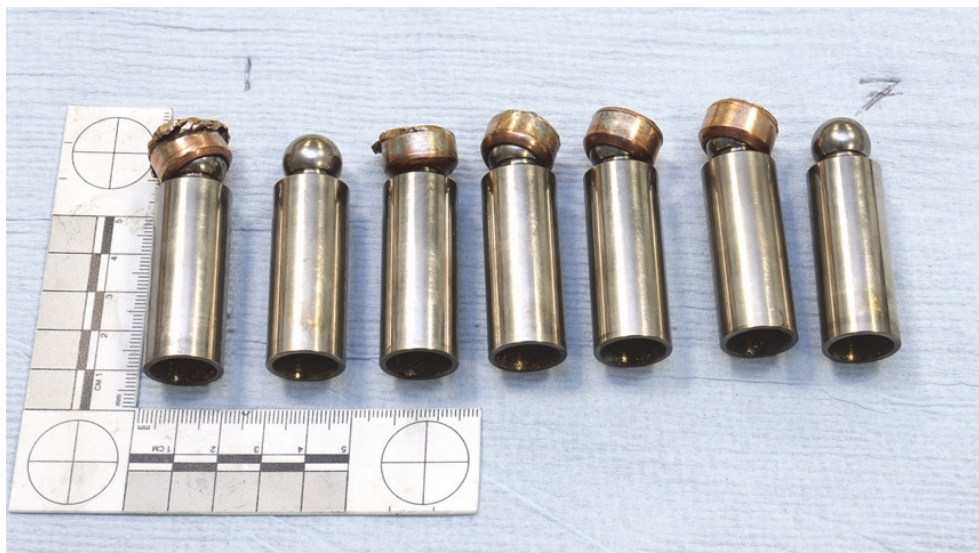
Figure 4

synchronising plate, were free to move and were undamaged. The servo piston and linkage to the swashplate was also seized. All the piston head collars had fragmented leaving just the ball and socket at the top of each piston (Figure 4).

Damage to the Red hydraulic pump piston heads

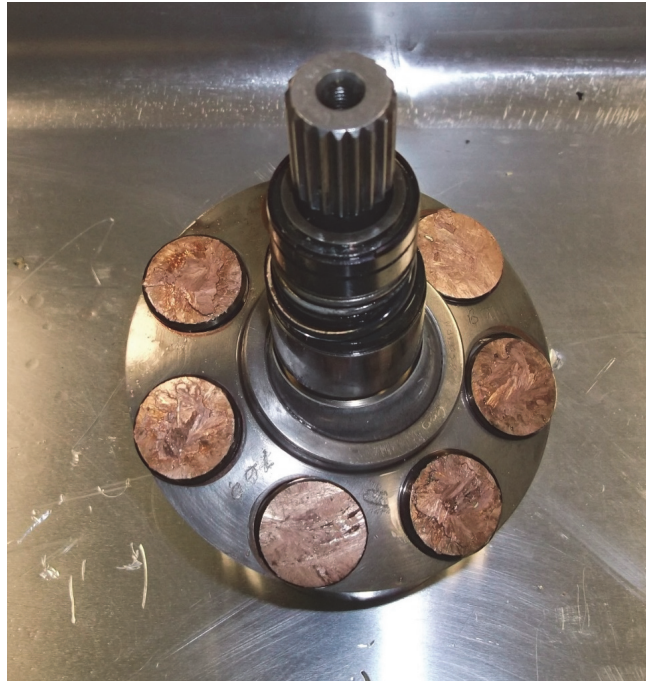
Figure 5

The Green pump was also disassembled. It showed no outward signs of damage and internally was in better condition than the Red pump, with minimal debris present. The swashplate piston track also exhibited non-ferrous metallic scuffing and pick-up from the piston heads but to a far lesser extent than the Red pump. All the pistons were present and some were seized in their carrier. The piston heads showed some signs of wear and scuffing

where they contacted the swashplate but were otherwise intact and correctly positioned in the synchronising plate. The servo piston was correctly attached to the swashplate and free to move. Figures 5 and 6 show the Green pump components.

Green pump piston heads and synchronising plate

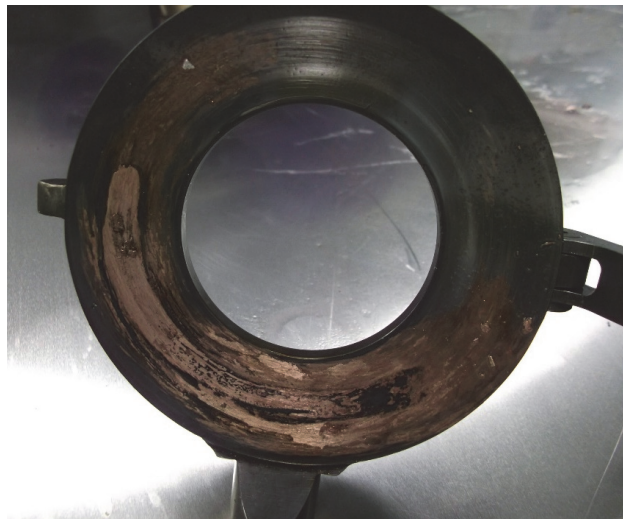
Figure 6

Associated swashplate piston track marks
