SERIOUS INCIDENT

Aircraft Type and Registration:	Let L-410 UVP-E, OK-LAZ	
No & Type of Engines:	2 Walter M601E turboprop engines	
Year of Manufacture:	1990 (Serial no: 902504)	
Date & Time (UTC):	23 February 2017 at 0927 hrs	
Location:	Isle of Man (Ronaldsway) Airport	
Type of Flight:	Commercial Air Transport (Passenger)	
Persons on Board:	Crew - 2	Passengers - 3
Injuries:	Crew - None	Passengers - None
Nature of Damage:	None	
Commander's Licence:	Airline Transport Pilot's Licence	
Commander's Age:	51 years	
Commander's Flying Experience:	7,800 hours (of which 2,200 were on type) Last 90 days - 120 hours Last 28 days - 40 hours	
Information Source:	AAIB Field Investigation

Synopsis

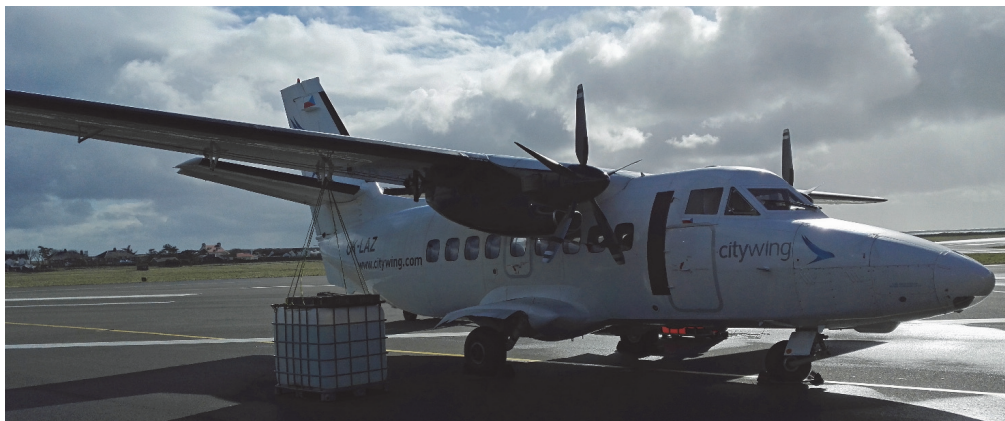
RFFS vehicles were positioned around the aircraft, to provide some screening from the wind, and a bus transferred the three uninjured passengers to the terminal building. The aircraft was later tied down until the wind subsided, (Figure 1).

Figure 1
Aircraft tied down at IOM
