ACCIDENT

Aircraft Type and Registration:	Kolb FireFly, G-CEPN	
No & Type of Engines:	1 Fuji Robin 330 piston engine	
Year of Manufacture:	2007 (Serial no: FF05.4.00048)	
Date & Time (UTC):	20 June 2017 at 0920 hrs	
Location:	Near Newell Lane, Luffenhall, Hertfordshire	
Type of Flight:	Private	
Persons on Board:	Crew - 1	Passengers - None
Injuries:	Crew - 1 (Fatal)	Passengers - N/A
Nature of Damage:	Aircraft destroyed	
Commander's Licence:	Private Pilot's Licence	
Commander's Age:	71 years	
Commander's Flying Experience:	5,215 hours (of which 342 were on type) Last 90 days - 0 hours Last 28 days - 0 hours	
Information Source:	AAIB Field Investigation

Synopsis

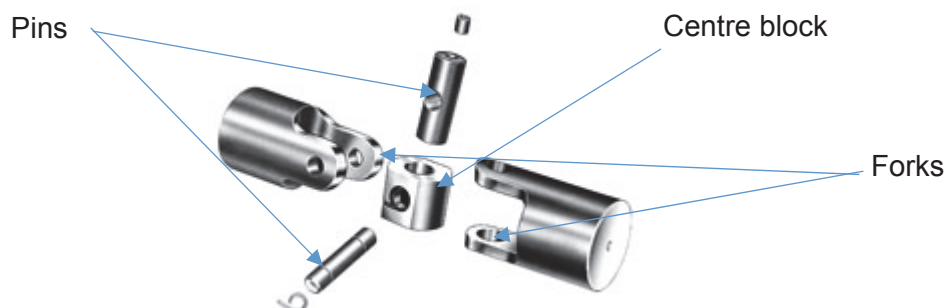
Figure 2

It was not possible to carry out any investigation of the aircraft's instrumentation due to impact damage. Examination of the aileron control circuit confirmed that it had been correctly rigged but the universal joint within the control circuit had fractured and the centre block was missing, Figure 2.

Example of a universal joint

Evidence of mechanical damage and deformation of the joint forks and pin locating holes was observed on the remaining sections of the joint, showing that the centre block was in place at the time of the impact with the ground.

The damage observed to the universal joint within the aileron control circuit was consistent with the joint being correctly connected at impact. No defects were observed within the aircraft's controls which would have prevented the aircraft responding to the pilot's control inputs and there was no evidence of an in-flight structural failure.
