**SERIOUS INCIDENT**

<b>Aircraft Type and Registration:</b>	Boeing 767-300, D-ABUK	
<b>No &amp; Type of Engines:</b>	2 GE CF6-80C2B6F turbofan engines	
<b>Year of Manufacture:</b>	1999 (Serial no: 30009)	
<b>Date &amp; Time (UTC):</b>	21 July 2017 at 0200 hrs	
<b>Location:</b>	En route from Kangerlussuaq, Greenland to Frankfurt, Germany	
<b>Type of Flight:</b>	Commercial Air Transport (Non-Revenue)	
<b>Persons on Board:</b>	Crew - 4	Passengers - 4
<b>Injuries:</b>	Crew - None	Passengers - None
<b>Nature of Damage:</b>	Window 1R, burnt terminal block and terminal lug and cable loom damaged	
<b>Commander's Licence:</b>	Airline Transport Pilot's Licence	
<b>Commander's Age:</b>	31 years	
<b>Commander's Flying Experience:</b>	5,200 hours (of which 5,200 were on type) Last 90 days - 120 hours Last 28 days - 70 hours	
<b>Information Source:</b>	Aircraft Accident Report Form submitted by the pilot

**Synopsis**

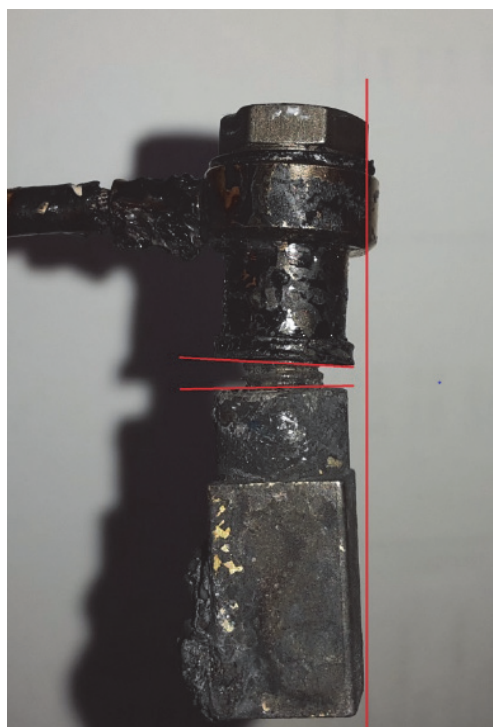
**Figure 1**

Troubleshooting by the operator revealed that the right windscreen was damaged, its terminal block J5 and terminal lug were burnt and the cable loom was damaged. The aircraft was then ferried to Frankfurt, with the window heat isolated, so the damaged components could be replaced.

Following removal, the operator initiated a more detailed examination of the affected parts. It identified that the terminal lug was not parallel to the terminal block; this could allow the mounting screw to become loose, creating a high resistance connection with the potential for overheating, Figure 1. No reason for the incorrect alignment was identified.

J5 Terminal block and terminal lug showing misalignment and heat damage  
(Image courtesy of the operator)

- Adopted a double inspection requirement for electrical terminal installation following windscreen replacement;
- Reduced the repeat inspection threshold for windscreen electrical terminals from 500 flight hours to 100 flight hours;
- Introduced an additional engineering condition inspection for all windscreens entering stores;
- Conducted a fleet check to ensure correct installation of windscreen terminal connections;
- Clarified Aircraft Maintenance Manual (AMM) task 56-11-01-404-017, No 1 Window Installation, so that the resistance test of the window heater element is performed before installation to prevent the J5 terminal block connection being made twice;
- Added advice to AMM task 30-41-00-765-046 to use a torque wrench when connecting the wiring to the window terminals;
- Evaluating a coordinated replacement of windscreens not using the later design pin and socket connections.
