**SERIOUS INCIDENT**

<b>Aircraft Type and Registration:</b>	Saab 2000, G-LGNS	
<b>No &amp; Type of Engines:</b>	2 Rolls-Royce AE 2100A turboprop engines	
<b>Year of Manufacture:</b>	1995 (Serial no: 2000-041)	
<b>Date &amp; Time (UTC):</b>	27 October 2017 at 1820 hrs	
<b>Location:</b>	Sumburgh Airport	
<b>Type of Flight:</b>	Commercial Air Transport (Passenger)	
<b>Persons on Board:</b>	Crew - 4	Passengers - 18
<b>Injuries:</b>	Crew - None	Passengers - None
<b>Nature of Damage:</b>	None	
<b>Commander's Licence:</b>	Airline Transport Pilot's Licence	
<b>Commander's Age:</b>	31 years	
<b>Commander's Flying Experience:</b>	4,302 hours (of which 1,821 were on type) Last 90 days - 106 hours Last 28 days - 52 hours	
<b>Information Source:</b>	Aircraft Accident Report Form submitted by the pilot

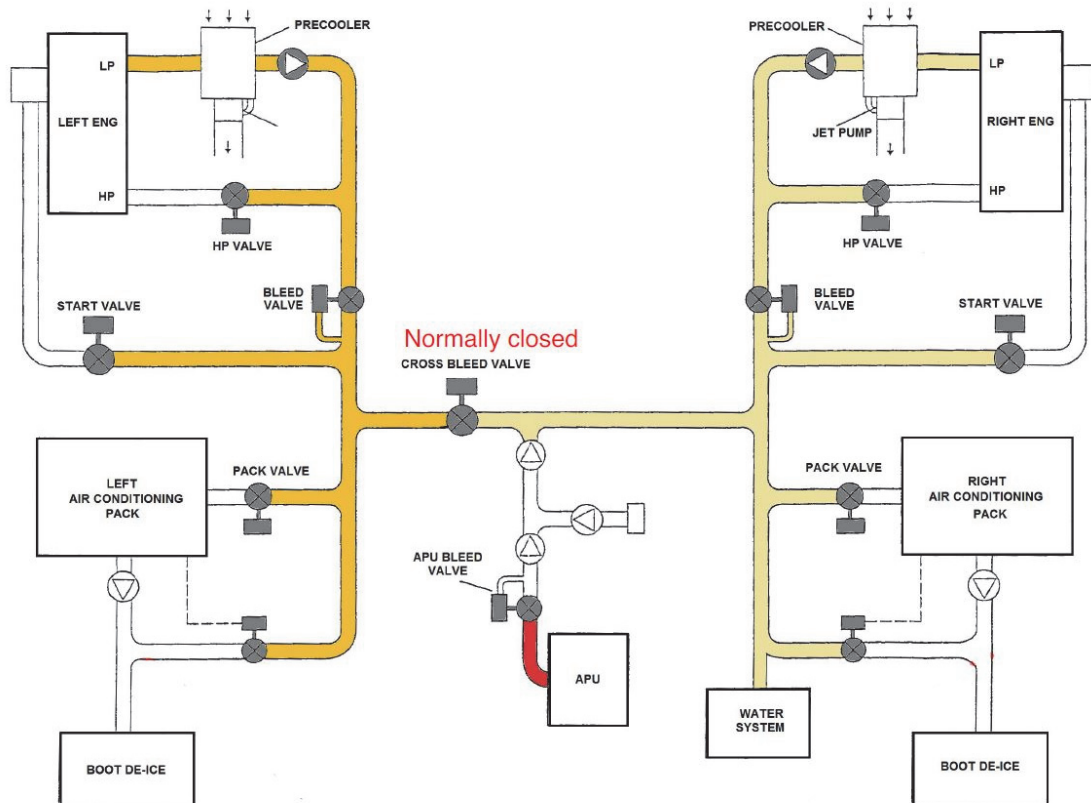
**Figure 1**

The aircraft is equipped with two air conditioning packs, which can be provided with compressed air from either of the engines or the APU (Figure 1). Except for engine start, the cross-bleed valve normally remains closed and the APU, which is normally only operated on the ground, supplies compressed air to the right air conditioning pack. The commander reported that the report of smoke in the cabin coincided with the starting of the APU after landing.

Schematic of the aircraft air system
