SERIOUS INCIDENT

Aircraft Type and Registration:	Airbus Helicopters EC120B Colibri, G-SWNG	
No & Type of Engines:	1 Turbomeca ARRIUS 2F turboshaft engine	
Year of Manufacture:	2008 (Serial no: 1532)	
Date & Time (UTC):	17 August 2017 at 11:30 hrs	
Location:	Wellesbourne, Warwickshire	
Type of Flight:	Private	
Persons on Board:	Crew - 1	Passengers - None
Injuries:	Crew - None	Passengers - N/A
Nature of Damage:	Right engine cowling and main rotor blades damaged	
Commander's Licence:	Private Pilot's Licence	
Commander's Age:	71 years	
Commander's Flying Experience:	341 hours (of which 195 were on type) Last 90 days - 26 hours Last 28 days - 12 hours	
Information Source:	Aircraft Accident Report Form submitted by the pilot

Synopsis

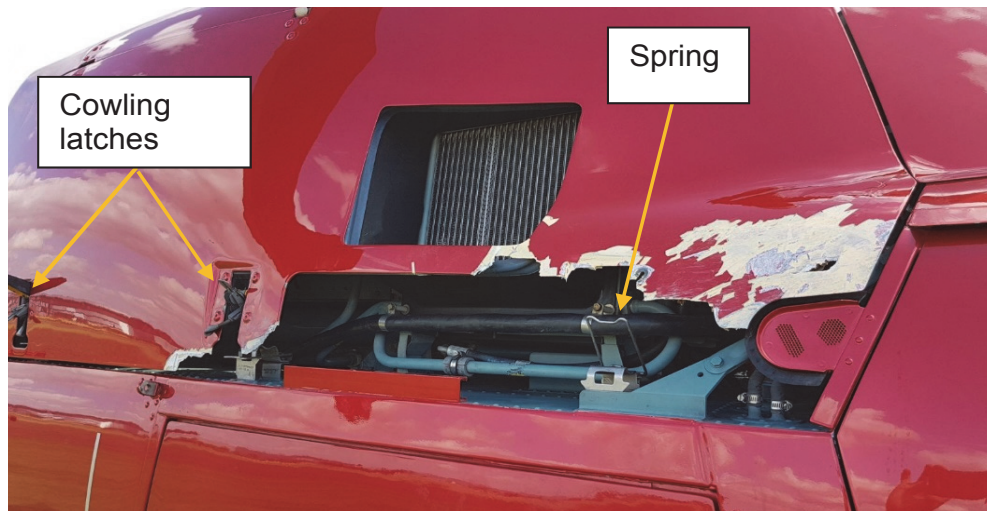
Figure 1

After flying for approximately one hour the pilot returned to land. During the flare he became aware of an unusual noise and landed immediately. Examination of the helicopter showed that the lower forward edge of the right engine cowling was damaged, the forward cowl latch assembly was missing and the centre latch had been damaged (Figure 1). Damage was also observed on the inboard sections of all the main rotor blades.

G-SWNG right engine cowling

Examination of the helicopter by the authorised maintenance organisation confirmed that the damage to the main rotor blades had been caused by contact with the right engine cowling. Inspection of the remaining two cowling latches confirmed that there was no evidence of unusual wear or damage to the latch hooks or the parts of helicopter structure where the hooks engage. There was no evidence of distortion or adverse wear to any of the springs used to retain the secondary latch levers.

The damage to the right engine cowling and main rotor blades was caused as a result of the cowling opening during the final stages of the helicopter's landing. The lack of damage and distortion to the remaining cowl latches, the helicopter structure onto which the latch hooks engaged and the latch springs confirmed that the latches had been unlocked prior to the flight.

In view of the maintenance activity immediately before the flight it is reasonable to conclude that the right engine cowling latches had not been correctly locked when the 'A' check was completed. Given that the inner faces of the latches had been painted in a contrasting colour to the helicopters paint scheme it is probable that this condition would have been observed by the pilot during a pre-flight walkaround inspection. The fact that the pilot left the helicopter for a short period of time before takeoff, coupled with the recent completion of routine maintenance, probably introduced sufficient interruption and distraction to the pilot's normal pre-flight routine to cause him to forget to carry out a pre-flight walkaround inspection.

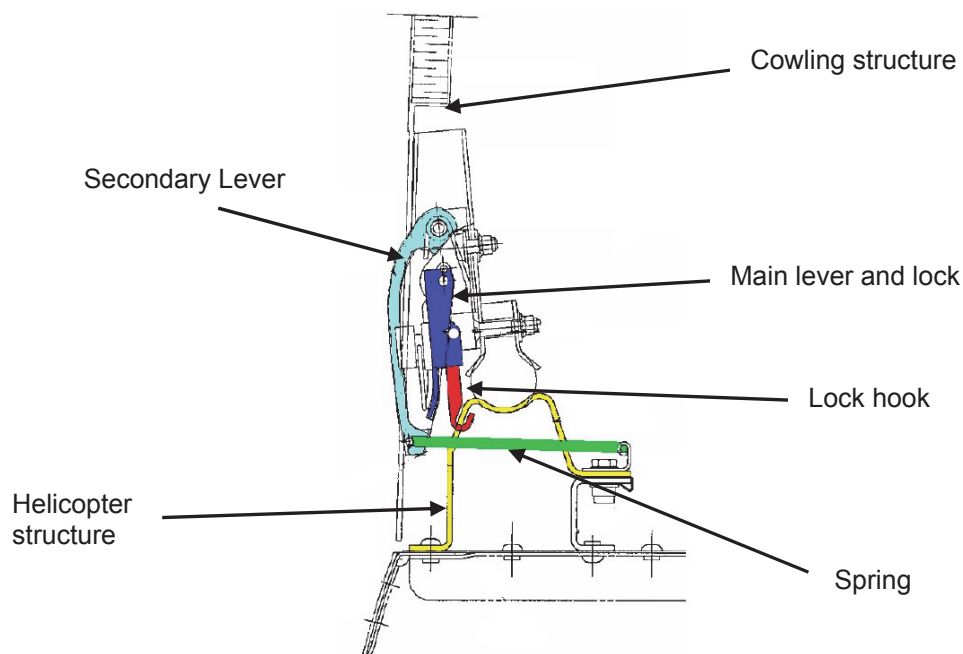
Figure 2

The engine cowlings on the EC120B are hinged to open upwards. Each cowling is held in the closed position by three hooked latches which engage with fixings on the helicopter structure (Figure 2). Closing the main lever of each latch places the latch hook under tension, securing the cowling to the structure and locks the main lever in the closed position. The secondary lever will not close if the main lever is not in the locked position, providing a positive indication of an unlocked latch. When the secondary lever is closed a spring can then be moved over the tip of the secondary lever to prevent it from opening.

Engine cowling latch diagram (courtesy of Airbus Helicopters)

As a result of a number of previous in-flight cowl opening events Eurocopter (now Airbus Helicopters) published Safety Information Notice No 2339-S-53 in June 2016. This highlighted the need to inspect the condition and function of the cowl latches during the Daily Inspection. In addition, the notice also advised that, for helicopters with a predominantly red colour scheme, the inside faces of the lock levers should be painted in a contrasting colour to the helicopter's colour scheme, to provide an increased visual cue of an unlocked cowl latch. The inner faces of G-SWNG's engine cowling lock levers had been painted in this manner.
