Rail Accident Investigation Branch

Rail Accident Report

**Trailer runaway near Hope, Derbyshire
28 May 2017**

Report 03/2018
February 2018

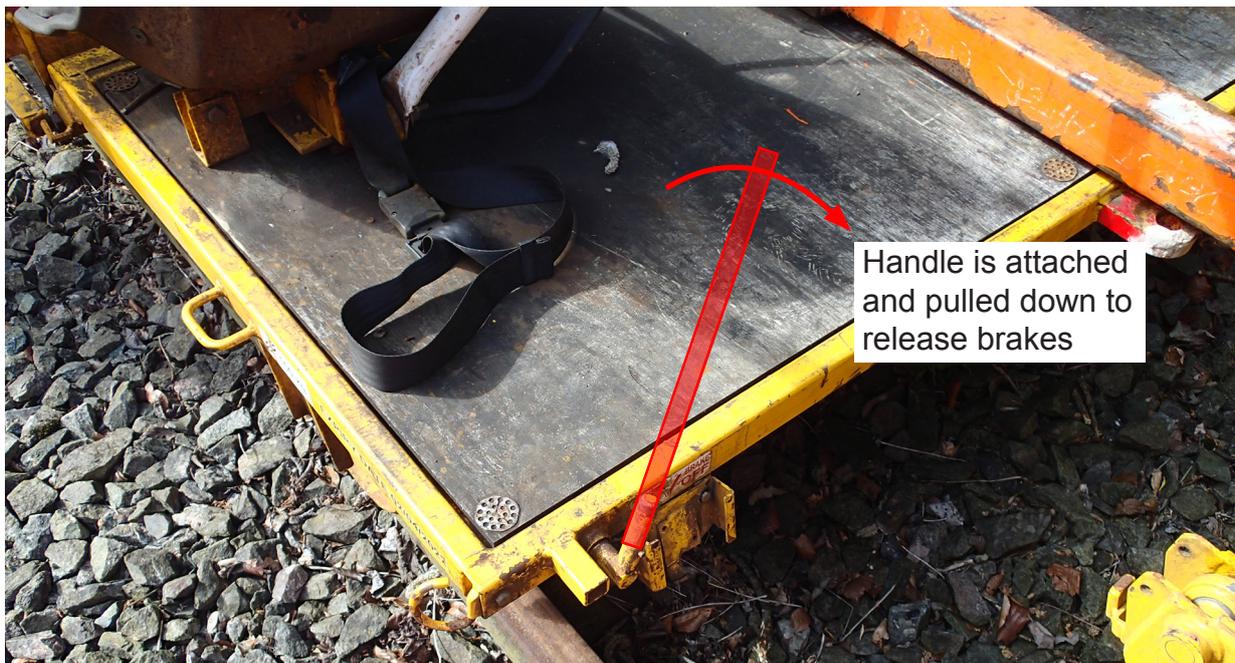
Figure 4: Manual brake release

- 73 The track worker and supervisor attempted to hold the brake handles over while riding on the trailer. They found this difficult to maintain and instead used a webbing strap which had been stored in the rear of the gator, to tie the brake release handles down. This was contrary to the operating manual for the trailer, which said that mechanical means should not be used to hold off the brakes. This action released the trailer brakes and allowed it to be moved freely. The gator then pushed the trailer out of the tunnel. At Edale, staff and equipment were unloaded, but the webbing strap was left in place for the machine operator to make the rest of the journey to Bamford, alone (paragraph 32). The trailer brakes were still disabled, with no mechanism available to apply them in the event of a breakaway from the gator.

- 74 The machine operator was conscious of the absence of trailer brakes, and reported that he attempted to apply some braking by loosening off the strap when he stopped to answer the first telephone call (paragraph 33). However, RAIB testing demonstrated that when the brake release handles are operated, there is a large range of movement over which the brakes are in the released state. This means that a partial loosening of the strap would have almost certainly left the brakes still fully released.

Network Rail should provide clear instructions and training to users of rail mounted trolleys and trailers on its infrastructure, on the procedures to be followed in the event of failures, such as of braking systems, that require them to be recovered (paragraph 98b).

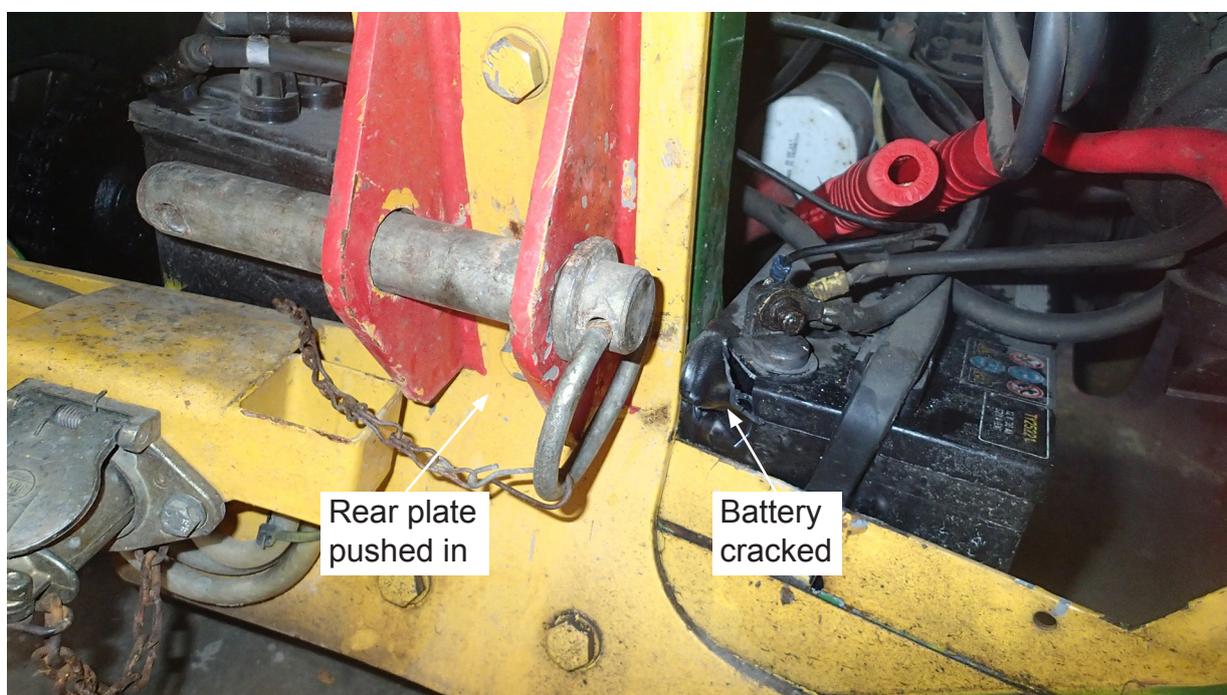
Figure 9: Rear end damage to the gator

- 49 After the runaway, the rear of the gator was found to have damage consistent with an end-on impact to the towbar (figure 9). No evidence was found to explain how this damage had occurred. The gator was able to operate correctly after the runaway, with this damage in place, and so it is possible that the damage was present prior to the incident.

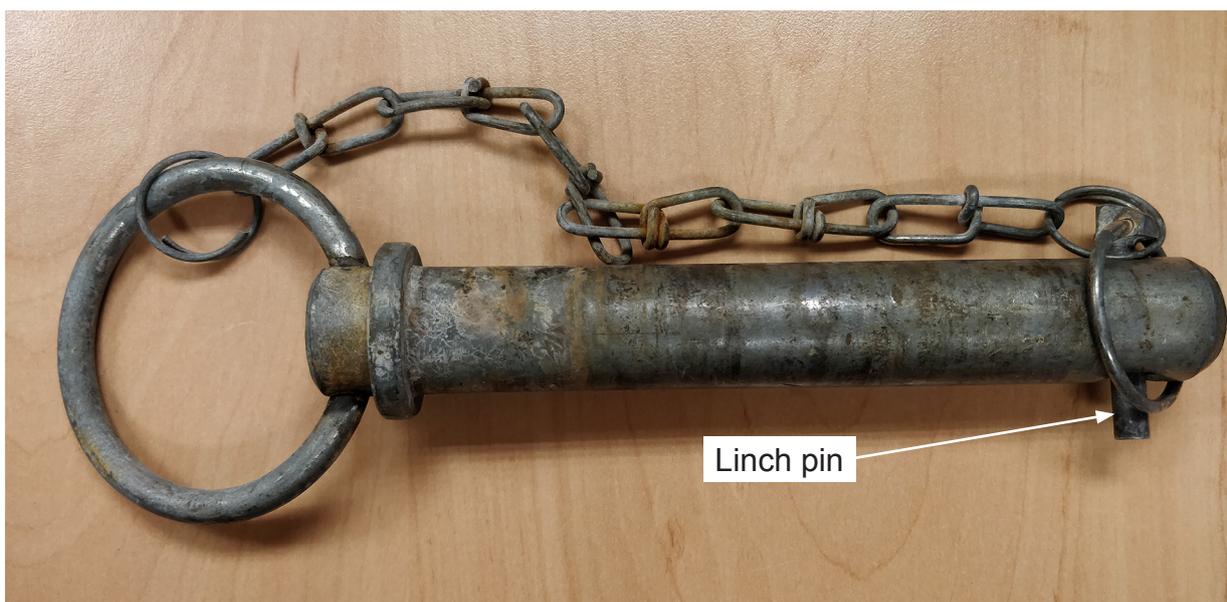
Figure 11: Towbar pin

- 59 Near the end of the towbar pin, there is a hole to allow fitment of a linch pin (figure 11) that is intended to prevent the horizontal towbar pin from vibrating out of the coupling. The linch pin consists of a metal pin with a ring in the end that snaps securely into position. The ring is intended to be snapped over the end of the towbar pin and rest hard against one side of the linch pin. In that position, the ring prevents the linch pin from falling out, in any orientation, which in turn prevents the towbar pin from falling out.

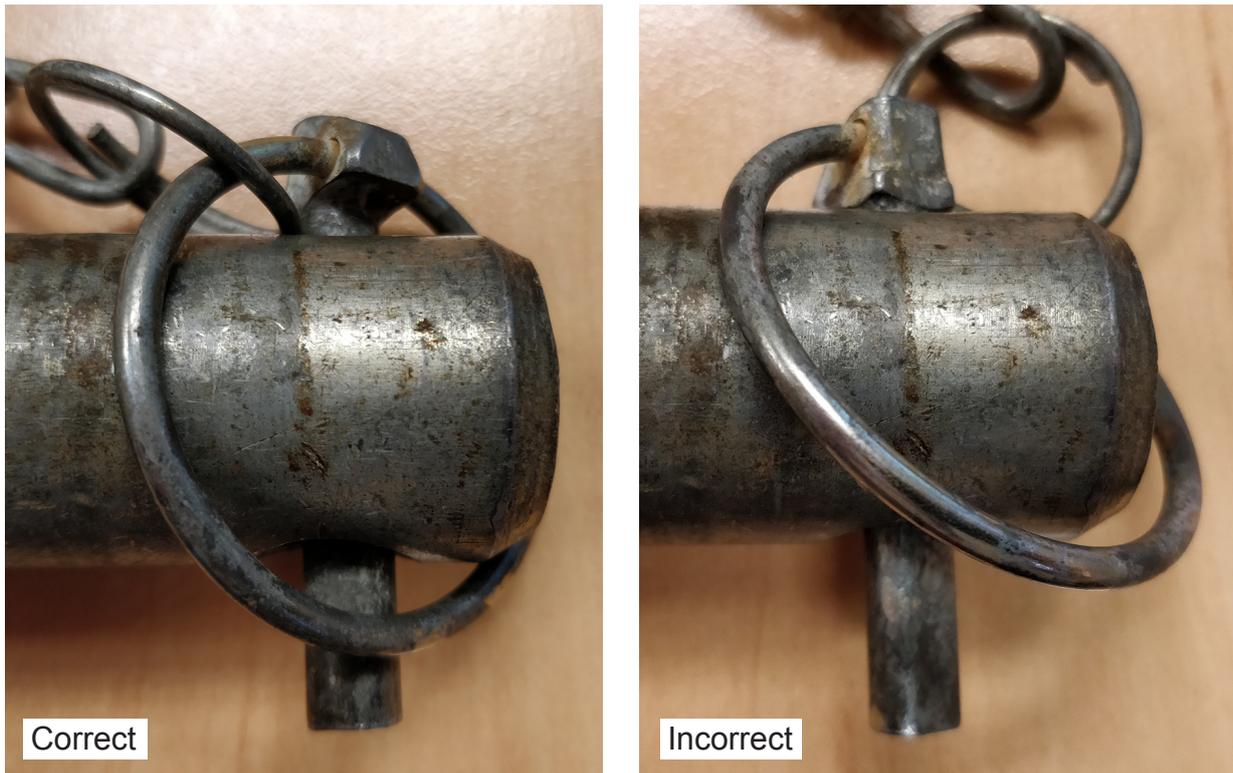
Figure 12: Linch pin in correct and incorrect orientations

60 The RAIB identified that it was possible to snap the ring on the linch pin in two orientations. The ring snaps into position against the linch pin in only one of these orientations. In the other orientation, the ring remains at an angle to the linch pin, potentially allowing it to fall out, while still looking as if it has been snapped in place correctly (figure 12). If the linch pin has fallen out, the horizontal orientation of the towbar means there is nothing preventing the towbar pin falling out under vibration and the towbar becoming detached.

- 61 After the runaway, the towbar pin was found on the rear deck of the trailer, adjacent to the coupling. The linch pin was attached to it by a chain but was not inserted in the hole in the towbar pin. This is consistent with the towbar pin having vibrated its way out.

- 102 Network Rail has issued a safety bulletin describing the circumstances of the towbar separation and the importance of fitting the linch pin in the correct orientation. This was distributed to users in Network Rail and to its contractors.
- 103 Permaquip has updated the user and maintenance manuals for plant that it supplies that uses this design of towbar. The changes include clarification that there is a correct and an incorrect way of securing the linch pin, showing photographs of both conditions. The maintenance regime has also been amended to include an inspection of the linch pin condition.

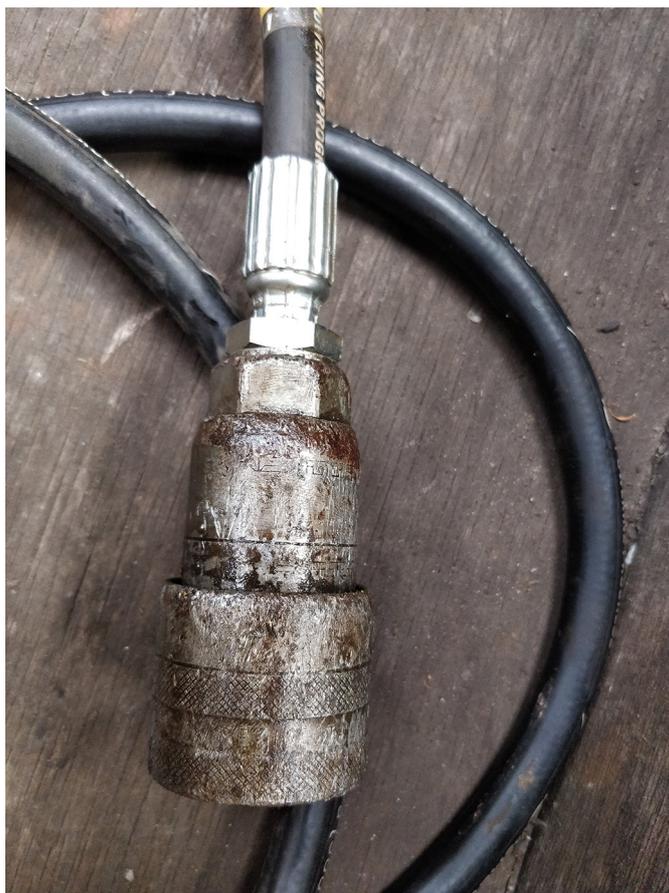
Figure 13: Hydraulic hose coupling

- 64 **The hydraulic hose between the gator and the trailer was not correctly connected at the time that the towbar coupling pin fell out.**
- 65 When the trailer came to a stop at Earles Sidings, the bayonet fitting at the end of the trailer's hydraulic brake hose was not connected to the gator. The fixed coupling at the trailer end of the hose had snapped and the hose was found on the track close to where the trailer came to a stop. The outer surfaces of the hydraulic hose bayonet coupling were covered in scratches and marks consistent with it having been dragged along the track, although it is possible that some of these were present prior to the incident (figure 13).

- 68 The RAIB considered the possibility that the hose was connected to the gator and broke at the trailer fixed coupling as the trailer started to run away. However, this is not credible because witness evidence indicates that the hydraulic system was active, and this would have resulted in the pump discharging the hydraulic oil through the broken pipe. After the incident, the hydraulic system was full of oil.

- 69 The RAIB also considered the possibility that the hose was connected to the gator prior to the runaway and that the bayonet coupling parted as the trailer started to run away. However, the hose is designed so that the fixed coupling at the trailer forms a weak link and will break in the event of excessive force being applied along the hose. The RAIB was unable to replicate any condition where the coupling was connected allowing hydraulic pressure to reach the trailer, yet able to be disconnected by pulling on the hose.
