# Near miss with staff at Clapham Junction, London, 17 January 2018

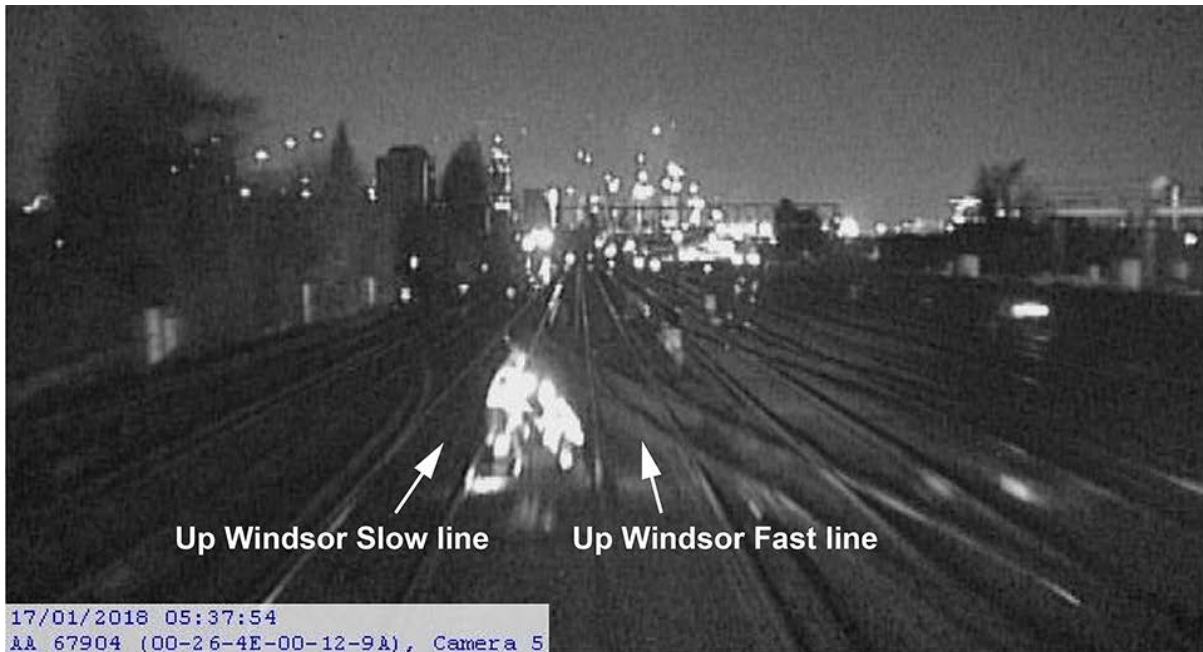
At about 05:51 hrs on Wednesday 17 January 2018, three signalling technicians were involved in a near miss with a train while they were working on a set of points near Clapham Junction station, south-west London. The technicians were diagnosing a fault on a machine that operates the points, which is situated in the space between two adjacent railway tracks – the Up Windsor Slow line and the Up Windsor Fast line. Although the Up Windsor Slow line had been blocked to carry out this work, the train passed on the Up Windsor Fast line, which was open to traffic.

The train involved was the 05:17 hrs South Western Railway empty coaching stock train from Wimbledon Park Sidings to London Waterloo. It was travelling at a speed of about 42 mph (68 km/h) at the time of the incident. The driver sounded the horn about five seconds before reaching the group of technicians, and then applied the emergency brake at almost the same time as he passed them. One of the group heard the approach of the train and shouted a warning to his colleagues. They started moving clear of the train about two seconds before it passed them.

Image from the train's forward facing closed-circuit television camera showing the position of the track workers (with their reflective clothing visible) just prior to the near miss (image courtesy of South Western Railway)

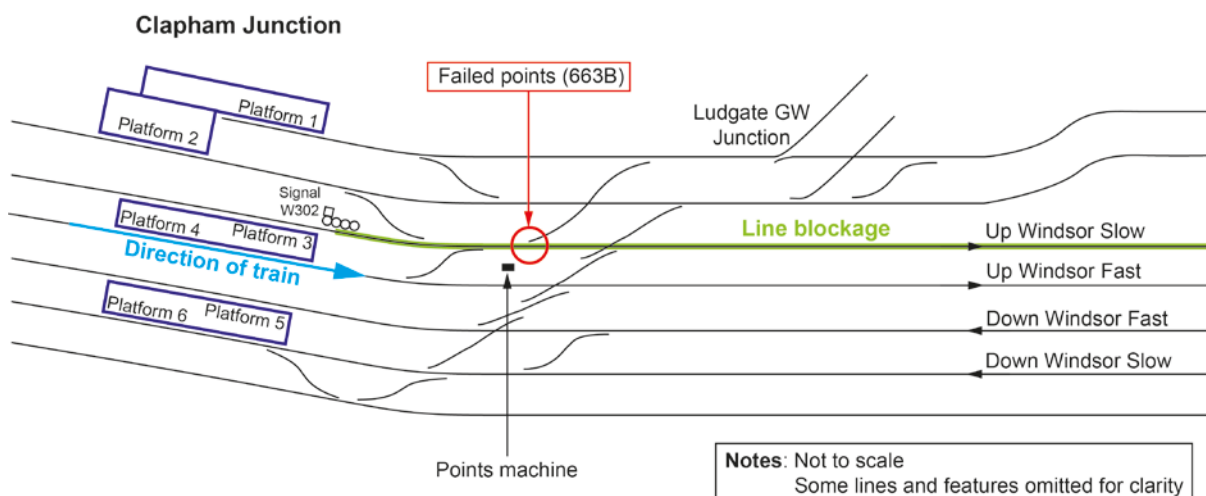
The incident occurred because the technicians were working in a location where they were not protected from moving trains. The system of work that they had set up was arranged so that the Up Windsor Slow line provided a position of safety for them, but this safe area did not extend to the space (known as the six-foot) between that line and the Up Windsor Fast line. Consequently, to work in that space would have required a change to the system of work to provide protection from train movements on the Up Windsor Fast line.

Track layout at Clapham Junction showing the line blockage, the failed points and the direction of the train

The fault with the set of points was caused by an engineering train (a tamper), which cut through some cables connected to the points machine during engineering work in the early hours of the morning. The engineering work involved a possession of the line, in which all lines are blocked to train movements. The three technicians involved in the incident had earlier been working in this possession on a night shift from 22:00 hrs to 07:00 hrs. When the fault was identified, they were dispatched to deal with it, but they arrived at Clapham Junction after the possession had finished and the lines were open again, so they had to set up a new safe system of work to protect themselves.

The senior technician in the group, who was acting as Controller of Site Safety (COSS) for this work, set up the system of work while standing on platform 3 at Clapham Junction station. He did this by telephoning the signaller and arranging that the Up Windsor Slow line would be blocked from Clapham Junction station to beyond the faulty set of points. Once this was done, the group then walked from the platform to the location of the work, using the Up Windsor Slow line as a safe route to reach the points.

Following the incident, Network Rail issued a bulletin across its Wessex route reminding staff of the need for a suitable and valid safe system of work at all times, including a reassessment of the protection arrangements when the nature of the anticipated work changes.
