Defence
Infrastructure
Organisation

SAFETY ALERT

Subject: Inspection and Maintenance of Efflux doors to Hardened Aircraft Shelters (HAS)

Number: SA 2018/01

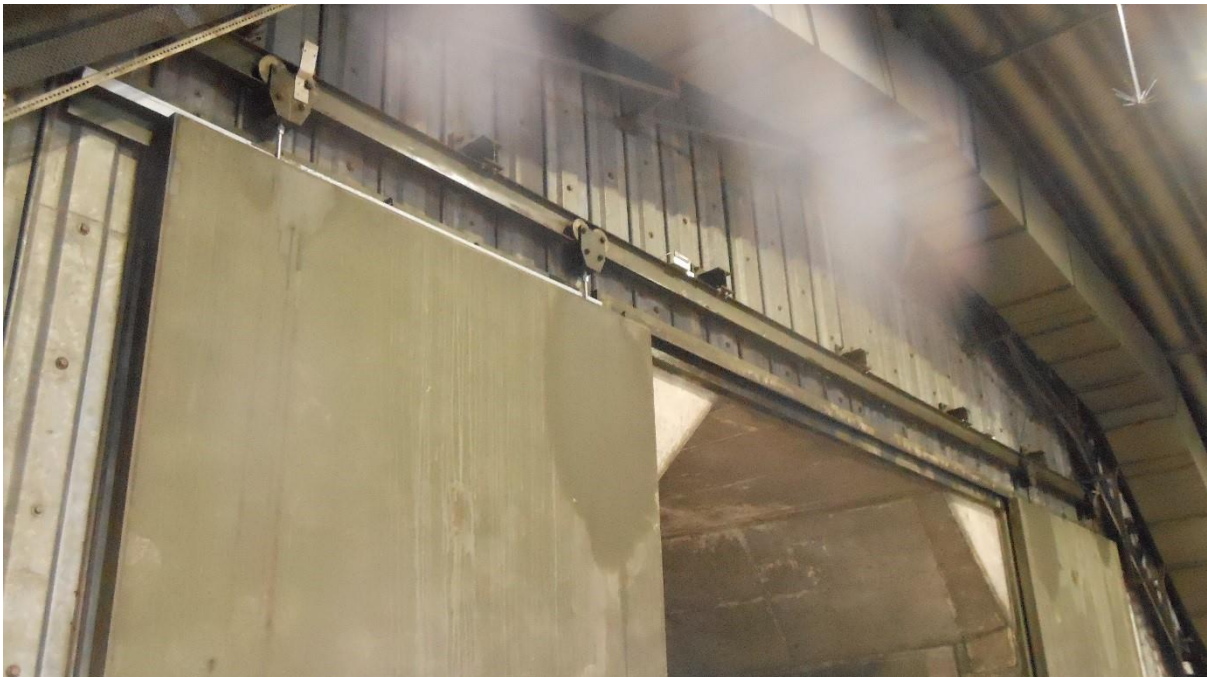
7. A steel shim of approximately 1kg weight fell some 5m to ground from one of the 7 runway beam support brackets.

Photo 1 Showing efflux door, runway beam and supporting brackets

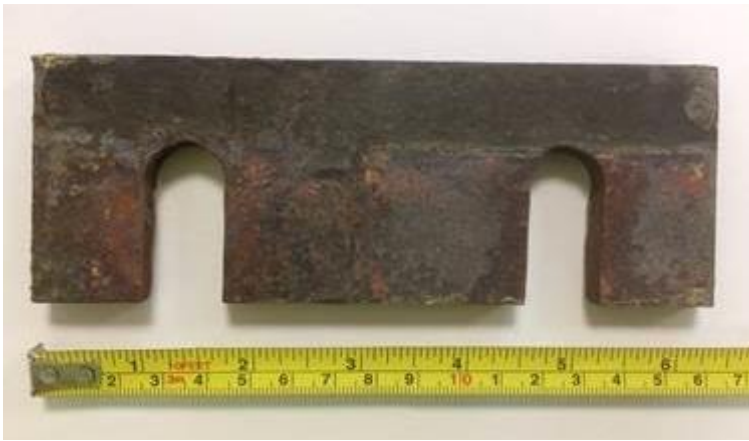
8. The original shims have slotted holes, as shown in photo 2 below, which may aid inserting them, but this also makes them prone to sliding out and falling should the bolts become loose.

Photo 2 Original slotted shim

21. On direction from the DIO Service Manager or equivalent, the MMO is to check:
 - a. HAS Efflux door installations to ensure all existing bolts and fittings are tight, especially those at high level, and to determine if shims are missing, displaced or if alternative inappropriate packing such as washers have been installed.

- b. Associated records (H&S file, O&Ms, inspection records) for completeness.
 - c. And advise on suitable arrangements could be applied to prevent the bolts from working loose and the shims from slipping out.

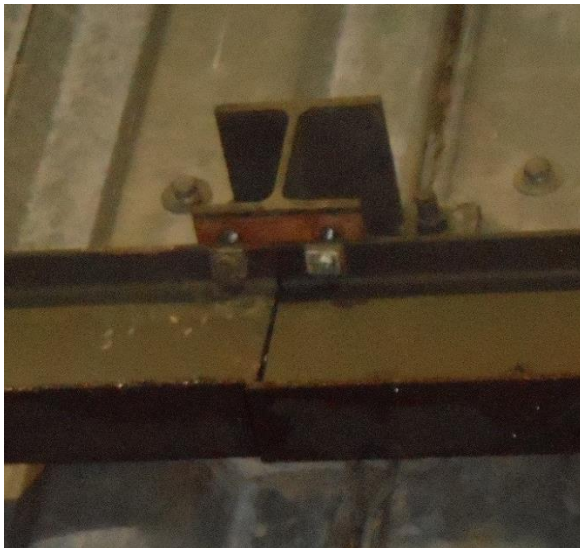
9. It was noted that shims were missing from other brackets and had been replaced with several washers to pack out the gap. See photographs below.

Photo 3 Bracket with shim missing

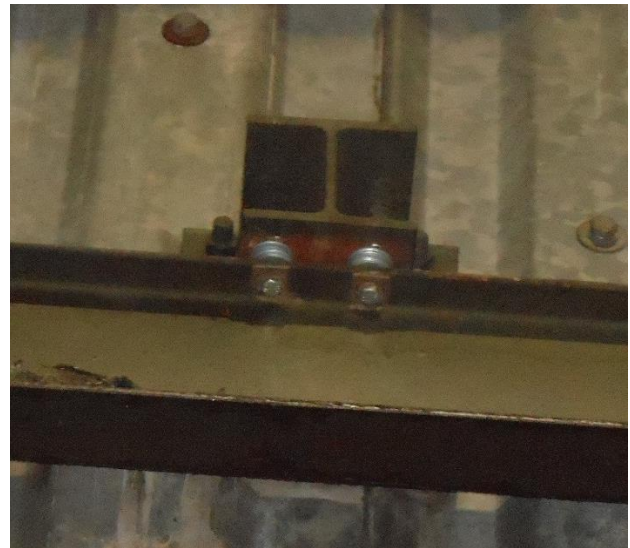
Photo 4 Adjacent bracket with washers in lieu of shim

10. Use of washers is considered an inappropriate solution to replace the shims. Whereas shims would enable a tight connection between the steel brackets and the runway beam, washers could allow lateral movement of the runway beam, as the installation is subject to vibration from both use of the doors and by aircraft engine run-up.
