Baseline Survey Report for 11 Low-Volume Sealed Roads in Kenya

Final Report

By: Across Africa Consultants Ltd.

Prepared for Kenya Materials Testing and Research Department (MTRD)

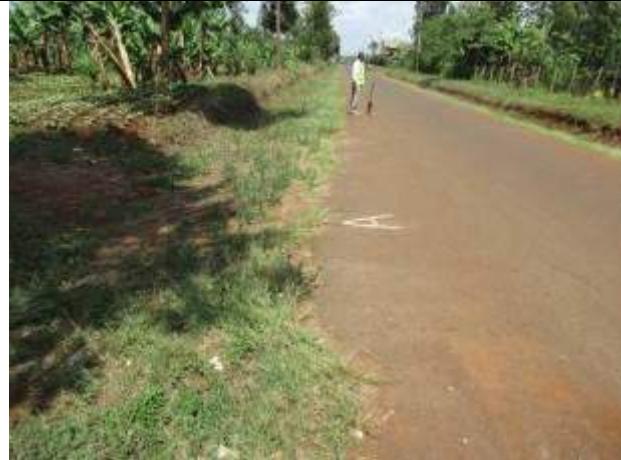
Fig3	Km 0+050 main carriage way at the centerline	-Crack sealing done on the main carriage way at the centerline

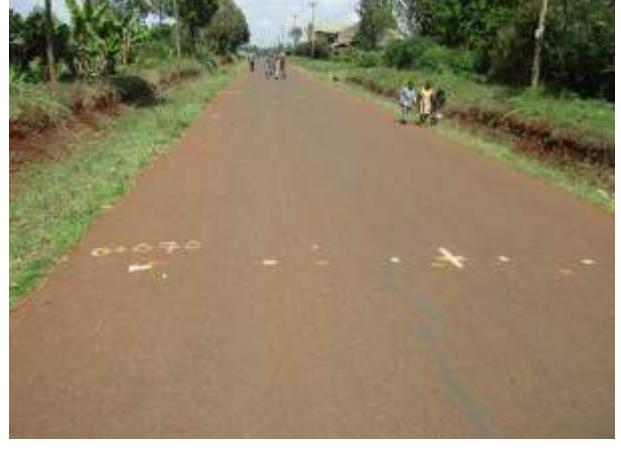
Fig 5	Km 0+100 – 0+130 main carriage way at the centerline	-Crack sealing on carriage way -Vegetation on the encroaching the road edge

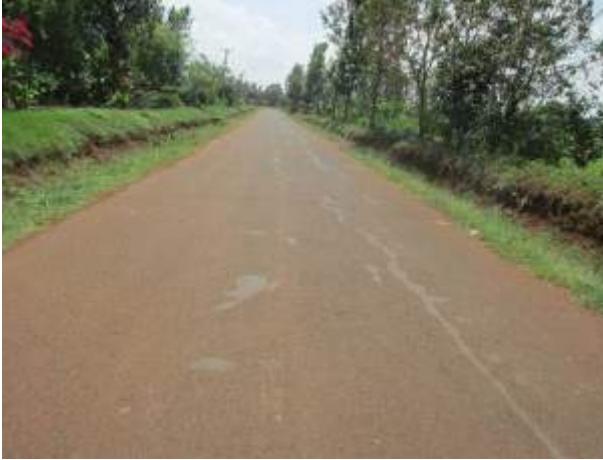
Fig 8	Km 0+200 – 0+250 main carriage way	-No visible defect on the main carriage way -Vegetation on the side slope extending towards the edge

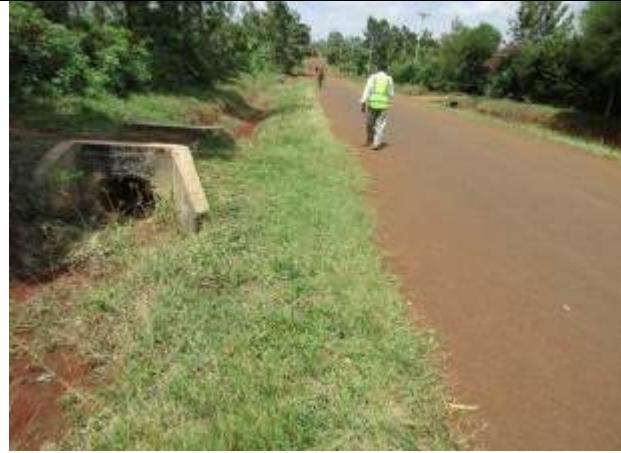
Fig 9	Km 0+260 -0+300 main carriage way	- No visible defect on the main carriage way

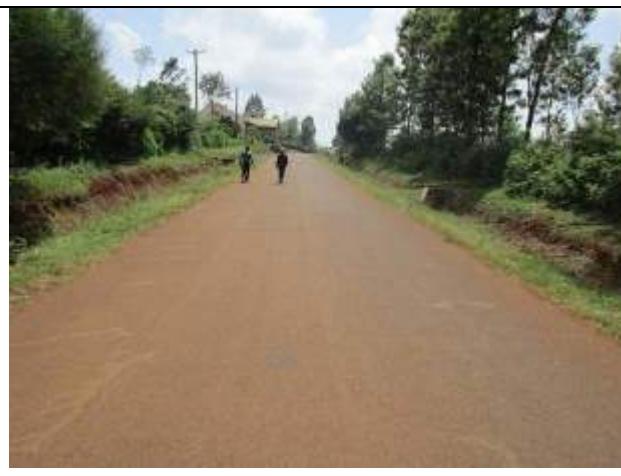
Fig10	Km 0+300 – 0+350 main carriage	-Vegetated side slope extending towards the edge and may result into moistening pavement hence premature failure

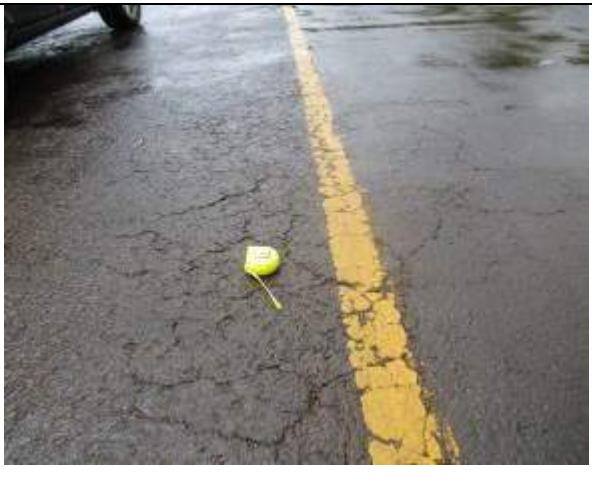
Fig 4	Km 0+025 main carriageway	-Extensive alligator cracking on the carriage way

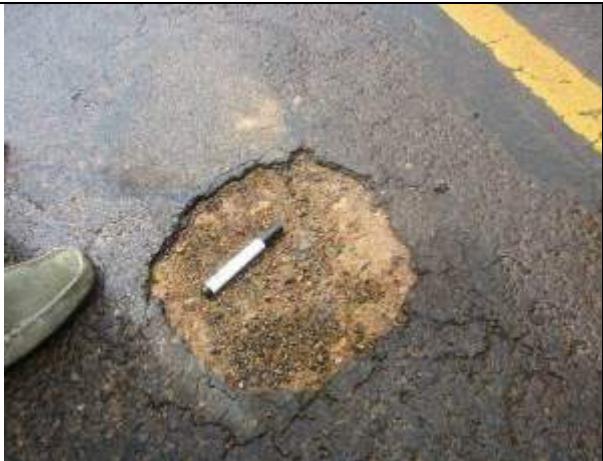
Fig6	Km 0+030 – 0+042 LHS inner wheel path	-Alligator cracks on the inner wheel path

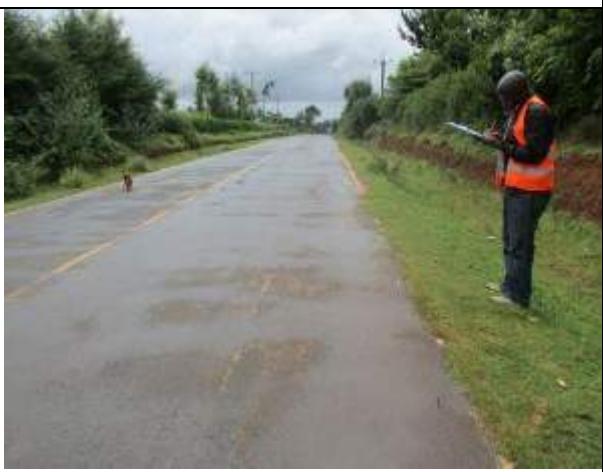
Fig10	Km 0+130 -0+160 main carriageway	-Alligator cracking all over the road carriage way and general surface irregularity -Ponding on the depressions

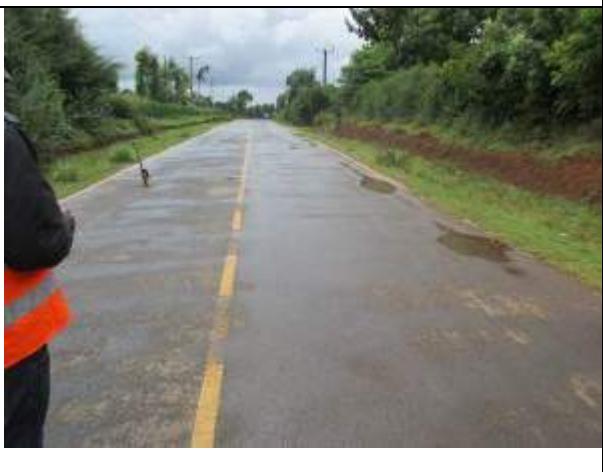
Fig 11	Km 0+140 -0+160 main carriage way	-Alligator cracking all over the road carriage way and general

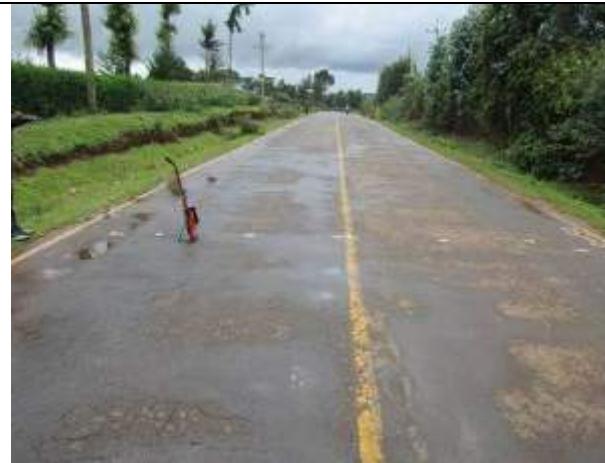
Fig 11	Km 0+200 – 0+305 LHS carriage way	-Extensive alligator cracks and potholes on the carriage way especially on the LHS lane

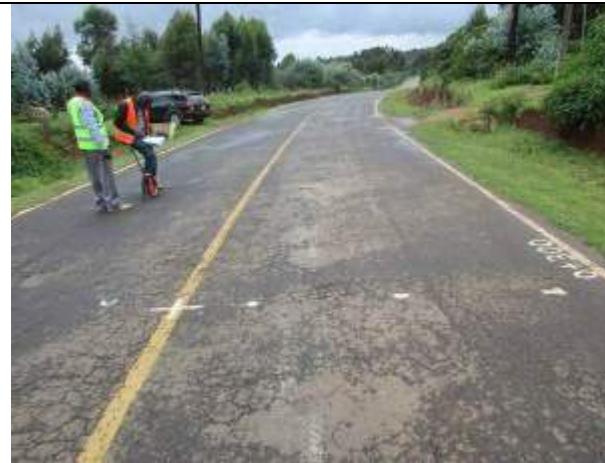
Fig 14	Km 0+335 – 0+360 main carriage way	-No alligator cracks on the carriage way

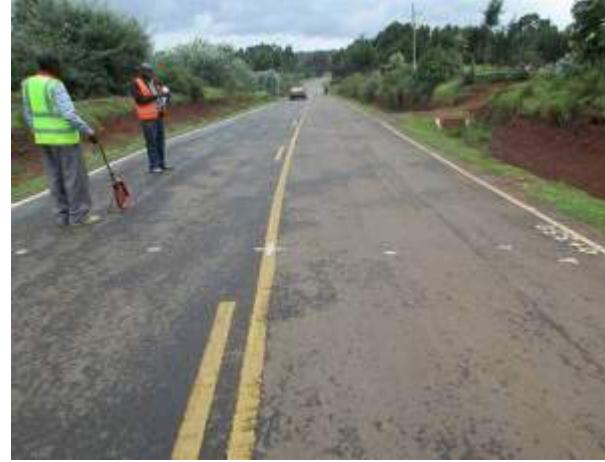
Fig 15	Km 0+356 -0+380 LHS	-Gully erosion on the side and side slope drain approx. 30m long

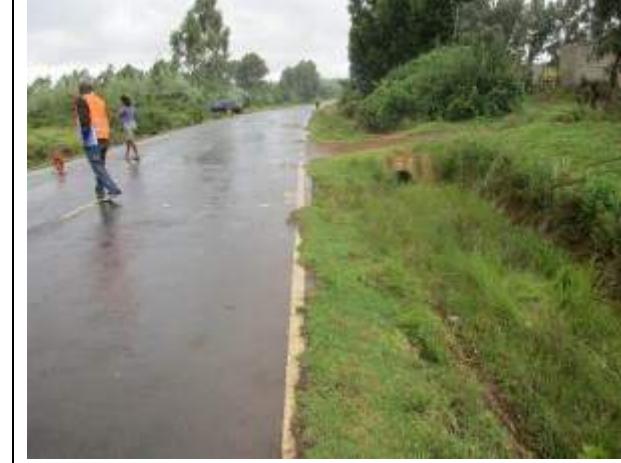
Fig 15	Km 0+530 – 0+560 LHS	<ul style="list-style-type: none"> -Extensive potholes and deformation on the outer wheel path covering approximately 0.5m by 0.9m area, Ponding on the cracks

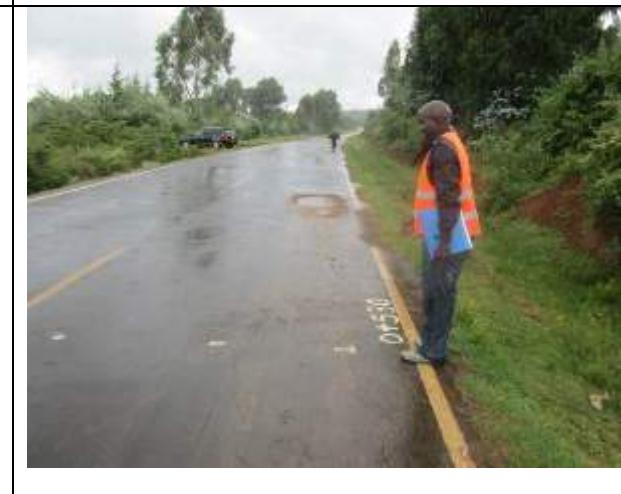
Fig 17	Km 0+587 – 0+600 RHS lane	<ul style="list-style-type: none"> -Vegetation encroaching towards the RHS edge and shoulders -Silted & Vegetation side drain hindering free flow of water along the drain -Deformation and alligator cracks on the main carriage way

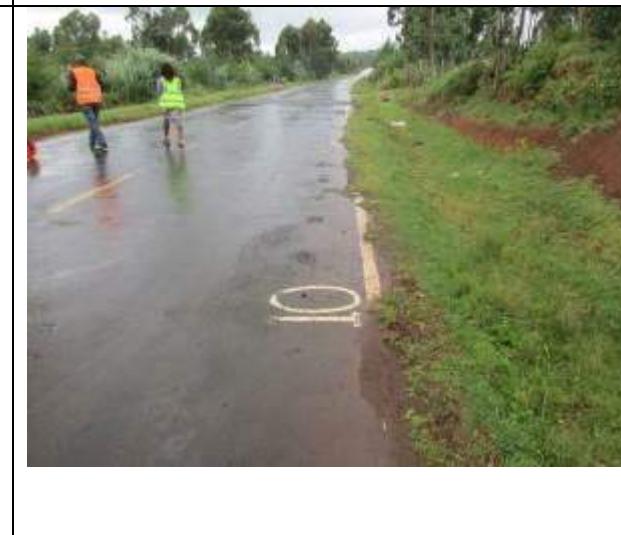
Fig 18	Km 0+640 – 0+680 main carriage way	<ul style="list-style-type: none"> -Surface bumpy and irregular -Edge deformation and subsidence on the outer wheel path covering about 20m long and 7m width with a depth 30mm

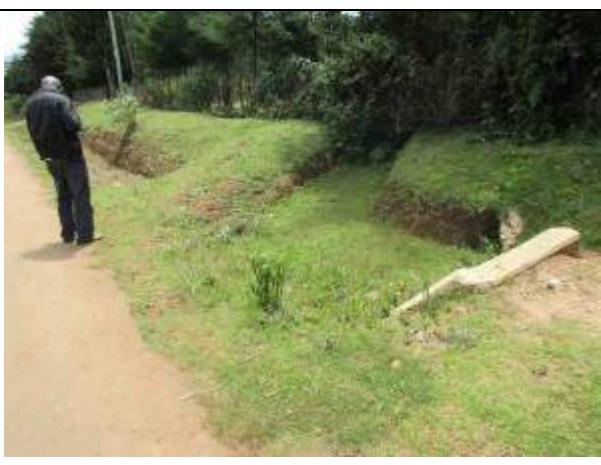
Fig 7	Km 0+140 LHS	-Blocked side drain and silted access culvert

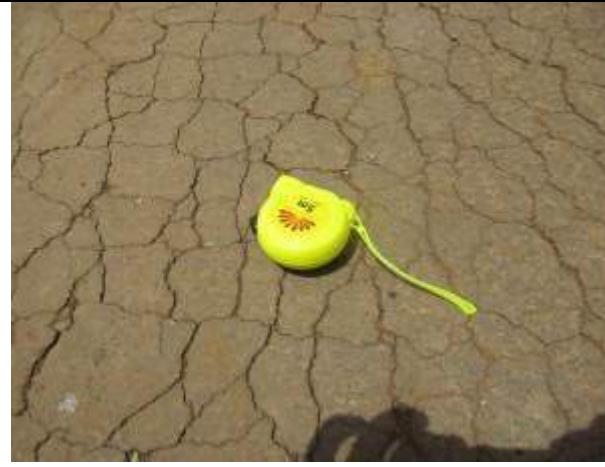
Fig 9	Km 0+255 – 0+260 main carriage way at centerline	- Alligator cracks ,pothole and loss of pavement material due insufficient lift thickness at centerline -3.4m*4.4m long

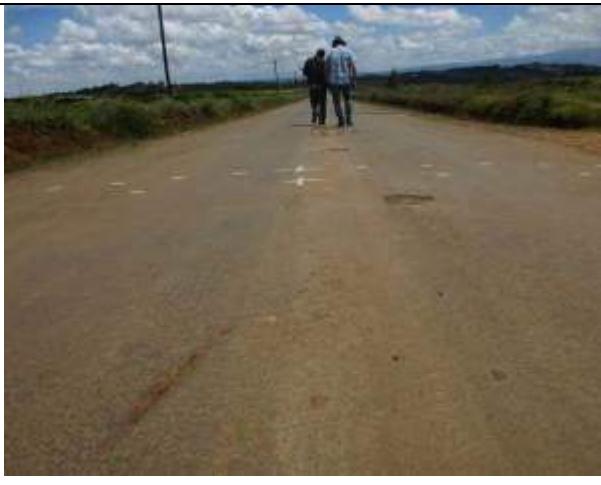
Fig 14	Km 0+340 -0+350 Centerline	-Extensive alligator cracks on the surface, pothole and localized loss of asphalt layer of about 11m long *2 m width at especially at the centerline

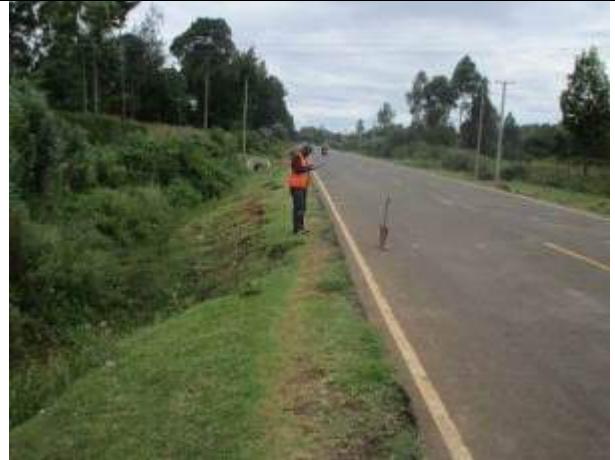
Fig 5	Km 0+116 – 0+140 main carriageway	-Alligator cracks scattered in isolated areas within carriage way

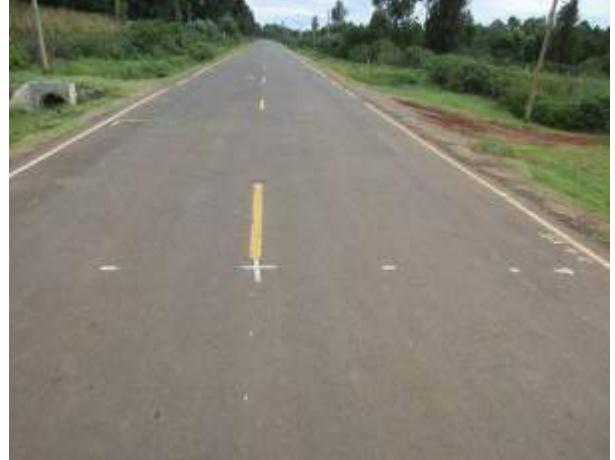
Fig6	Km 0+100- 0+145RHS	- Slightly eroded ,caused stopping matatus picking and dropping passengers approx. 40m long

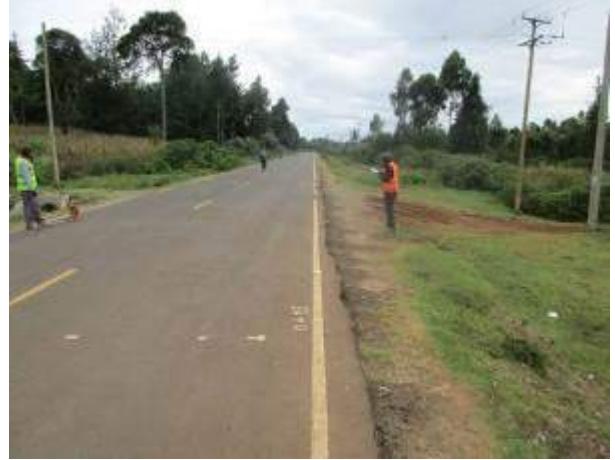
Fig 7	Km 0+145 -0+180 RHS and main carriage way	-Alligator cracks scattered all over the carriage way -Eroded side slope -Spot bleeding on the main carriageway

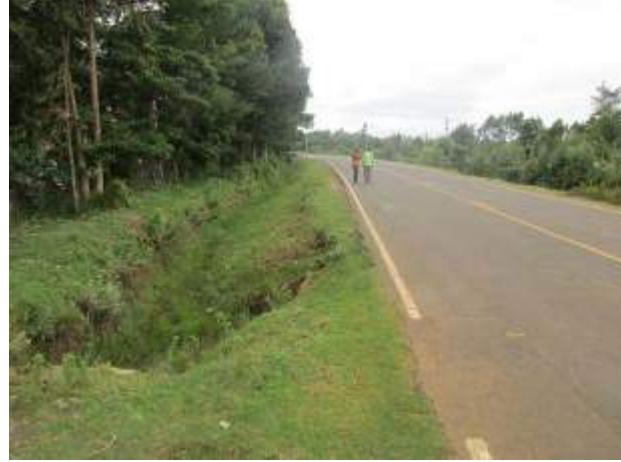
Fig 12	Km 0+473-0+500	<ul style="list-style-type: none"> -Alligator cracks all over the carriage way covering 30m long and 3m width

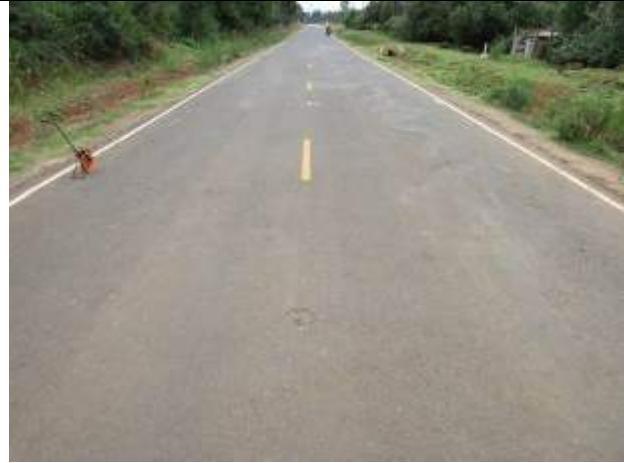
Fig 15	Km 0+683 – 0+816 main carriage way	-No visible defect on the main carriage way

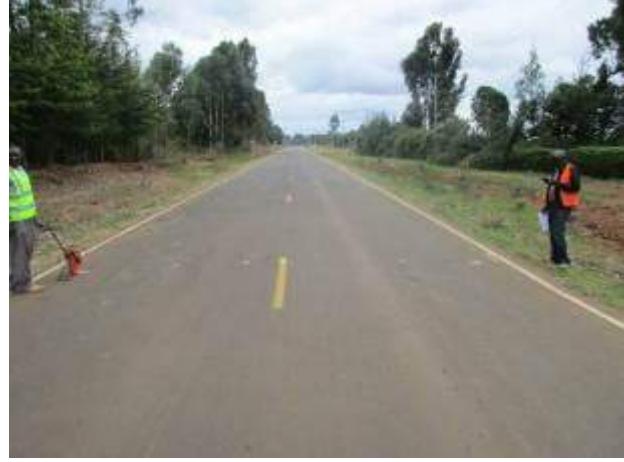
Fig 16	Km 0+816-0+821 LHS	Alligator cracks on the LHS carriage way , area -(7m*2m) 14m ²

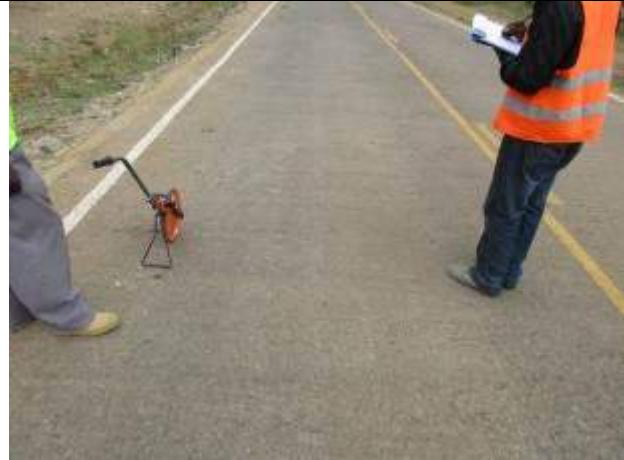
Fig 19	Km 0+963-0+990 LHS	-Transverse cracks on the concrete slab on LHS

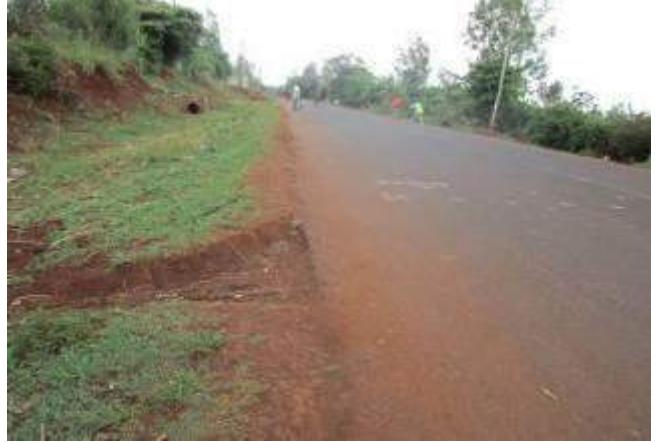
Fig 10	Km 0+455 main carriage at the centerline	-Extensive alligator cracks on the carriage way especially at the centreline

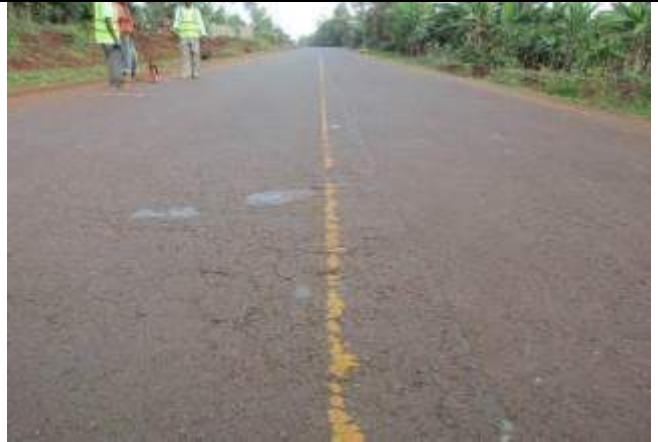
Fig 11	Km 0+467 Centerline	-Extensive alligator cracks leading to the development potholes at the centreline

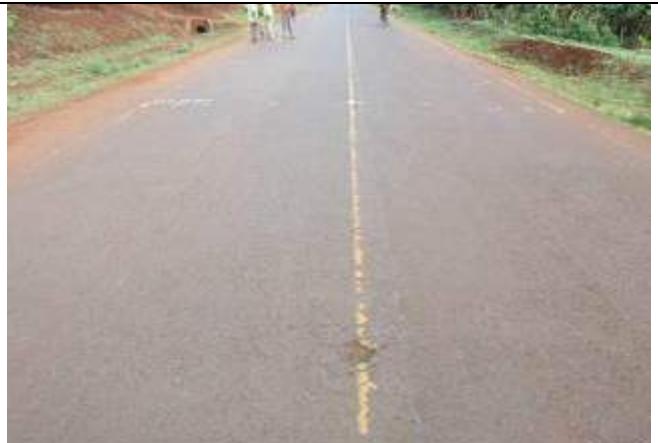
Fig 12	Km 0+540 RHS on inner wheel path	-Alligator cracks and pothole on the inner wheel path

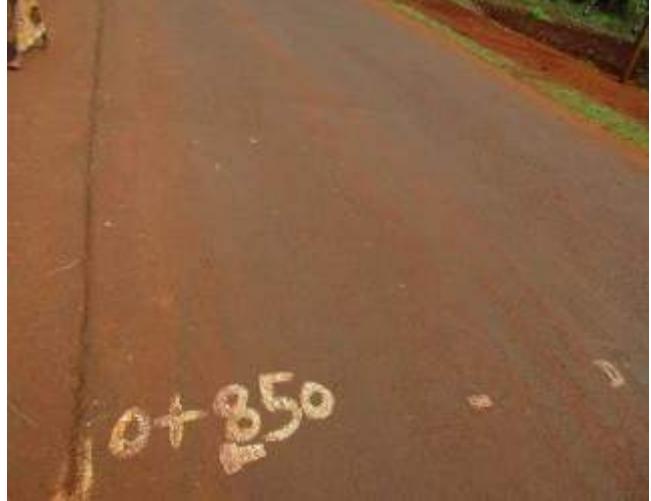
Fig 16	Km 0+860 - 0+900 main carriage way	-Extensive alligator cracks all over the surface leading to penetration of water into underlying layers

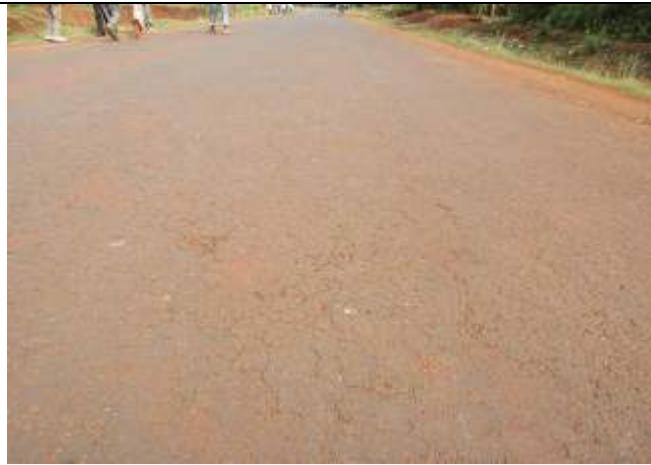
Fig 17	Km 0+950 - 0+980 main carriage way	-Alligator cracks all over the surface

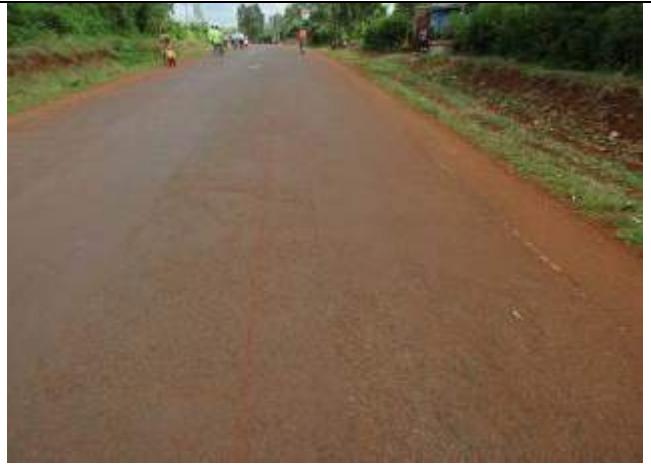
Fig 18	Km 0+980 – 1+000	-Alligator cracks and slight bleeding on the surface

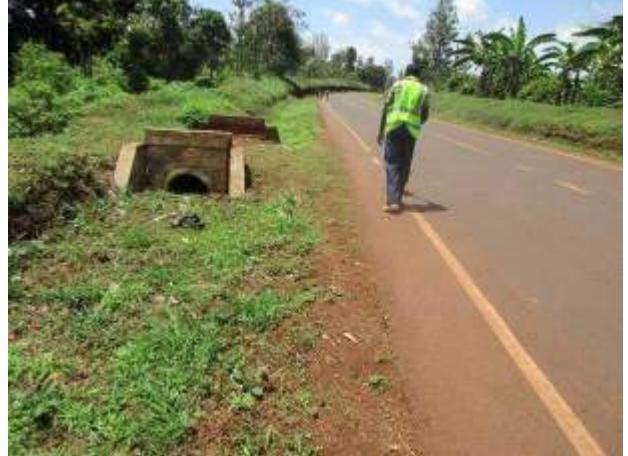
Fig 3	Km 0+240 - 0+270LHS	-Silted side drain - No visible defects on the surface

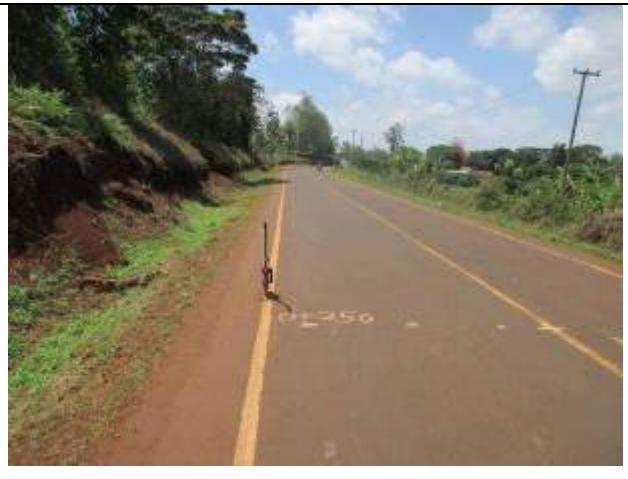
Fig 4	Km 0+340 – 0+356LHS carriage way	-Stripping on the LHS lane covering 12m long and 3m width – Could have been contributed to a coarser mix -Noticeable inconsistency in the mix

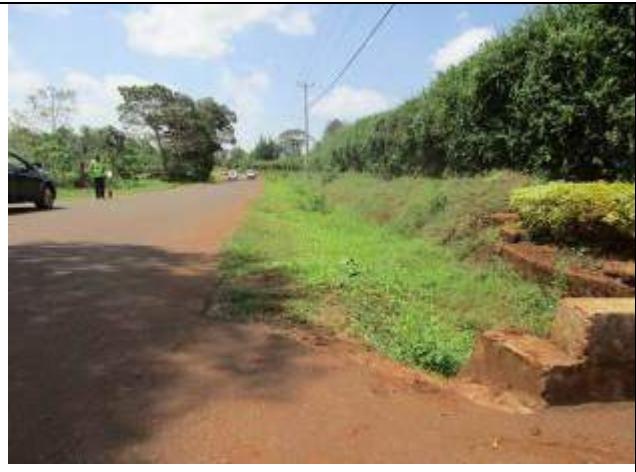
Fig 12	Km0+778-0+800 both sides	-Erosion on side slope and shoulders and edge braking caused by traffic dodging the bump

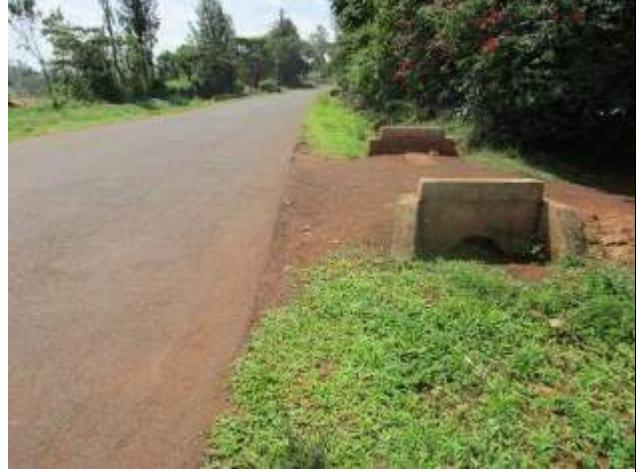
Fig 15	Km 0+950 at the centerline	-Alligator cracks developing on the centerline of the main carriage way

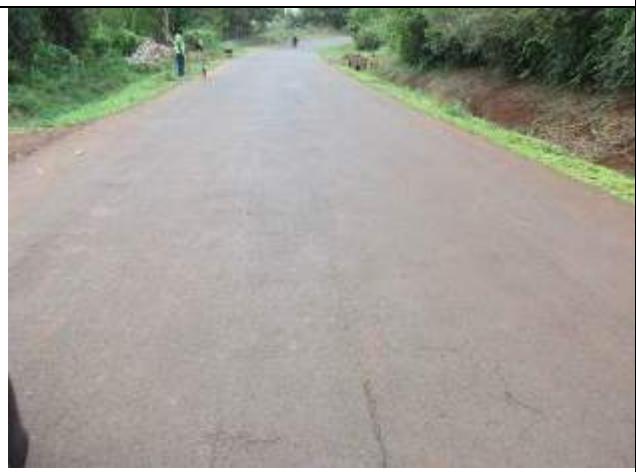
Fig 16	Km 0+970 main carriage way	Extensive alligator cracks at the centerline covering 10m long by 2m width

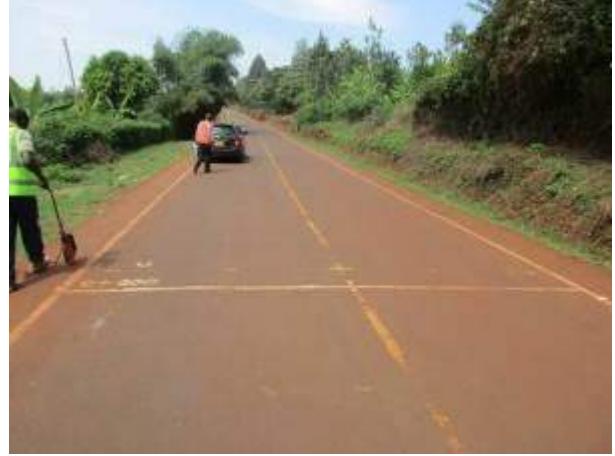
Fig 2	Km 0+084RHS	-Potholes developing on the main carriage way inner wheel path

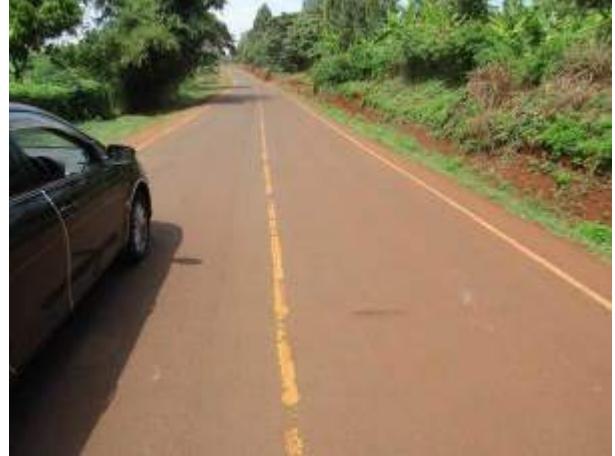
Fig 3	Km 0+100 -0+125	-Potholes and alligator cracks on the surface covering an area of about 2m by 20m ² -Faded road marking

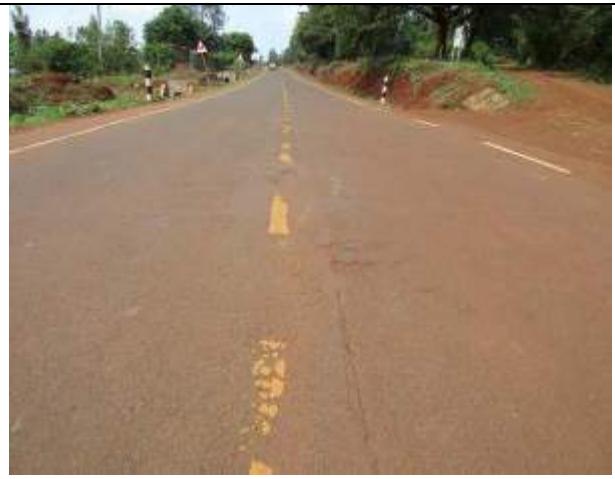
Fig 4	Km 0+100 – 0+126 RHS	-Water crossing over the carriage way due to blocked drain -Blocked and silted side drain

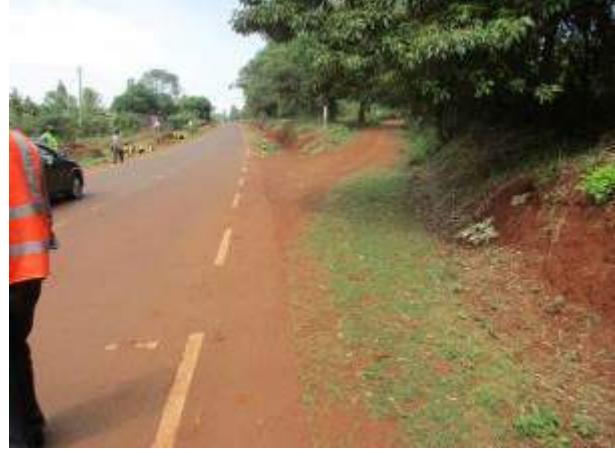
Fig 5	Km 0+177LHS	-Potholes and alligator cracks on the outer wheel path

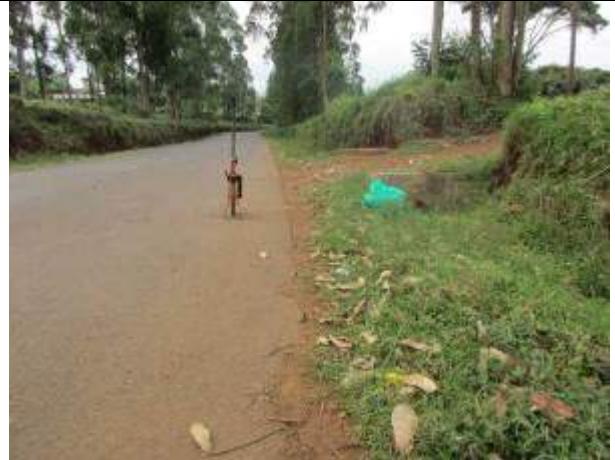
Fig 3	Km 0+080 - 0+096 LHS main carriage way	-Extensive alligator cracks and deformation and depression on the outer wheel path 12m long -Silted and narrow drain hindering free flow of water along the drain

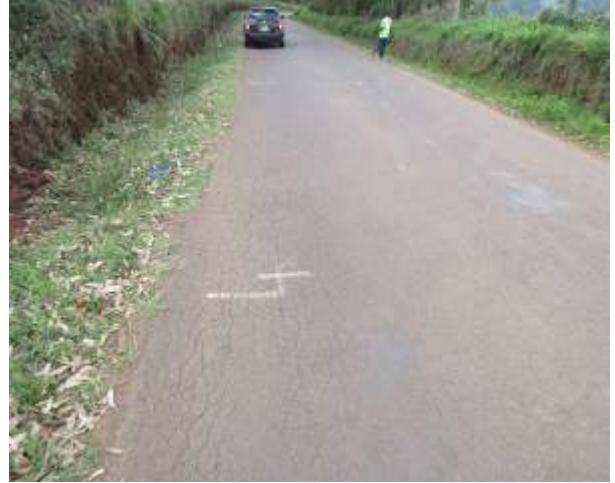
Fig 4	Km 0+094 – 0+100 RHS	-Extensive alligator cracks on the outer wheel path -Deformation and depression on the outer wheel path of about -Area - 4m by 6m (24m^2)

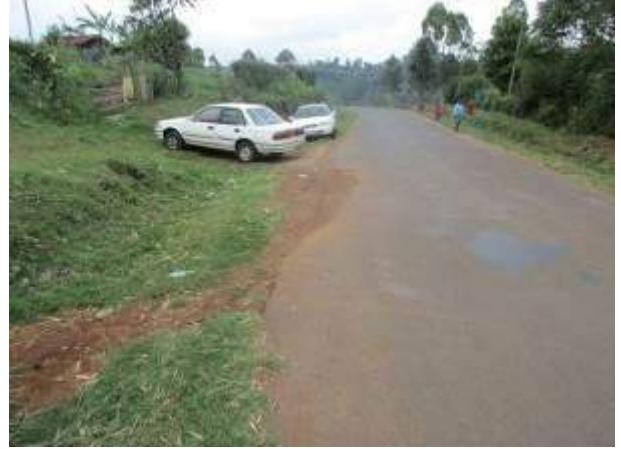
Fig 7	Km 0+270 – 0+300 RHS	-Extensive alligator cracks on the outer wheel path causing deformation and alligator cracks at the edge -silted side drain

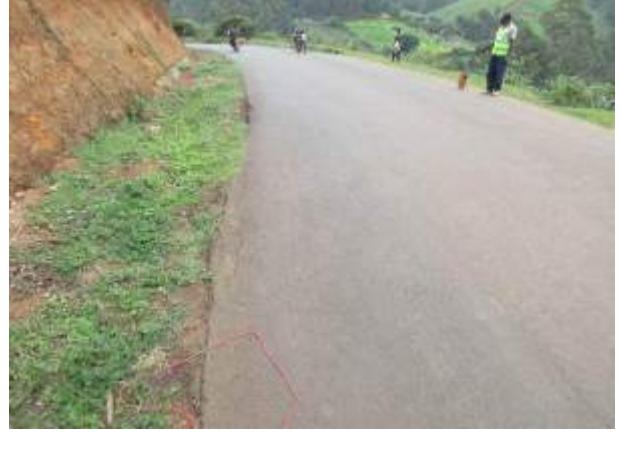
Fig 8	Km 0+030 - 0+320LHS	<ul style="list-style-type: none"> -Extensive alligator cracks on the outer wheel path causing deformation and alligator cracks at the edge -Silted side drain hindering free flow of water along the drain and enhancing accumulation of deposits

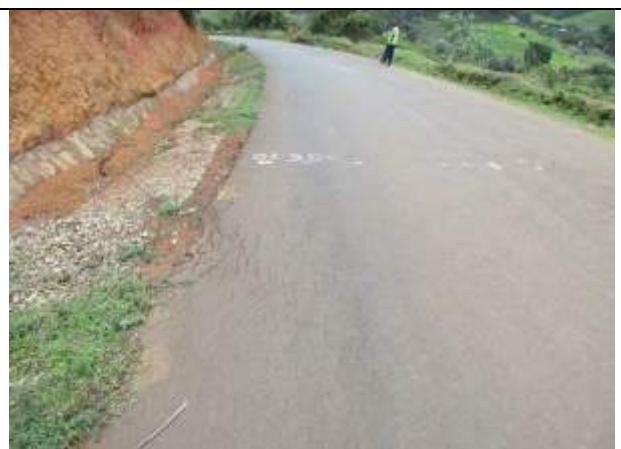
Fig 10	Km 0+320 – 0+440 LHS main carriage way	<ul style="list-style-type: none"> -Edge deformation ,subsidence breaking and cracking -Too thin ac layer

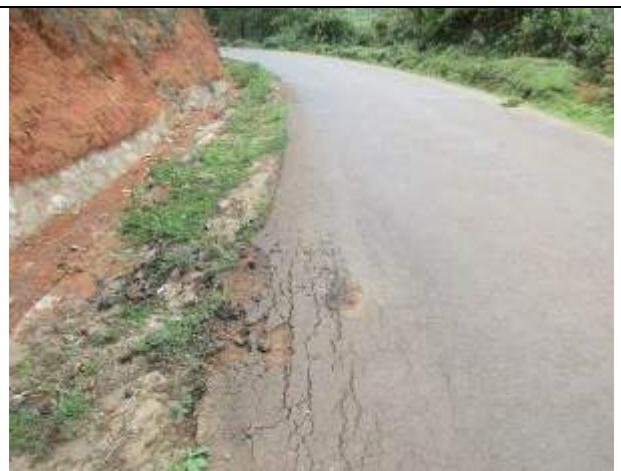
Fig 11	Km 0+533 – 0+600 both sides	-Blocked and silted with waste debris side drain

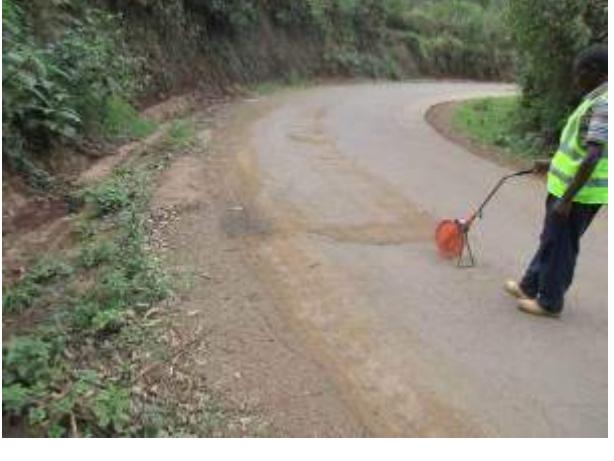
Fig 17	Km 0+850 – 0+900 LHS	-Eroded side slope and edge braking -Collapsing side slope
