AIRCRAFT ACCIDENT REPORT 1/2018

Report on the accident to Sikorsky S-92A, G-WNSR West Franklin wellhead platform, North Sea on 28 December 2016

Air Accidents Investigation Branch

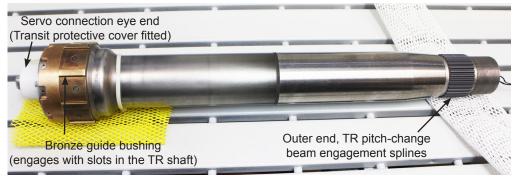
Figure 3 TRPCS

The non-rotating servo output rod is connected to the rotating portion of the TRPCS by a double row self-aligning barrel bearing. Each race of the bearing consists of a set of barrel-shaped rollers running on inner and outer races inclined outwards from each other. This allows push and pull loads to be imparted into the TRPCS. The outer races are mounted in a phosphor bronze carrier which engages in grooves cut into the crown wheel shaft to ensure that

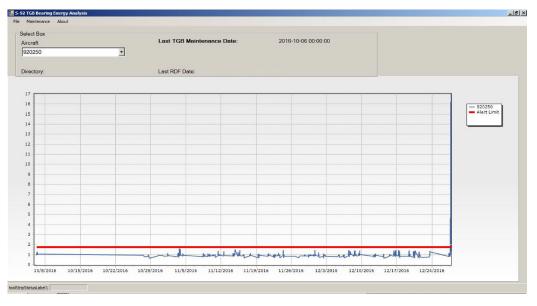
Figure 9 shows the time-history chart as presented to Engineers A and B, when they visually inspected the TGB bearing energy CI ratio (this figure has been recreated, using the original data, for the purposes of this accident report). Note that the x-axis automatically scales to show the complete time-history since last TGB maintenance date, which for G-WNSR was 6 October 2016, and the y-axis automatically scales from zero to the full range of CI ratio values.

Recreated TGB bearing energy CI ratio time-history chart

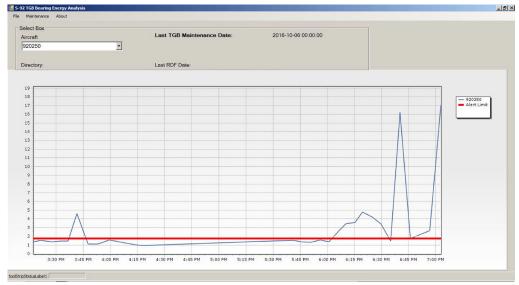
However, had either of the licensed engineers successfully zoomed in on the day's flight, the exceedences would have been clearly visible (see Figure 10 for a recreated zoomed-in version of the original data) with the highest and final exceedence being just over 17 compared to the alert limit threshold of 1.75.

Recreated TGB bearing energy CI ratio time-history chart zoomed to last flight on 27 December 2016

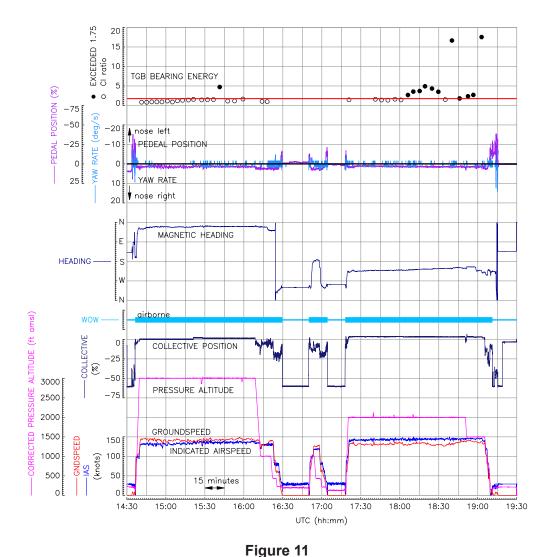
Figure 11 shows the TGB bearing energy CI ratio relative to the flight data for the third and final flight (comprising three sectors) on 27 December 2016 (during which the exceedences occurred), showing the various flight conditions at which data from the TGB accelerometers was acquired. The first exceedence (a single point) occurred just over an hour into the first sector of the third flight, about 45 minutes before landing. The next exceedences occurred during the last hour of the third sector back to the MOB at Aberdeen.

TGB bearing energy CI ratio and recorded data for third flight on 27 December 2016

In summary, the helicopter was operational (with rotors turning) for a total of 10.4 hours on 27 December 2016 and the first exceedence occurred after 6.9 of these operational hours. It was a further 3.5 operational hours before the helicopter returned to its MOB for the HUMS data to be downloaded and hence the first opportunity (which was missed) for the operator to become aware of the exceedence. During these 3.5 hours the helicopter landed twice (but did not shut down) – the first after about 0.7 hours and the second after a further 0.6 hours before returning to the MOB.

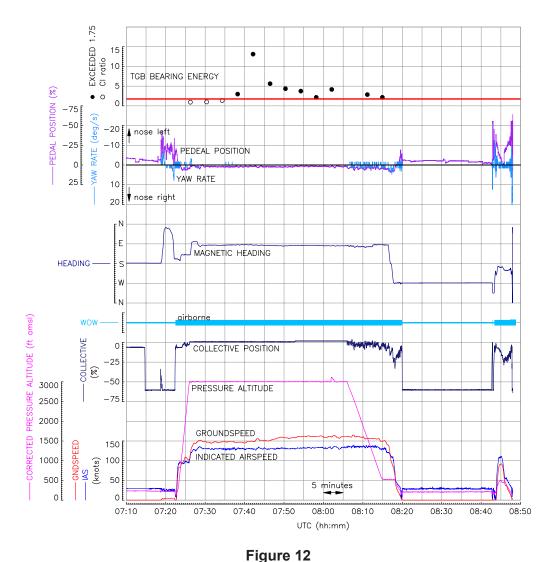
After G-WNSR was recovered following the accident on the West Franklin, the HUMS data for 28 December 2016 was downloaded. Figure 12 shows the TGB bearing energy CI ratio for this flight and indicates that during the first leg (from Aberdeen to the Elgin PUQ) 12 sets of data were acquired of which the last nine resulted in TGB bearing energy CI ratio exceedences.

TGB bearing energy CI ratio and recorded data for the flight on 28 December 2016

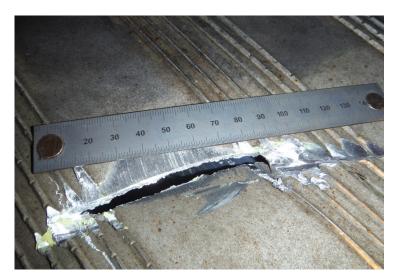
The helideck surface sustained minor damage to its surface consisting of tyre scuff marks and a small dent within which the aluminium surface had split (Figure 18).

Figure 18 Helideck damage (courtesy of CHC Scotia Ltd)

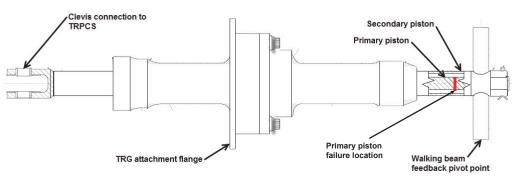
Figure 20

An external visual examination was carried out. The servo appeared to be in a good overall condition with the exception of a fracture of the primary piston within the secondary piston sleeve. A cross-section of the servo primary and secondary pistons and cylinder with the location of the fracture is shown in Figure 20. A functional test under hydraulic pressure could not be carried out due to the damage on the primary piston. There was no evidence of hydraulic leakage and the walking beam, servo valves and body were undamaged. The anti-rotation tab showed evidence of wear on both sides with a corresponding witness mark within the anti-rotation plate slot.

The servo was disassembled as far as possible; however, the inboard face of the primary piston head was tight against the gland seal and could not be moved. Remnants of seal material were present in the vicinity of the outboard piston face. There were signs that the primary piston had been rotating within its cylinder evidenced by rotational scoring on the bore of the cylinder. This scoring was approximately 35 mm from the housing face (TGB mounting flange) and extended along the bore, in the piston retraction direction, by approximately 18 mm. Rotational marks were also present on the contact surface between the primary and secondary pistons. The clevis assembly, which attaches the primary piston to the TRPCS bearing, could not be removed despite the application of a 350 lb ft torque. Residual hydraulic fluid within the servo appeared normal. The primary piston which had parted within the secondary piston tube, was removed and sectioned for metallurgical examination. The surfaces were examined under a scanning electron microscope which revealed evidence of smearing and shear overload, consistent with a ductile overload in torsion.

Servo cross-section and fracture location (courtesy of Sikorsky)

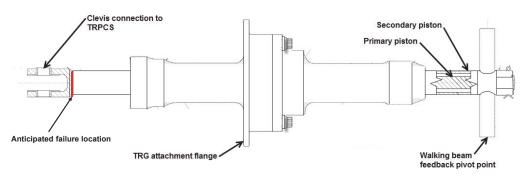
Figure 26

The work carried out to rectify the first bearing failure event in 2007 also considered a disconnection between the TRPCS and the servo piston, and considered a partial or full seizure of the TRPCS bearing applying torque to the servo piston. It was anticipated that should this happen, the servo would fail in the threaded portion of the clevis where it connects directly to the TRPCS (Figure 26). This would leave the now-disconnected, but hydraulically-driven, piston attached to the helicopter yaw control system and therefore in a relatively safe condition, albeit with the servo piston moving in and out, colliding with the remains of the clevis and its eye end.

Anticipated servo failure location
