# AIRCRAFT ACCIDENT REPORT 1/2018

Report on the accident to  
**Sikorsky S-92A, G-WNSR**  
West Franklin wellhead platform, North Sea  
on 28 December 2016

**Air Accidents Investigation Branch**

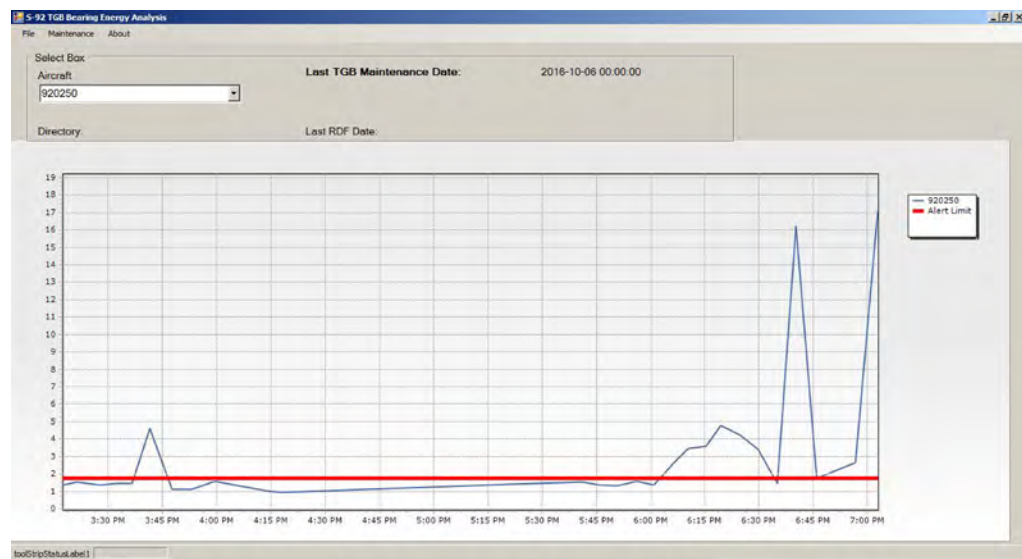
**Figure 10**

However, had either of the licensed engineers successfully zoomed in on the day's flight, the exceedences would have been clearly visible (see Figure 10 for a recreated zoomed-in version of the original data) with the highest and final exceedence being just over 17 compared to the alert limit threshold of 1.75.

Recreated TGB bearing energy CI ratio time-history chart zoomed to last flight on 27 December 2016

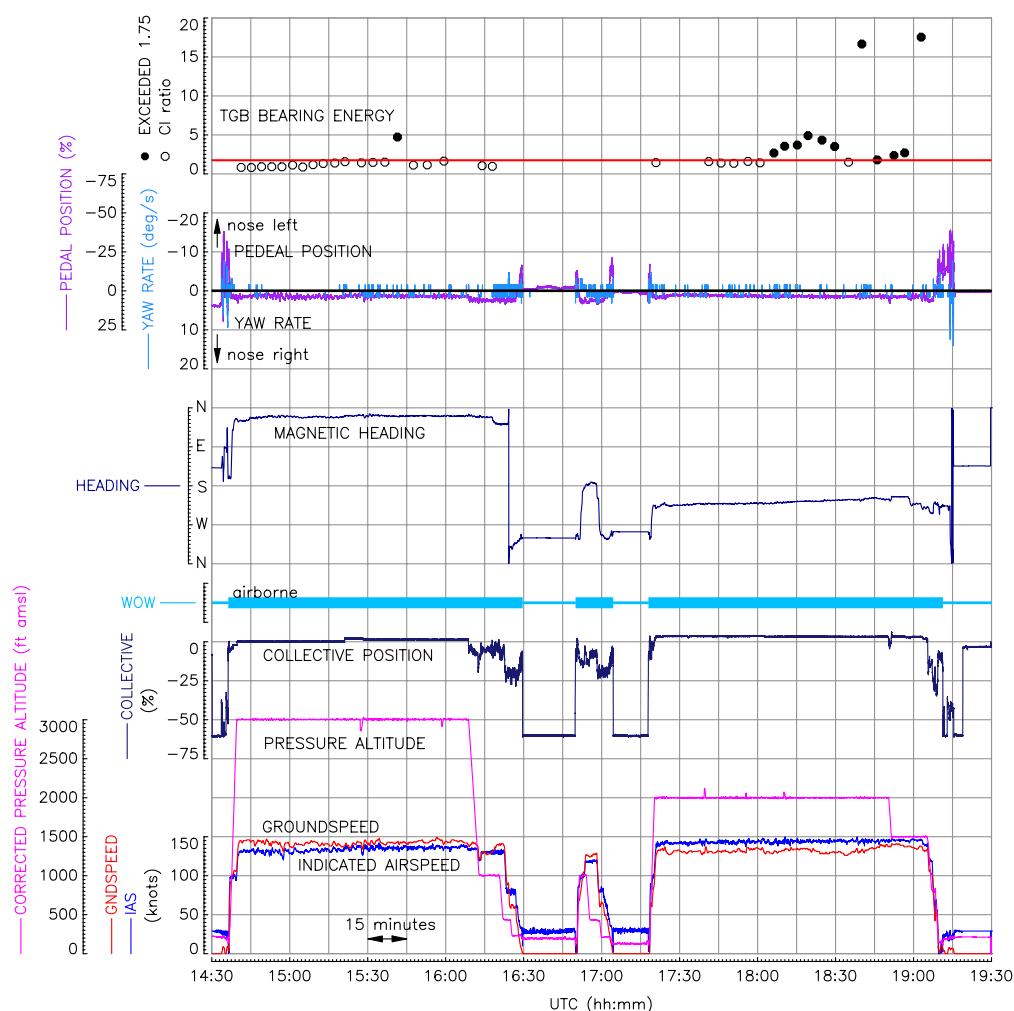
**Figure 11**

Figure 11 shows the TGB bearing energy CI ratio relative to the flight data for the third and final flight (comprising three sectors) on 27 December 2016 (during which the exceedences occurred), showing the various flight conditions at which data from the TGB accelerometers was acquired. The first exceedence (a single point) occurred just over an hour into the first sector of the third flight, about 45 minutes before landing. The next exceedences occurred during the last hour of the third sector back to the MOB at Aberdeen.

TGB bearing energy CI ratio and recorded data for third flight  
on 27 December 2016

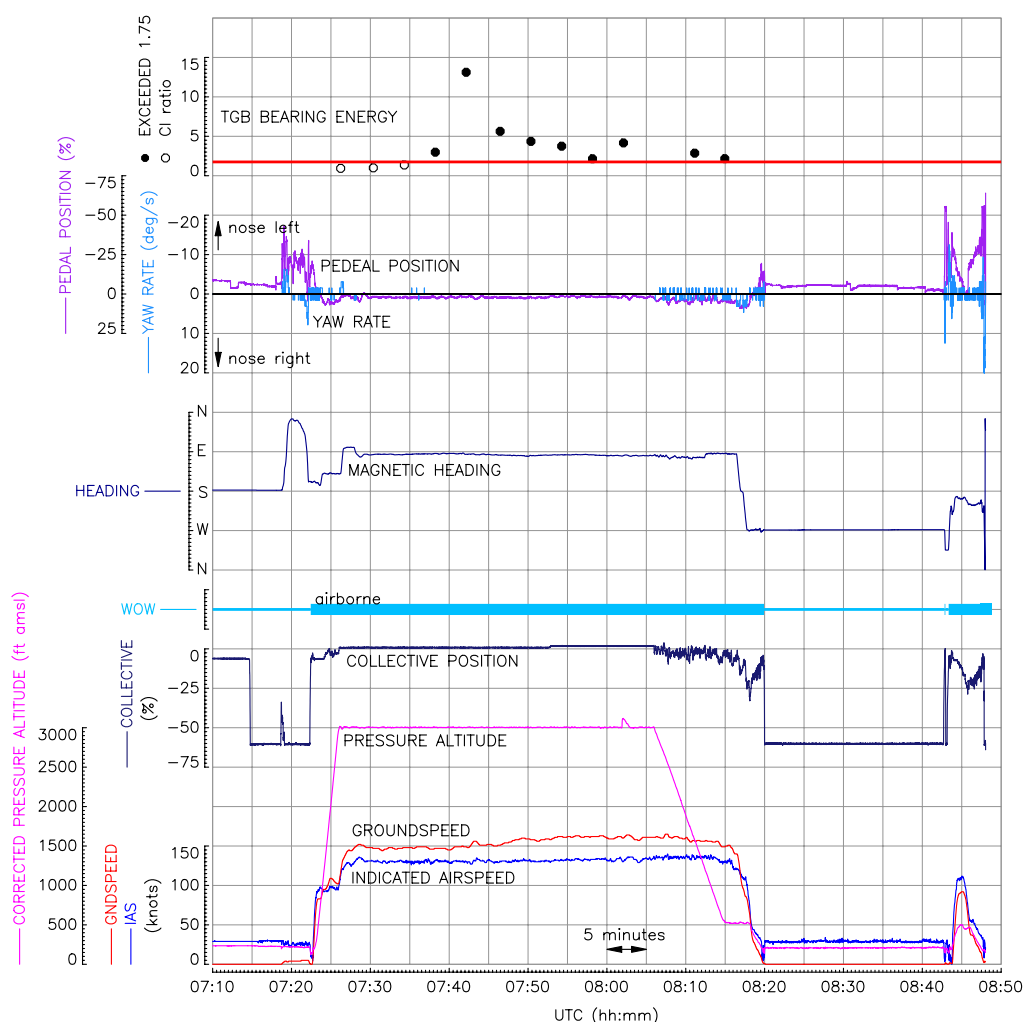
**Figure 12**

After G-WNSR was recovered following the accident on the West Franklin, the HUMS data for 28 December 2016 was downloaded. Figure 12 shows the TGB bearing energy CI ratio for this flight and indicates that during the first leg (from Aberdeen to the Elgin PUQ) 12 sets of data were acquired of which the last nine resulted in TGB bearing energy CI ratio exceedences.

TGB bearing energy CI ratio and recorded data for the flight  
on 28 December 2016

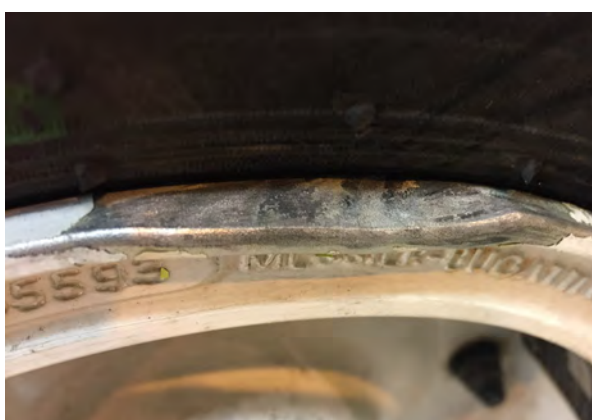
**Figure 17**

The helicopter sustained minor visible damage which consisted of a small dent, approximately 80 mm long, to the left side outer mainwheel outer rim; the main landing gear was undamaged. Despite the dent, the left side outer mainwheel tyre remained inflated. There was no other visible evidence of external damage to the helicopter. However, later examination revealed damage to the TR pitch control servo (TR servo) and TRPCS bearing.

Left outer wheel rim distortion (courtesy of CHC Scotia Ltd)

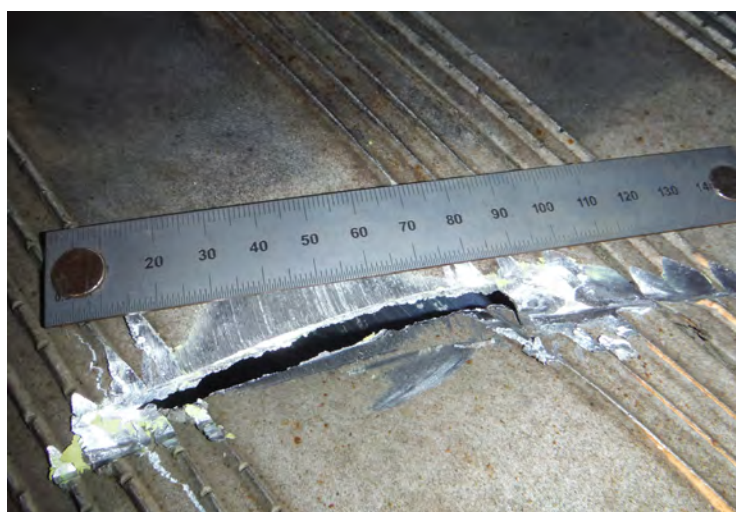
**Figure 18**

The helideck surface sustained minor damage to its surface consisting of tyre scuff marks and a small dent within which the aluminium surface had split (Figure 18).

Helideck damage (courtesy of CHC Scotia Ltd)

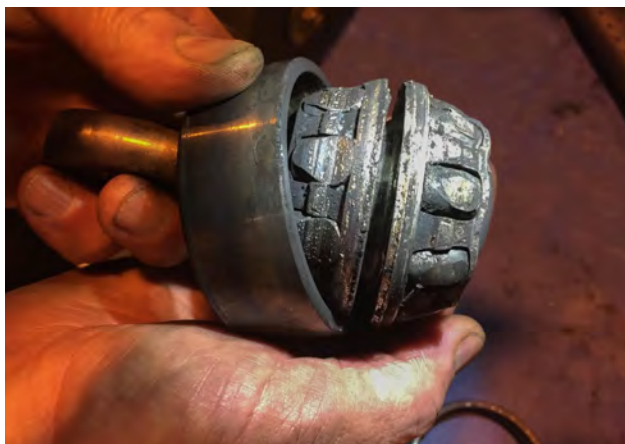
**Figure 19**

The TR servo was removed and a disassembly of the TRPCS revealed severe damage to the TRPCS bearing. The bearing showed evidence of overheating and discolouration, a partial friction welding of the rollers, cages and inner race with the outer races loose and heavily scored. The PTFE seals and snap rings were not evident. There was no lubricant present in the bearing. Figure 19 shows the bearing on removal.

TRPCS bearing from G-WNSR

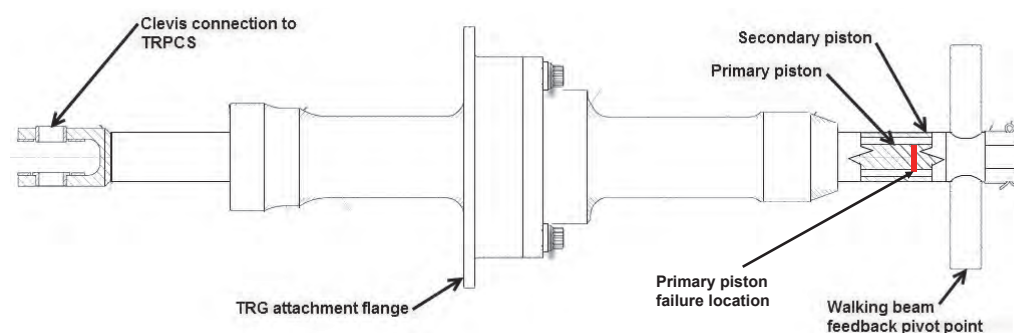
**Figure 20**

The servo was disassembled as far as possible; however, the inboard face of the primary piston head was tight against the gland seal and could not be moved. Remnants of seal material were present in the vicinity of the outboard piston face. There were signs that the primary piston had been rotating within its cylinder evidenced by rotational scoring on the bore of the cylinder. This scoring was approximately 35 mm from the housing face (TGB mounting flange) and extended along the bore, in the piston retraction direction, by approximately 18 mm. Rotational marks were also present on the contact surface between the primary and secondary pistons. The clevis assembly, which attaches the primary piston to the TRPCS bearing, could not be removed despite the application of a 350 lb ft torque. Residual hydraulic fluid within the servo appeared normal. The primary piston which had parted within the secondary piston tube, was removed and sectioned for metallurgical examination. The surfaces were examined under a scanning electron microscope which revealed evidence of smearing and shear overload, consistent with a ductile overload in torsion.

Servo cross-section and fracture location (courtesy of Sikorsky)

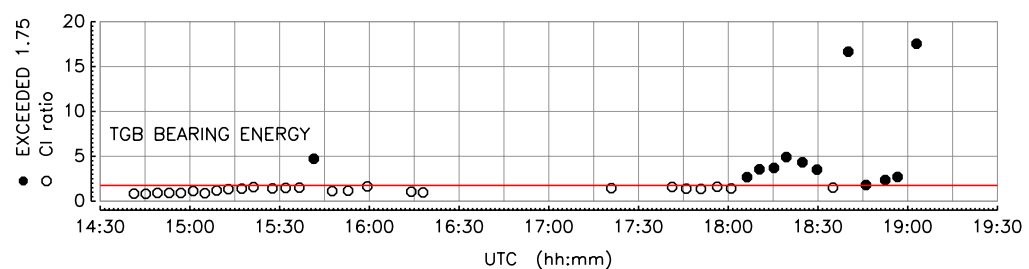
**Figure 25**

The HUMS Tail Gearbox Bearing Energy Tool shows bearing degradation over a very short period of time. The first exceedence was picked up at five operating hours prior to the accident. Figure 25 shows that the bearing degradation produced inconsistent vibration levels which suggests the bearing did not follow a gradually increasing wear pattern leading to eventual failure.

Extract from Figure 12 - TGB bearing energy CI ratio for third flight on 27 December 2016

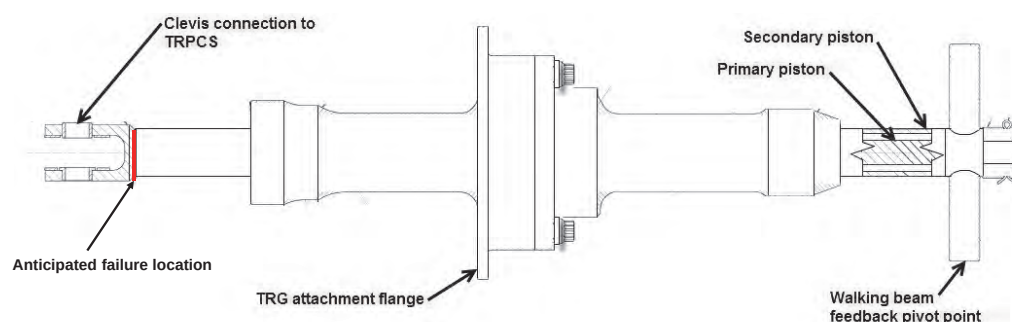
**Figure 26**

The work carried out to rectify the first bearing failure event in 2007 also considered a disconnection between the TRPCS and the servo piston, and considered a partial or full seizure of the TRPCS bearing applying torque to the servo piston. It was anticipated that should this happen, the servo would fail in the threaded portion of the clevis where it connects directly to the TRPCS (Figure 26). This would leave the now-disconnected, but hydraulically-driven, piston attached to the helicopter yaw control system and therefore in a relatively safe condition, albeit with the servo piston moving in and out, colliding with the remains of the clevis and its eye end.

Anticipated servo failure location
