SERIOUS INCIDENT

Aircraft Type and Registration:	DHC-8-402, G-PRPH	
No & Type of Engines:	2 Pratt & Whitney Canada PW150A turboprop engines	
Year of Manufacture:	2010 (Serial no: 4323)	
Date & Time (UTC):	26 May 2017 at 1030 hrs	
Location:	On descent into Manchester Airport	
Type of Flight:	Commercial Air Transport (Passenger)	
Persons on Board:	Crew - 4	Passengers - 53
Injuries:	Crew - None	Passengers - None
Nature of Damage:	None	
Commander's Licence:	Airline Transport Pilot's Licence	
Commander's Age:	33 years	
Commander's Flying Experience:	4,000 hours (of which 330 were on type) Last 90 days - 185 hours Last 28 days - 40 hours	
Information Source:	AAIB Field Investigation

Synopsis

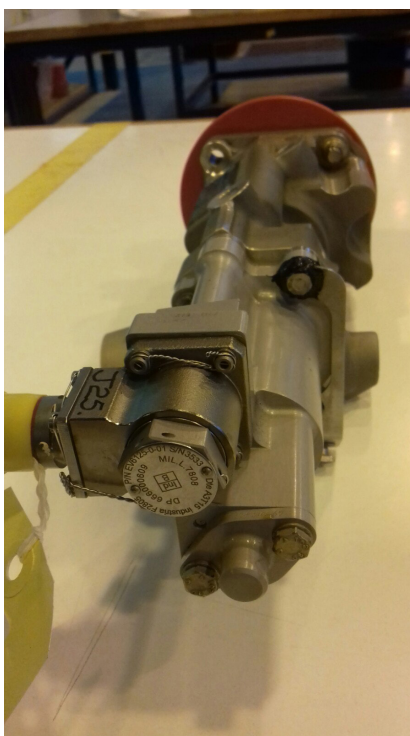
Figure 1

During examination of the No 2 engine on G-PRPH after the landing, it was observed that the propeller overspeed governor ground reset solenoid valve cap had separated from the body of the unit. Engine oil had therefore leaked under pressure until most of the system contents were lost.

General view of propeller overspeed governor unit

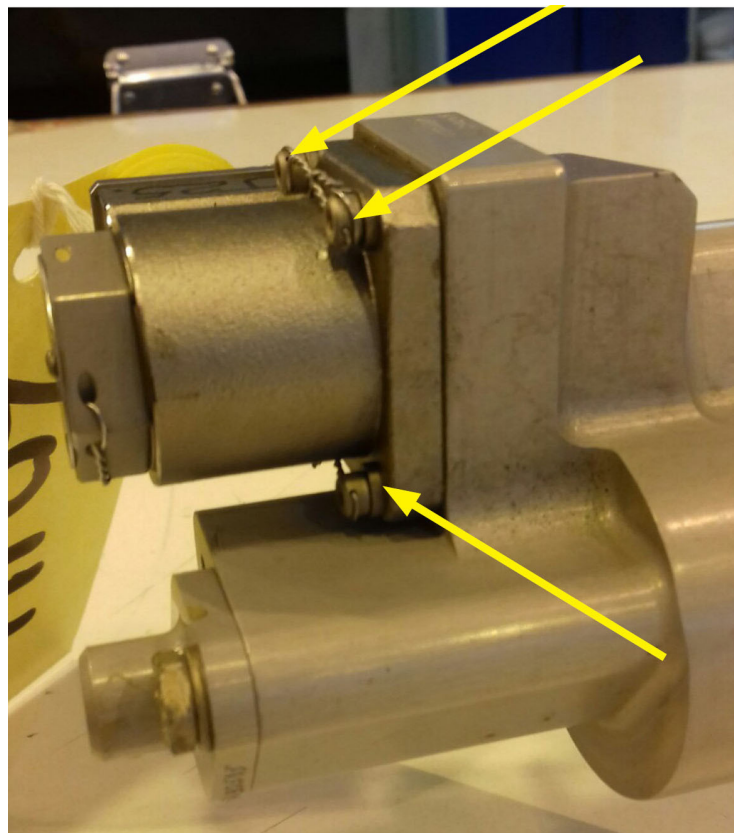
Figure 2

The No 2 engine overspeed governor unit was removed from the reduction gearbox and sent to the AAIB. Examination showed that the cap over the ground reset solenoid had detached as a consequence of failure of the four ultra-high tensile steel bolts securing it to the body of the governor unit (Figure 2). The hydraulic nose had fractured approximately in the plane of the bolt failures. The component was examined by the manufacturer in the presence of the AAIB. It was noted that considerable fretting was present on the shim under the end cap and on the mating faces. The separated heads of the four bolts remained joined in pairs by wire locking and were recovered.

The failed bolts were forwarded to a specialist laboratory for examination. One bolt showed evidence of predominant fatigue failure, a second started as fatigue then changed to serial overload. The third started in fatigue in the reverse direction to the previous two, whilst the fourth was a complex fracture, probably indicating this was the last of the four to fail. Attempts at fatigue striation counting indicated that one of the bolts had suffered in excess of 7,000 cycles to failure. The numbers of cycles to initiation are not known.

Examination of the wire locking that both secured the bolt heads and joined them in pairs indicated that, though not in conflict with the production drawings, the orientation on this unit resulted in different pairs being joined from the norm. Consequently, the length of wire locking between two of them was greater and the routing was less direct.

Arrows showing position of bolt group which failed on G-PRPH

The loss of oil pressure on the No 2 engine was because a cap locating the propeller overspeed governor test solenoid had detached due to failure of the attachment bolts, predominantly in fatigue. The cause of the bolt group fatigue failure was not established, but the possibility that a lower than specified assembly torque tightening figure was used on one or more bolts during assembly could not be ruled out.
