ACCIDENT

Aircraft Type and Registration:	Europa, G-MIME	
No & Type of Engines:	1 Rotax 912 ULS piston engine	
Year of Manufacture:	2001 (Serial no: PFA 247-12850)	
Date & Time (UTC):	28 September 2017 at 1500 hrs	
Location:	Grove Farm, Wolvey, Warwickshire	
Type of Flight:	Private	
Persons on Board:	Crew - 1	Passengers - 1
Injuries:	Crew - 1 (Fatal)	Passengers - 1 (Fatal)
Nature of Damage:	Aircraft destroyed	
Commander's Licence:	National Private Pilot's Licence	
Commander's Age:	55	
Commander's Flying Experience:	546 hours (of which 48 were on type) Last 90 days - 12 hours Last 28 days - 1 hour	
Information Source:	AAIB Field Investigation

Synopsis

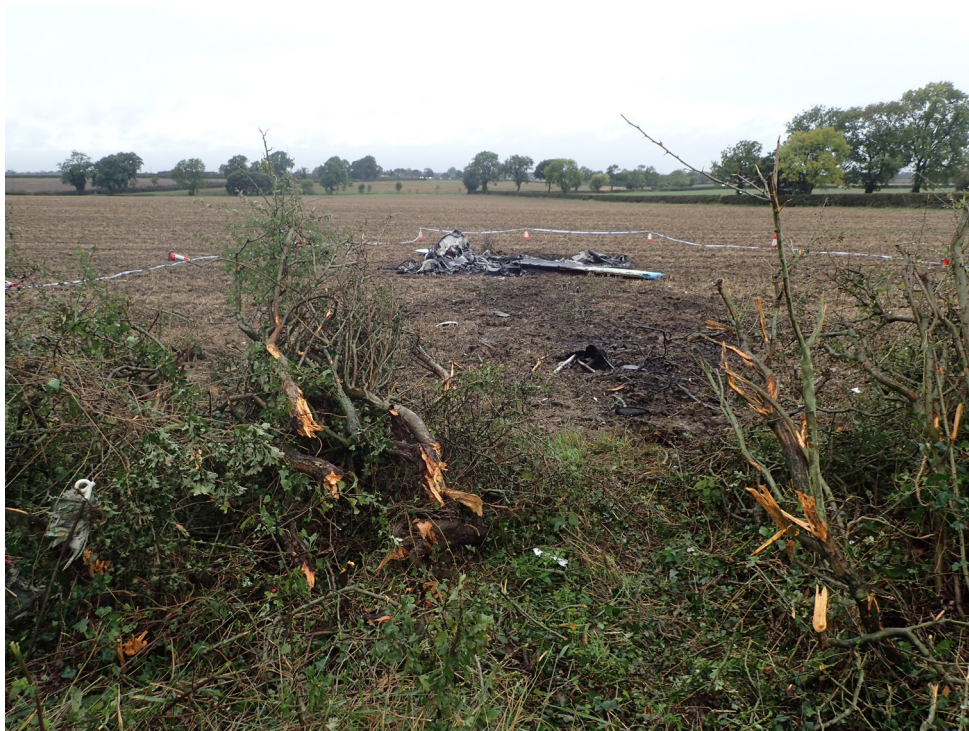
Figure 1

The aircraft wreckage was located close to the western end of the runway. It had overshoot the runway, passed through a thick, four-foot high hedge and a shallow ditch before coming to rest approximately 10 m past the hedge (Figures 1 and 2). Evidence indicated that the aircraft was on the ground and turning slightly left when it contacted the hedge. As a result, the right wingtip contacted the hedge before the left wingtip and this slewed the aircraft back more in line with the runway centreline.

General view of accident site from the end of the runway through the hedge

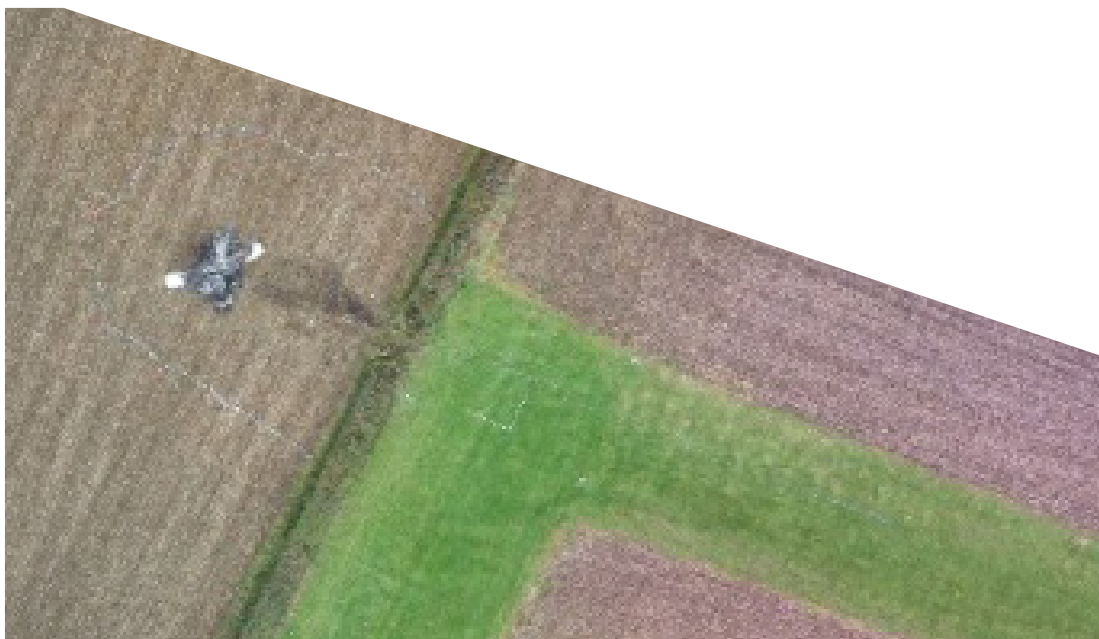
Figure 2

General overhead view of the accident site (from AAIB UAS)

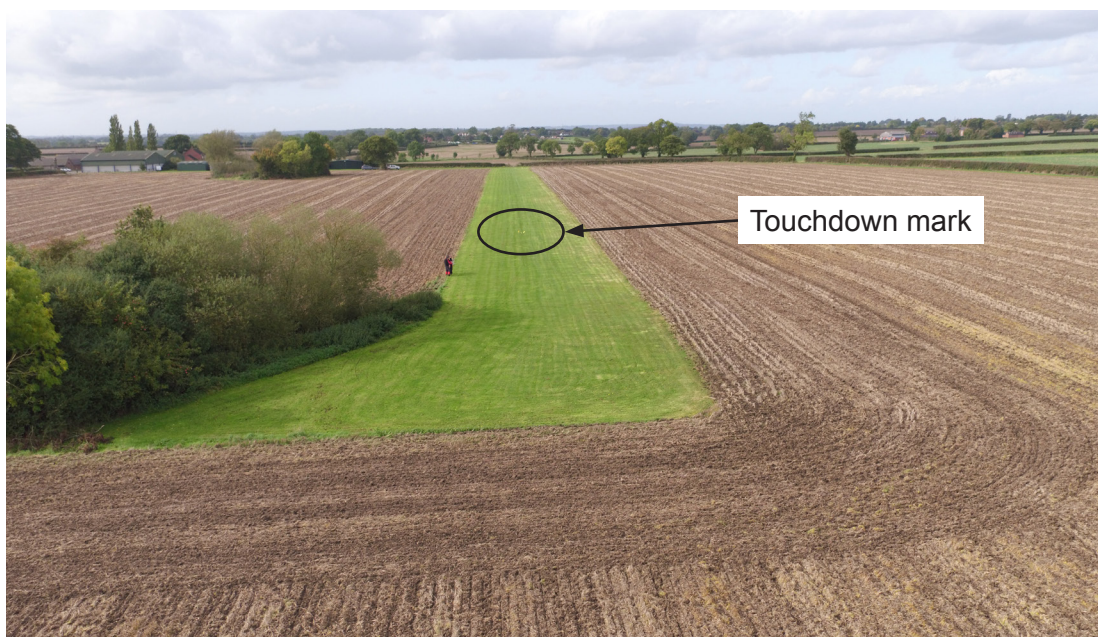
Figure 3

The runway was examined and it was in good condition with short grass and a reasonably firm surface. A touchdown mark from the single mainwheel was found close to the centre line of the runway approximately 73 m from the start of the runway (Figure 3). It indicated the aircraft had made a firm touchdown after which it became airborne again. Although there were more ground markings approaching the hedge, the subsequent touchdown point could not be identified.

View in direction of landing (from AAIB UAS)

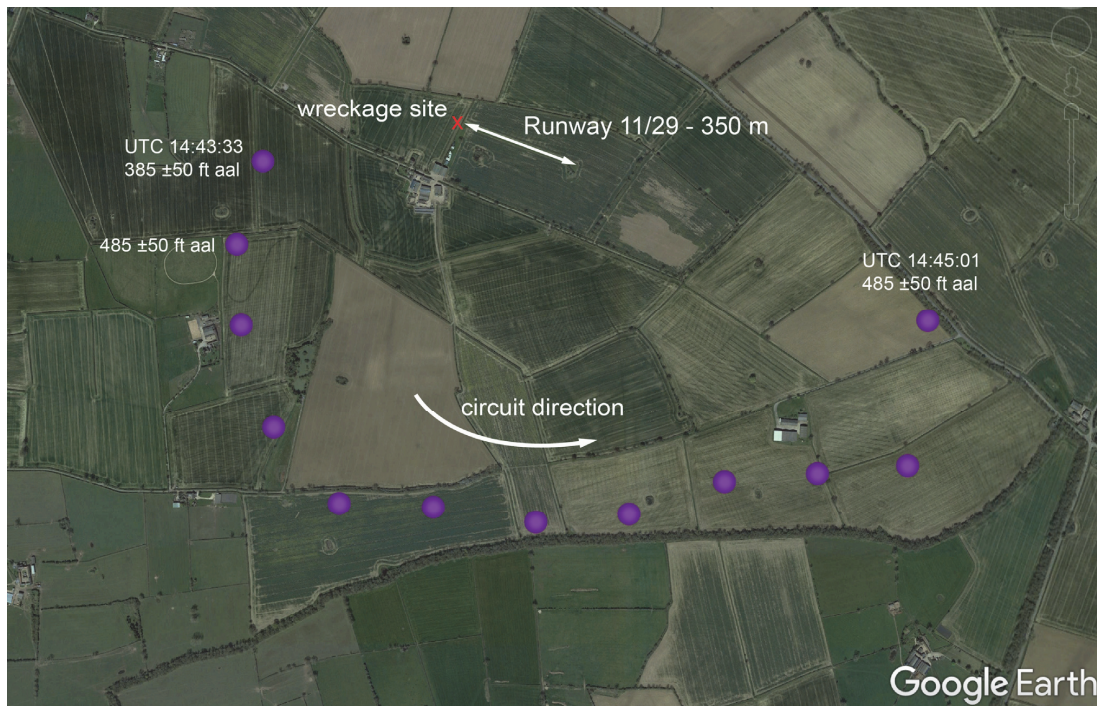
Figure 4

None of the aircraft's avionics survived the post-accident fire and no aircraft recorded data was recovered; however, a limited amount of radar data was recorded that tracked the aircraft in a left-hand circuit for Runway 29. Transponder Mode C altitude information, corrected to the QNH of 1017 hPa and the runway elevation of 380 ft, indicated that the circuit was flown at a height of 485 ± 50 ft aal (Figure 4).

Circuit ground track from radar data
