## ACCIDENT

<b>Aircraft Type and Registration:</b>	Rockwell Commander 114, G-TWIZ
<b>No &amp; Type of Engines:</b>	1 Lycoming IO-540-T4B5D piston engine
<b>Year of Manufacture:</b>	1978 (Serial no: 14375)
<b>Date &amp; Time (UTC):</b>	1 August 2017 at 1243 hrs
<b>Location:</b>	Lydd Airport, Kent
<b>Type of Flight:</b>	Private
<b>Persons on Board:</b>	Crew -1                      Passengers - 1
<b>Injuries:</b>	Crew - None                      Passengers - None
<b>Nature of Damage:</b>	Left landing gear upper side-brace fractured, damage to left wing and left cabin access step
<b>Commander's Licence:</b>	Light aircraft pilot licence (LAPL)
<b>Commander's Age:</b>	79 years
<b>Commander's Flying Experience:</b>	469 hours (of which 347 were on type) Last 90 days - 1 hour Last 28 days - 1 hour
<b>Information Source:</b>	AAIB Field Investigation

## Synopsis

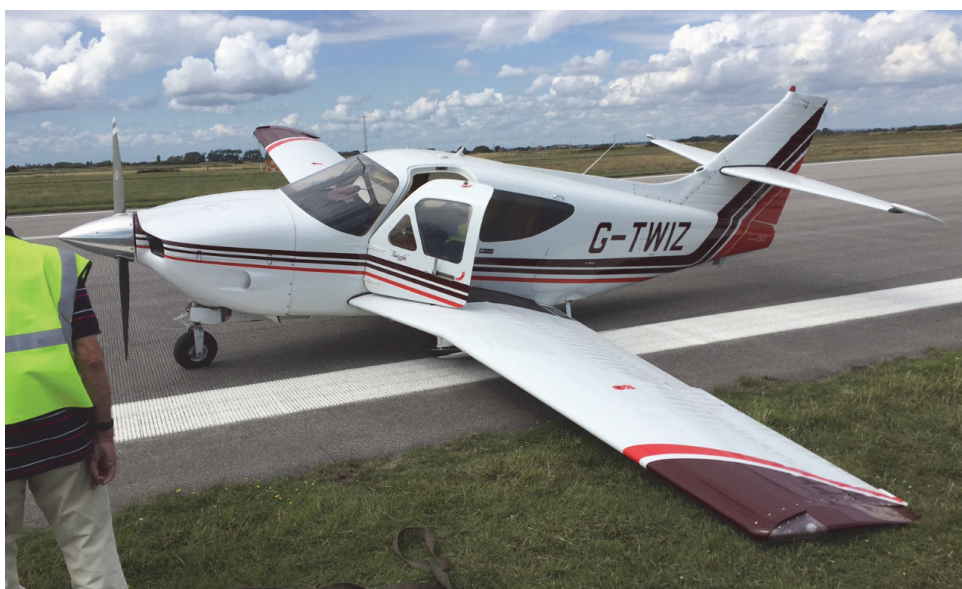
**Figure 1**

left MLG leg folded inwards. The commander turned the fuel selector and battery master switch to OFF before the aircraft stopped, and he guided the aircraft to the grass to the left of the runway. Once the aircraft came to rest, the commander and his passenger exited the aircraft without difficulty. The aircraft sustained damage to the left wing and left cabin access step. During the recovery of the aircraft it was discovered that the left MLG upper side-brace had fractured, preventing the left landing gear leg from retracting, or locking in the extended position.

G-TWIZ following the collapse of the left MLG (photo courtesy James Giller)

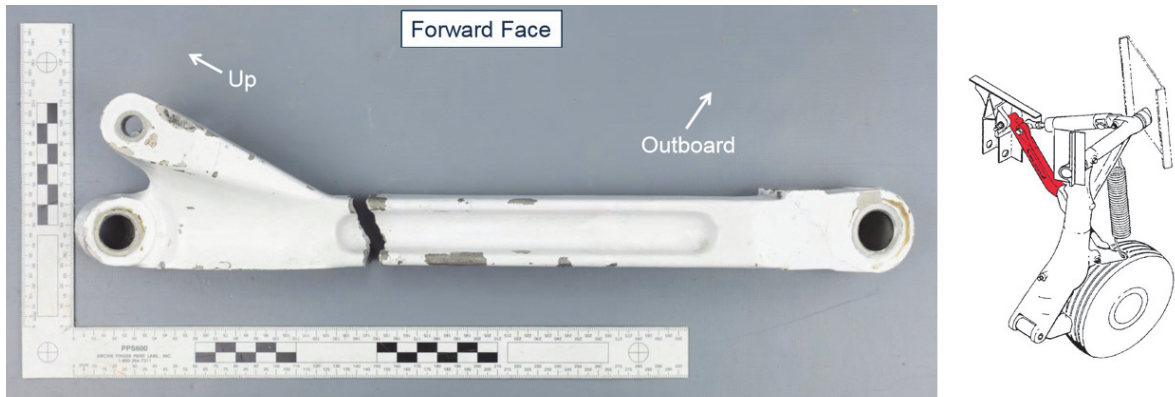
**Figure 2**  
Fractured left MLG upper side-brace

The fractured landing gear upper side-brace, part number 45304-1, was removed from the aircraft and subjected to metallurgical examination.

The side brace fractured due to ductile overload, following propagation of a fatigue crack originating at a 'cold shut' casting defect. This casting defect was large enough to be detected by radiographic (X-ray) inspection and the side brace component should have been inspected using this method during the manufacturing process, as required by the component's Class 1A classification under the MIL-C-6021 standard.

The aircraft's left MLG leg collapsed during landing due to the fracture of the upper side-brace during retraction of the landing gear after takeoff. The upper side-brace fractured under the application of landing gear retraction loads due to the presence of a fatigue crack originating at a 'cold shut' casting defect. This casting defect was large enough to be detectable by radiographic (X-ray) inspection when the casting was manufactured and this inspection method was required according to the component's classification under MIL-C-6021. This is the second occurrence of a Rockwell Commander 114 MLG collapse due to side-brace fracture originating at a casting defect within the side-brace.

In response to this investigation the Type Certificate holder, Commander Aircraft Corporation, issued Service Bulletins SB-112-75 and SB-114-37, applicable to the Rockwell Commander 112 and 114 aircraft models respectively. These Service Bulletins require inspection of the upper side-brace for cracking in the area of the retraction cylinder attachment and replacement of the upper side-brace if it is found to be cracked and not repairable.

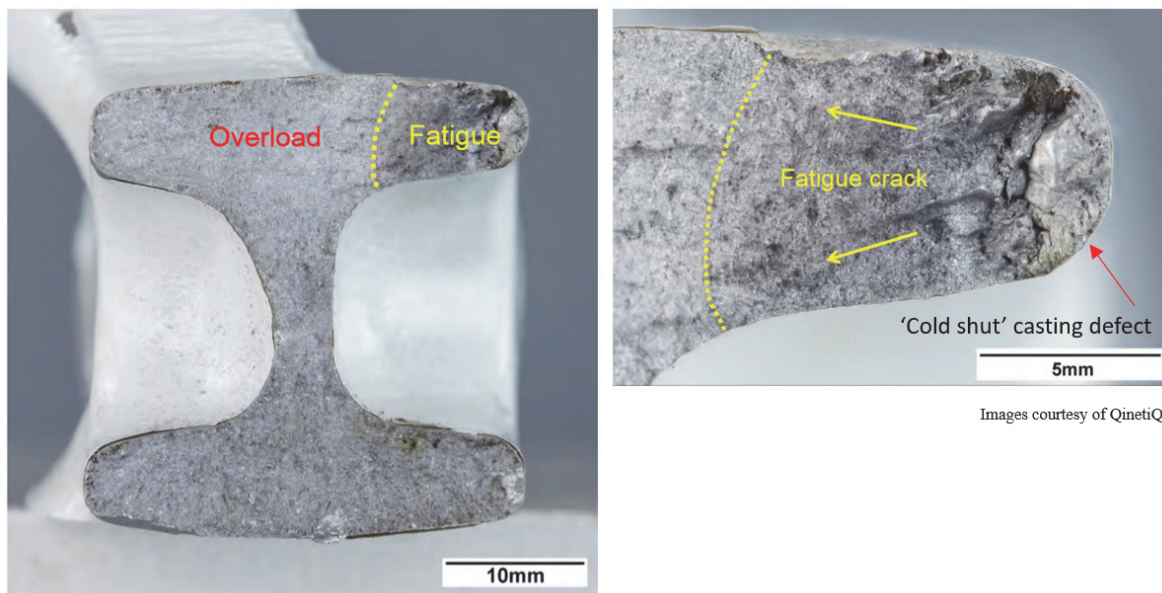
**Figure 3**  
Casting defect and fatigue crack region

Ink markings on the surface of the casting, beneath the external paint layer, indicated that it had been manufactured in October 1977. The metallurgical examination indicated that a fatigue crack had initiated at the location of a 'cold shut'<sup>1</sup> casting defect. The fatigue crack and casting defect extended to approximately 14% of the cross-sectional area of the side-brace section. The remainder of the fracture surface consisted of ductile overload and no crack arrest marks were observed. The metallurgical analysis also revealed the presence of additional internal and surface-breaking casting defects and sand particles within the casting, adjacent to the fracture surface.

The metallurgical examination determined that the casting defect that initiated the fatigue crack was large enough to be observed by radiographic inspection.
