ACCIDENT

Aircraft Type and Registration:	Piper PA-28R-200 Cherokee Arrow, G-RACO	
No & Type of Engines:	1 Lycoming IO-360-C1C piston engine	
Year of Manufacture:	1975 (Serial no: 28R-7535300)	
Date & Time (UTC):	5 December 2017 at 1130 hrs	
Location:	Manchester/Barton Airport	
Type of Flight:	Training	
Persons on Board:	Crew - 2	Passengers - None
Injuries:	Crew - None	Passengers - N/A
Nature of Damage:	Collapsed nose landing gear, damaged propeller and wings deformed around main landing gear mounts	
Commander's Licence:	Private Pilot's Licence	
Commander's Age:	74 years	
Commander's Flying Experience:	1,441 hours (of which 0 were on type) Last 90 days - 2 hours Last 28 days - 2 hours	
Information Source:	Aircraft Accident Report Form submitted by the pilot

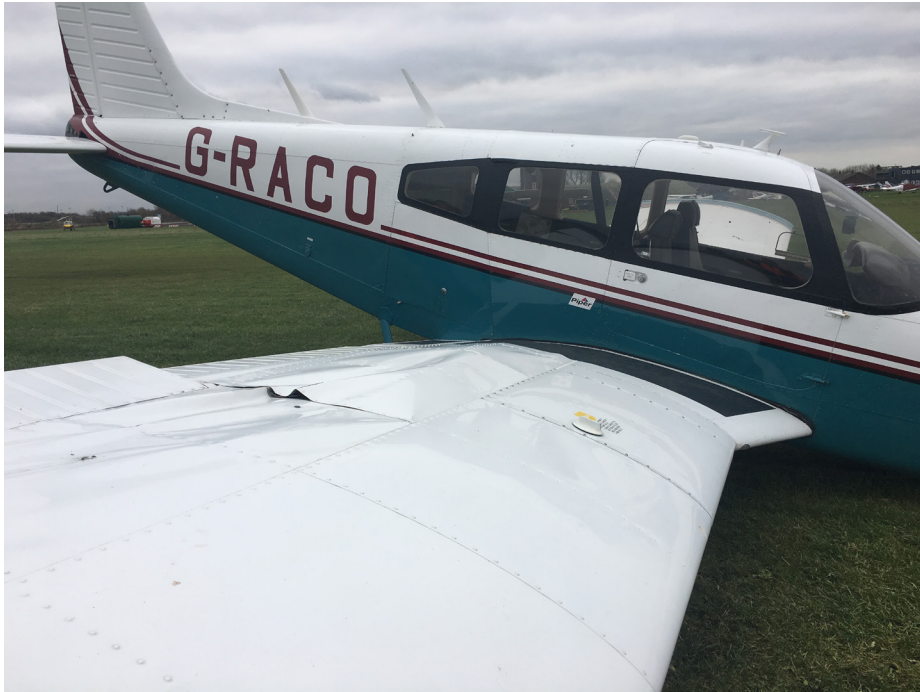
Figure 1

During the first circuit, the pilot configured the aircraft for landing and maintained a small amount of throttle once over the threshold. The pilot reported that when he flared the aircraft he realised he was too high and lowered the nose, as directed by the instructor. The aircraft pitched nose-down abruptly and struck the grass runway. The nose landing gear collapsed and the wing structure deformed around the main landing gear mounts (Figure 1).

The pilot assessed that he had stalled during the flare, causing the aircraft to pitch down abruptly. Conversely, the instructor considered that the pilot's forward input was too pronounced, causing the abrupt pitch down. The instructor stated that it was not possible to have reacted in time to avert the accident.

Both the pilot and the instructor considered that a contributory factor to the high flare was that most of the pilot's experience was on aircraft types with much higher seating positions than the PA-28R.

Deformation in wing around main undercarriage mounts
