SERIOUS INCIDENT

Aircraft Type and Registration:	PS-28 Cruiser, G-DTFT	
No & Type of Engines:	1 Rotax 912ULS2 piston engine	
Year of Manufacture:	2014 (Serial no: C0506)	
Date & Time (UTC):	23 August 2017 at 1616 hrs	
Location:	Leeds Bradford Airport	
Type of Flight:	Private	
Persons on Board:	Crew - 1	Passengers - None
Injuries:	Crew - None	Passengers - N/A
Nature of Damage:	None	
Commander's Licence:	Private Pilot's Licence	
Commander's Age:	34 years	
Commander's Flying Experience:	78 hours (of which 5 were on type) Last 90 days - 13 hours Last 28 days - 7 hours	
Information Source:	Aircraft Accident Report Form submitted by the pilot

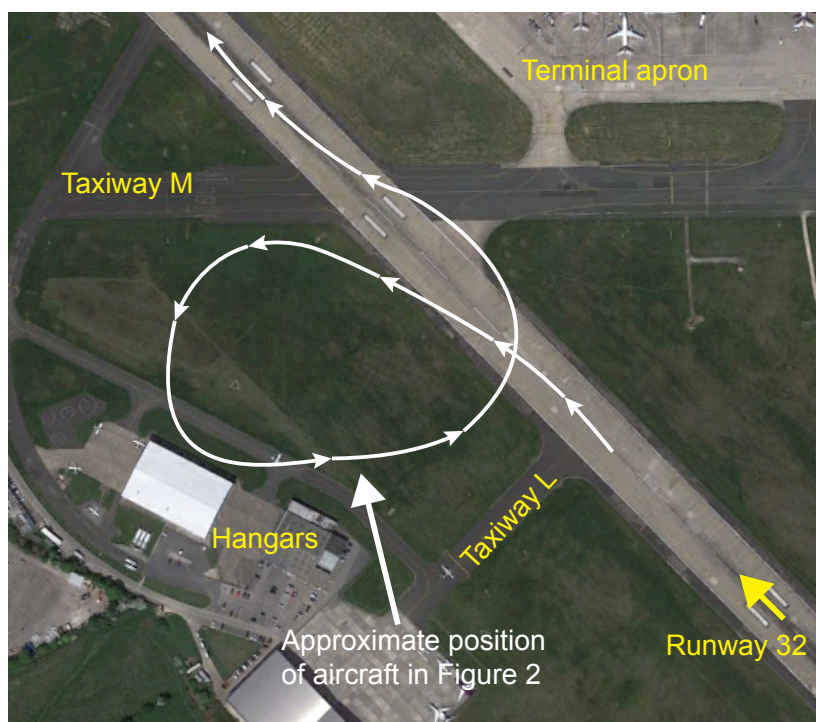
Figure 1

The takeoff and the low-level manoeuvres were recorded by several CCTV cameras and by a witness with a mobile phone. The recordings confirmed that when the aircraft approached the edge of the runway, south of Taxiway M (Figure 1), it rotated abruptly and rolled into a left turn but the pitch attitude then reduced and it made a short, shallow climb until it reached a height estimated to be no greater than 100 ft agl. At one point the aircraft appeared to start rolling out of the turn onto a south-westerly track, which might have taken it clear of the hangar area, but the angle of bank then increased suddenly.

Aerial view of Leeds Bradford Airport (© 2018 Google, Image © 2018 DigitalGlobe)

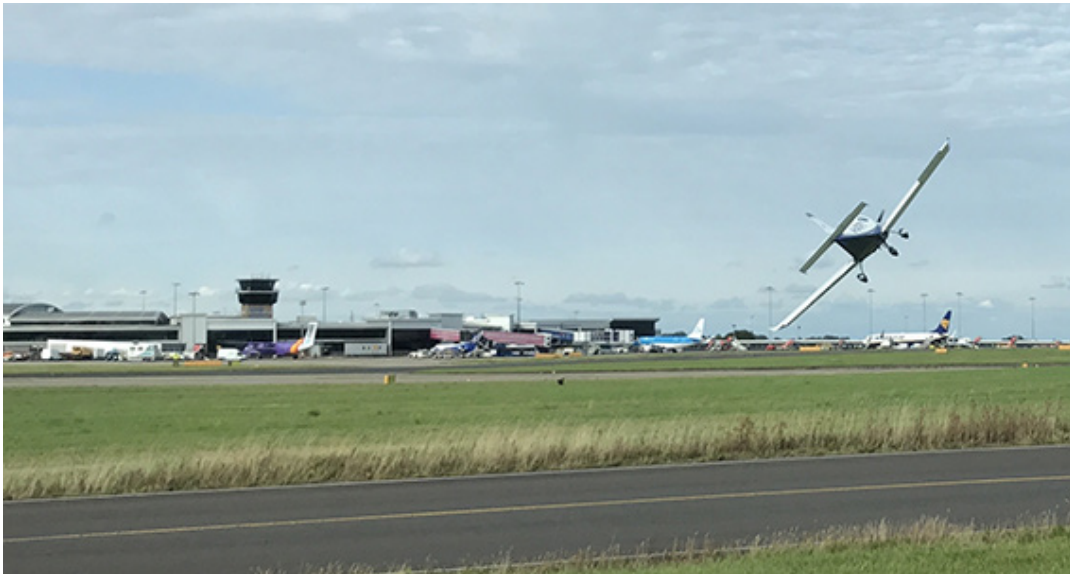
Figure 2

The aircraft continued turning, while flying at approximately the same height as the roof of the tallest hangar. It appeared to remain over the area between the hangars and the runway, with its angle of bank estimated to reach 60°. Then, as the aircraft turned back towards the runway, it descended below the level of the hangar roofs and the angle of bank began to reduce (Figure 2) but the left wingtip almost touched the grass while still in a left turn towards the runway, with an estimated angle of bank of 40°. However, the aircraft then started climbing again and it rolled out of the turn in the vicinity of the runway while climbing towards the north-west.

G-DTFT with a bank angle exceeding 40°, shortly before the wingtip almost touched the grass
(Photograph courtesy of Mr D Firman)
