ACCIDENT

Aircraft Type and Registration:	Reims Cessna F152, G-BHNA
No & Type of Engines:	1 Lycoming O-235-L2C piston engine
Year of Manufacture:	1980 (Serial no: 1683)
Date & Time (UTC):	14 May 2017 at 1214 hrs
Location:	Retford Gamston Airfield, Nottinghamshire
Type of Flight:	Training
Persons on Board:	Crew - 1 Passengers - None
Injuries:	Crew - 1 (Serious) Passengers - N/A
Nature of Damage:	Beyond economic repair
Commander's Licence:	Student
Commander's Age:	61 years
Commander's Flying Experience:	62 hours (all on type) Last 90 days - 16 hours Last 28 days - 7 hours
Information Source:	Aircraft Accident Report Form submitted by the pilot and further enquiries by the AAIB

Synopsis

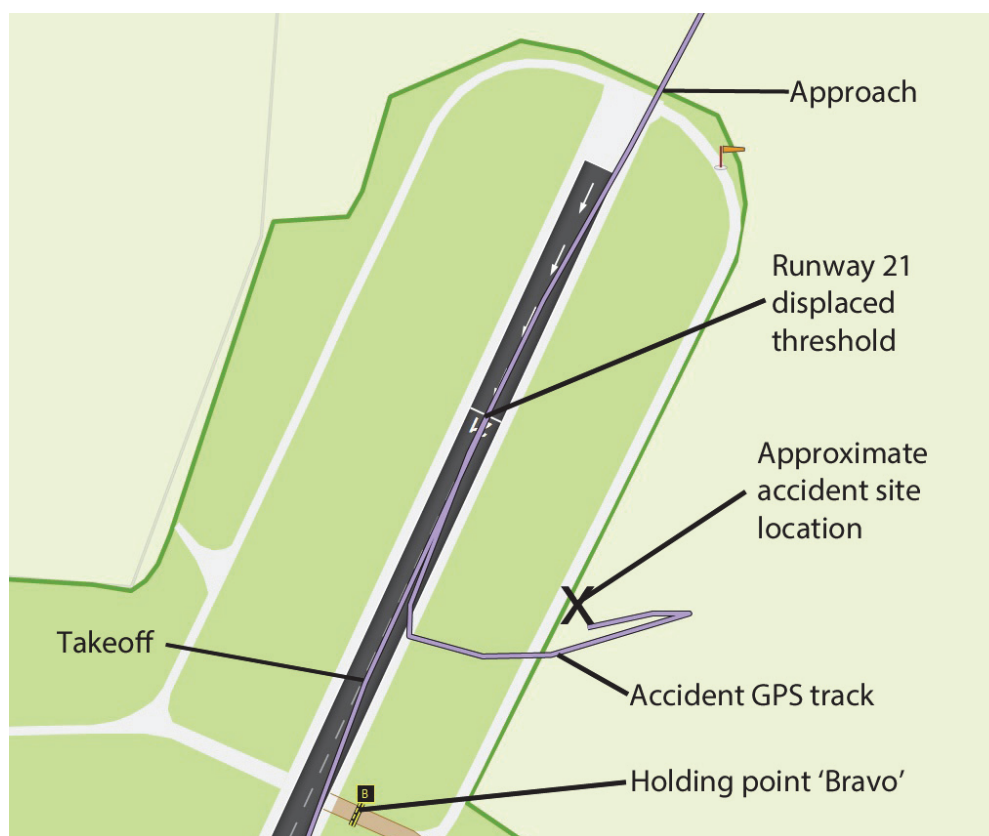
Figure 1

The aircraft struck the ground and came to rest close to the final recorded GPS point from the pilot's SkyDemon track log, to the left side of the runway (Figure 1). The pilot was seriously injured and transported to hospital by air ambulance.

Recorded GPS ground track from SkyDemon log showing the takeoff and the final accident track (underlying image ©SkyDemon)

The GPS groundspeed and altitude where the aircraft crossed the beginning of the paved surface were 60 kt and 190 ft amsl, with a displaced runway threshold elevation of 82 ft amsl. Over the runway numbers, the groundspeed was recorded as 59 kt and the altitude 83 ft amsl but the GPS altitude is not accurate enough to show whether the aircraft touched down; it could still have been at 50 ft agl or more. As the aircraft veered left from the runway, the GPS data showed a brief climb and reducing groundspeed, consistent with the eyewitness accounts.

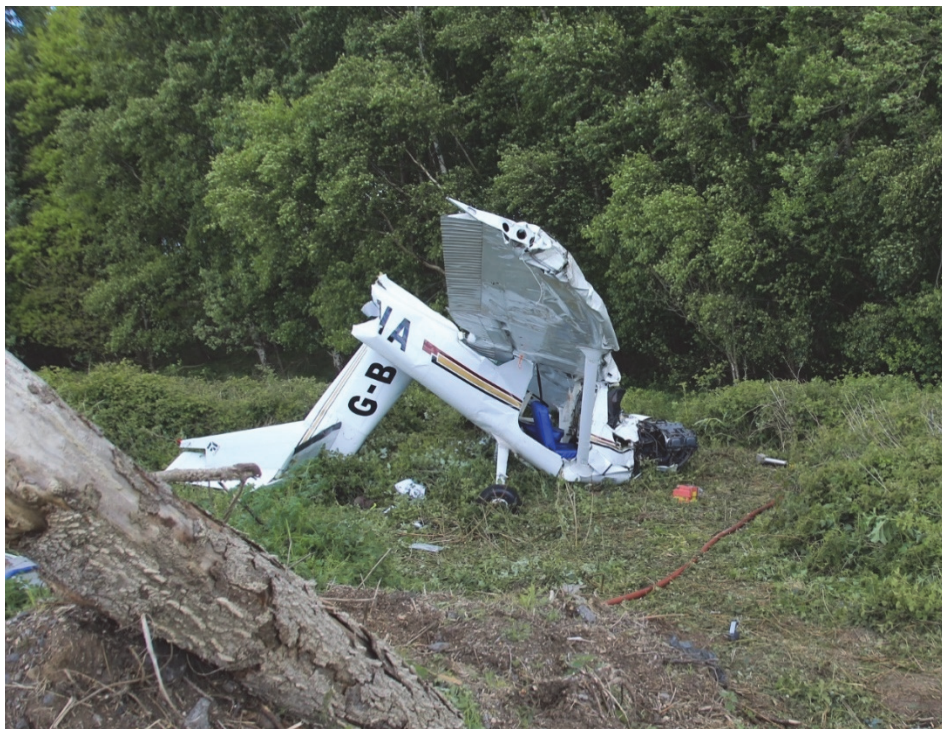
Figure 2
G-BHNA accident site

A loss adjustor attended the accident site (Figure 2). He reported that the aircraft appeared to have hit the ground vertically in a steep nose-down attitude. He checked the flight controls and did not find any defects. The left flap was down, the right flap was up, the flap selector was up but the flap indicator showed 30°. However, the flap lever could have easily moved in the impact sequence and the mismatch between the flap indicator and the right flap showed that the flap mechanism was disrupted and therefore this indication could not be relied upon as a valid pre-impact position. If the flaps had been asymmetric

as found it would have caused a right roll instead of the left roll that occurred. Therefore it is highly likely that the flap mechanism was damaged in the impact.

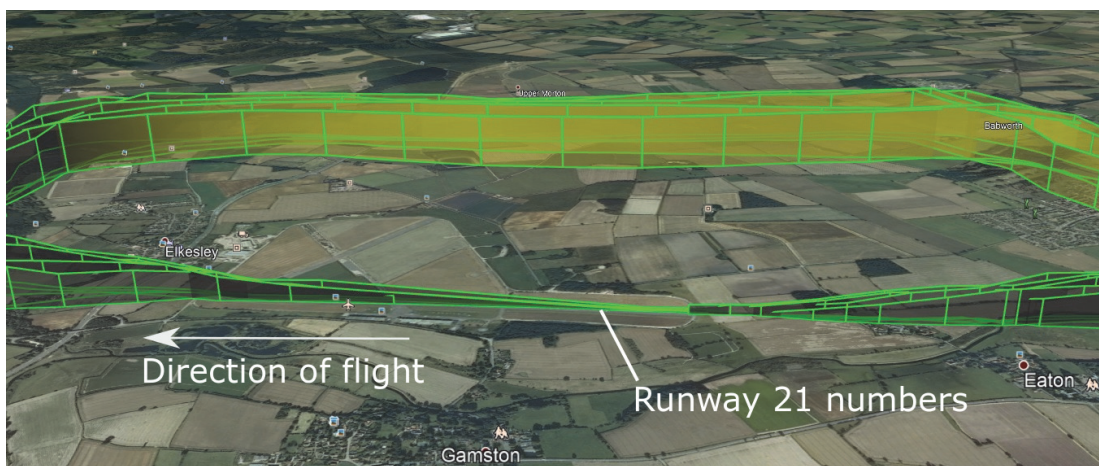
Figure 3

There was no recorded GPS data for the dual flight on 13 May 2017, but the radar data was obtained. This data revealed that five circuits were carried out to Runway 21 and the approach and climb-out profiles were almost identical for the first four, with the last one ending in a full-stop landing. The lowest recorded altitudes on each of the first four approaches was 47 ± 50 ft (corrected for QNH) and the runway elevation was between 72 and 87 ft. This data indicated that the first four were probably normal touch-and-go landings but it is possible that at least one was actually a very low go-around, from almost touchdown height, although a higher and earlier initial rate of climb would be expected from a go-around than a touch-and-go.

Radar data from G-BHNA's flight on the day before the accident, 13 May 2017

The pilot did not recall having practised go-arounds since around his first solo, seven months previously. The flying training record supported his recollection, apart from the entry of go-around practice on the day before the accident. The radar data showed that if a go-around had been practised on the day before the accident, it was very close to touchdown height, followed by a delayed or shallow climb-out. However, the pilot was confident that he had never performed a "low-level go-around" before.
