## ACCIDENT

| <b>Aircraft Type and Registration:</b> | Rotorsport UK Calidus, G-CIYU | |
| <b>Location:</b> | RAF Scampton, Lincolnshire | |

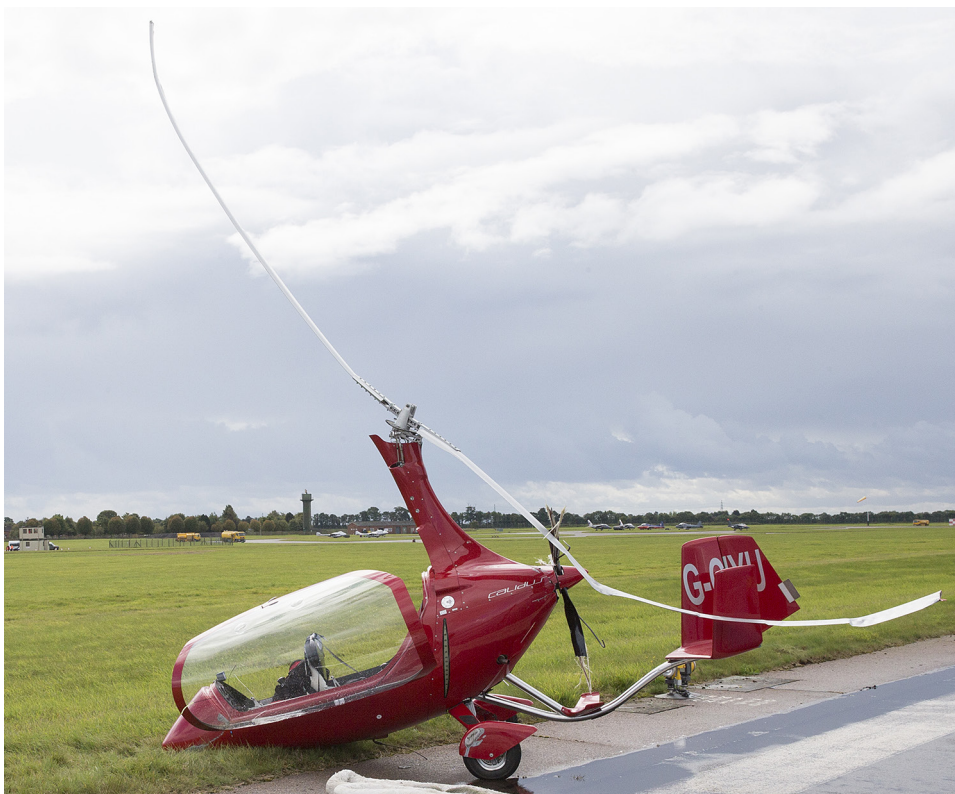
**Figure 1**

G-CIYU after righting and with the canopy open  
(Photograph MoD/Crown Copyright)

When the gyroplane began to roll left it was in such a nose-high attitude that the retreating blade struck the ground, to the left and rear of the machine. This caused the rate of roll to increase, while the nose dropped and hit the runway, resulting in separation of the nose landing gear. Next, the rotor which had been deformed, struck the propeller, causing debris to scatter across the runway before the gyroplane fell onto its left side and started to decelerate. After travelling approximately 50 m on its side, the gyroplane came to rest at the eastern edge of the runway, eight seconds after the accident sequence began and with its nose pointing left of the runway orientation.

The first RFFS vehicle was on the scene 2 minutes and 30 seconds later, by which time the crew had unlatched the canopy and one person had approached the gyroplane but had been unable to do anything to help. Approximately one minute after arrival, five firefighters manually righted the gyroplane onto its mainwheels, allowing the canopy to open normally and the occupants to step out.
