AAIB Bulletin

4/2018

Published 13 April 2018

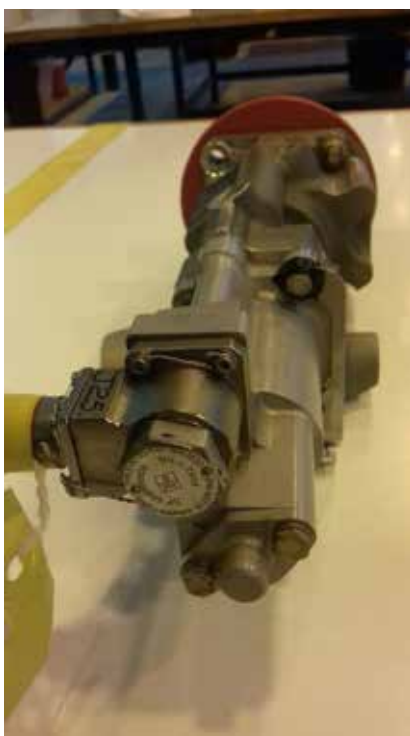
Figure 1

During examination of the No 2 engine on G-PRPH after the landing, it was observed that the propeller overspeed governor ground reset solenoid valve cap had separated from the body of the unit. Engine oil had therefore leaked under pressure until most of the system contents were lost.

General view of propeller overspeed governor unit

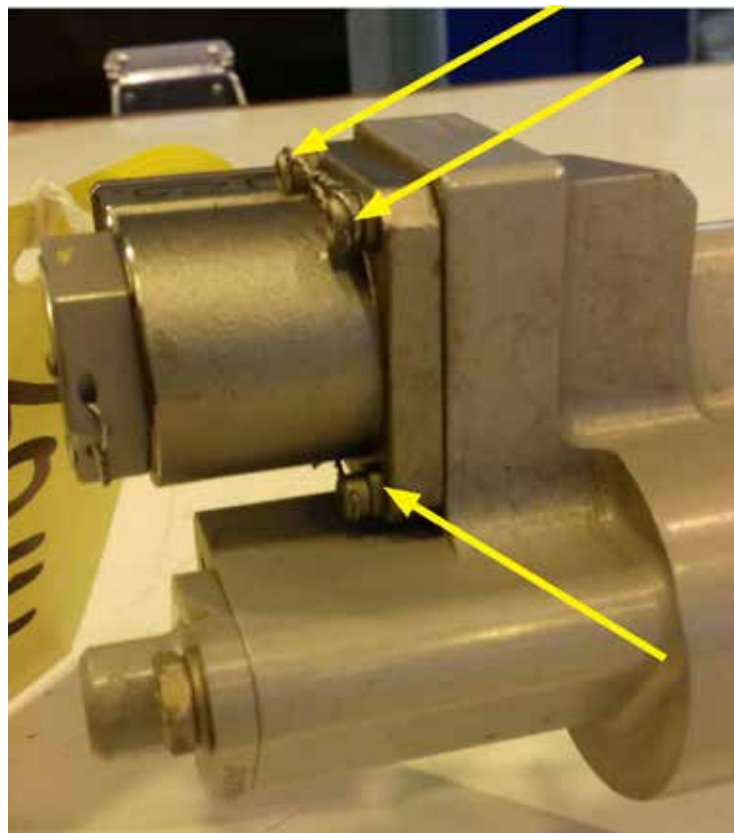
Figure 2

The failed bolts were forwarded to a specialist laboratory for examination. One bolt showed evidence of predominant fatigue failure, a second started as fatigue then changed to serial overload. The third started in fatigue in the reverse direction to the previous two, whilst the fourth was a complex fracture, probably indicating this was the last of the four to fail. Attempts at fatigue striation counting indicated that one of the bolts had suffered in excess of 7,000 cycles to failure. The numbers of cycles to initiation are not known.

Examination of the wire locking that both secured the bolt heads and joined them in pairs indicated that, though not in conflict with the production drawings, the orientation on this unit resulted in different pairs being joined from the norm. Consequently, the length of wire locking between two of them was greater and the routing was less direct.

Arrows showing position of bolt group which failed on G-PRPH

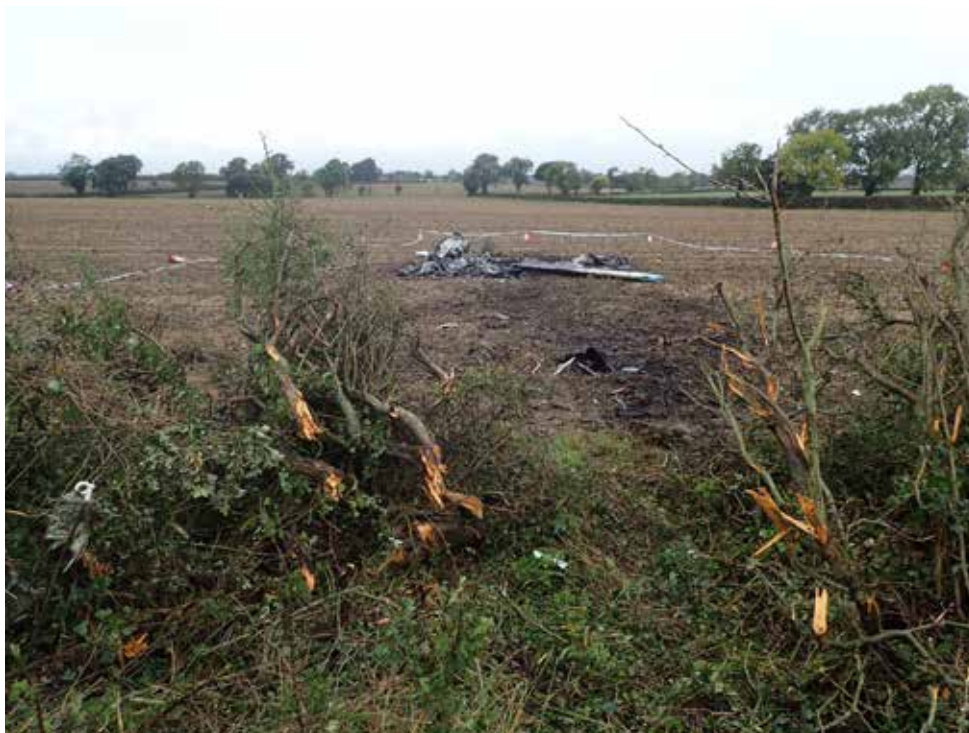
Figure 1

The internally mounted flap drive crosstube and its hinge attachments were found close to the hedge suggesting they had become detached as the aircraft passed through the hedge; the first signs of fire were visible on the ground in the vicinity. The engine and firewall forward section of the fuselage remained upright but the remainder of the aircraft was found inverted and the fuselage was substantially disrupted in the cockpit area; both doors were present. A post-impact fire, which burnt for over 30 minutes, consumed or severely damaged large parts of the aircraft including almost all the fuselage and empennage, but also the inboard parts of the wings and flaps.

The engine cowlings and engine were also severely damaged by the fire. All three blades of the propeller had broken off and were found close to the main wreckage; the nature of their damage and location indicated they were not under power when the aircraft passed through the hedge.

General view of accident site from the end of the runway through the hedge

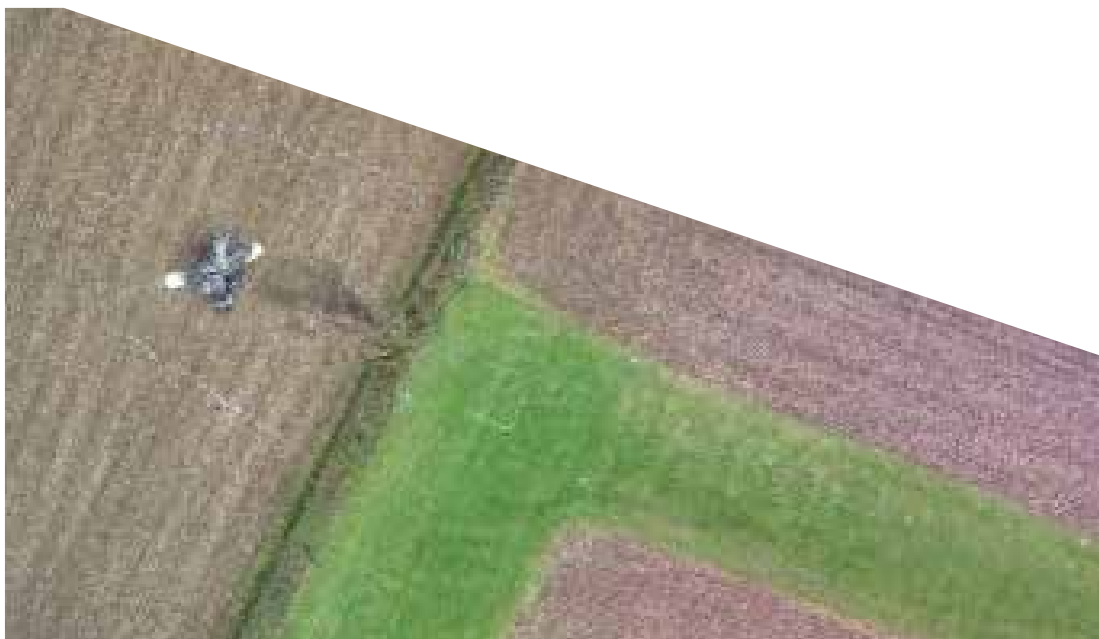
Figure 2

General overhead view of the accident site (from AAIB UAS)

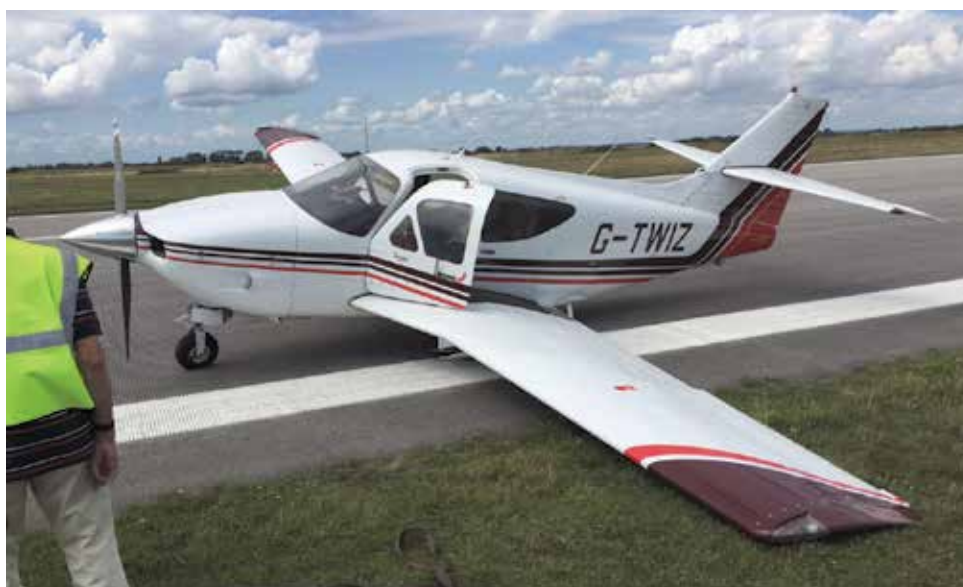
Figure 1

left MLG leg folded inwards. The commander turned the fuel selector and battery master switch to OFF before the aircraft stopped, and he guided the aircraft to the grass to the left of the runway. Once the aircraft came to rest, the commander and his passenger exited the aircraft without difficulty. The aircraft sustained damage to the left wing and left cabin access step. During the recovery of the aircraft it was discovered that the left MLG upper side-brace had fractured, preventing the left landing gear leg from retracting, or locking in the extended position.

G-TWIZ following the collapse of the left MLG (photo courtesy James Giller)

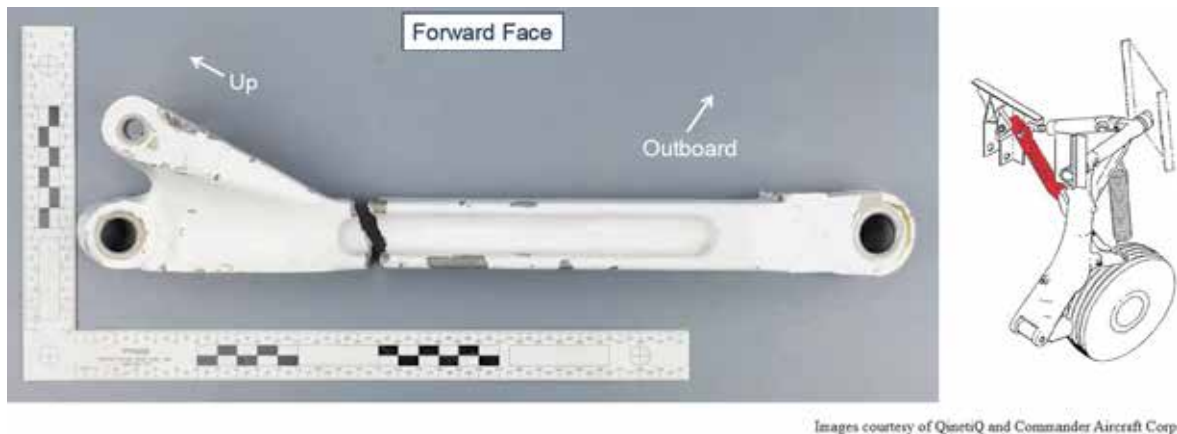
The fractured landing gear upper side-brace, part number 45304-1, was removed from the aircraft and subjected to metallurgical examination.

Figure 2
Fractured left MLG upper side-brace

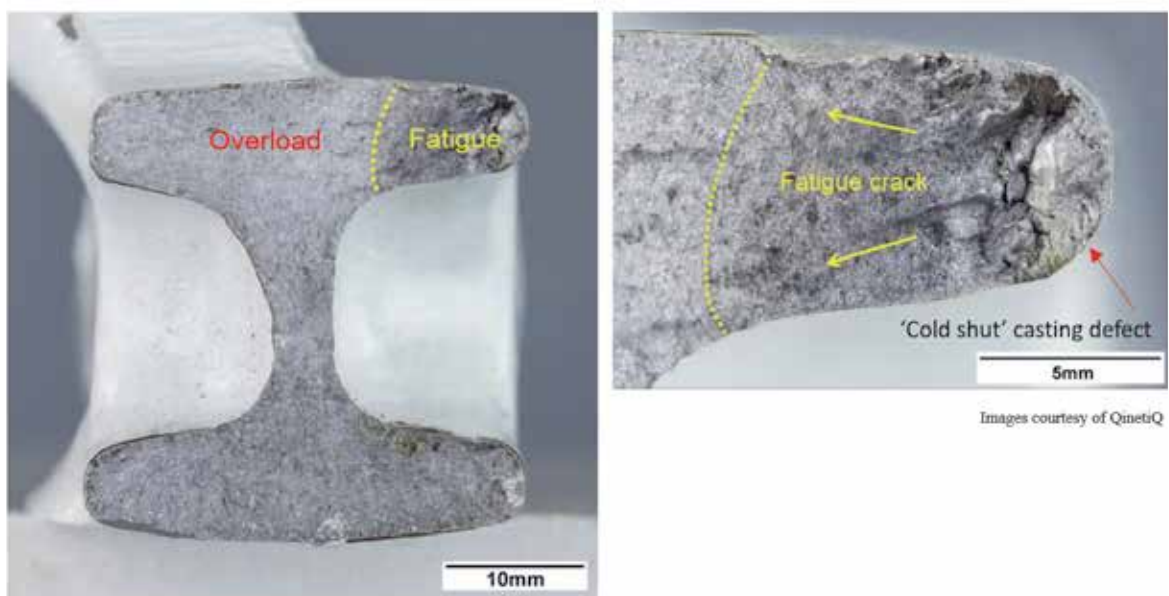
Ink markings on the surface of the casting, beneath the external paint layer, indicated that it had been manufactured in October 1977. The metallurgical examination indicated that a fatigue crack had initiated at the location of a 'cold shut'¹ casting defect. The fatigue crack and casting defect extended to approximately 14% of the cross-sectional area of the side-brace section. The remainder of the fracture surface consisted of ductile overload and no crack arrest marks were observed. The metallurgical analysis also revealed the presence of additional internal and surface-breaking casting defects and sand particles within the casting, adjacent to the fracture surface.

Figure 3
Casting defect and fatigue crack region

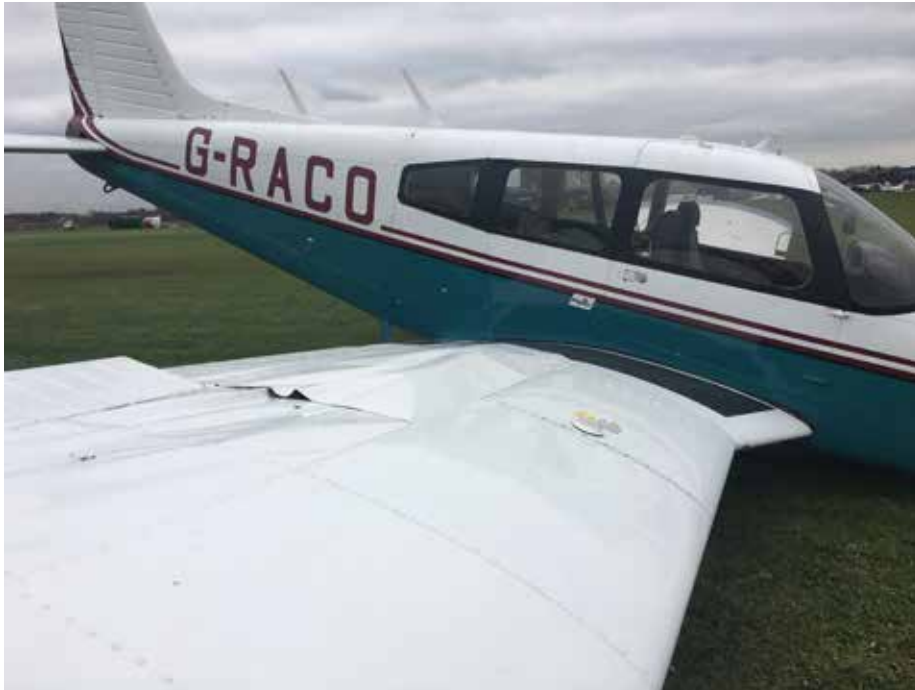
Figure 1

Deformation in wing around main undercarriage mounts

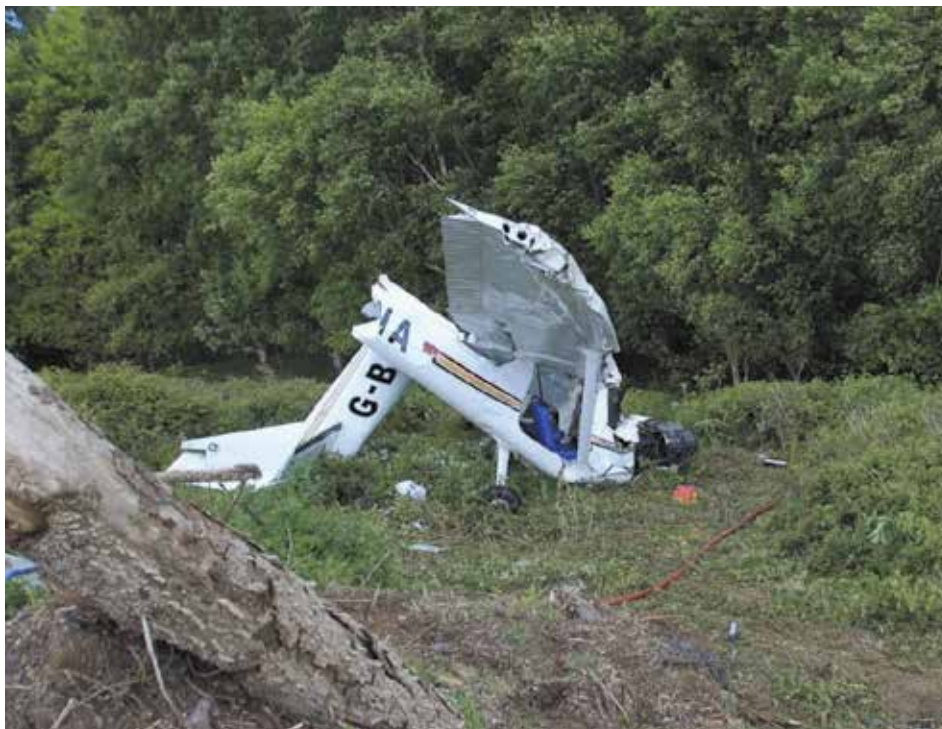
A loss adjustor attended the accident site (Figure 2). He reported that the aircraft appeared to have hit the ground vertically in a steep nose-down attitude. He checked the flight controls and did not find any defects. The left flap was down, the right flap was up, the flap selector was up but the flap indicator showed 30°. However, the flap lever could have easily moved in the impact sequence and the mismatch between the flap indicator and the right flap showed that the flap mechanism was disrupted and therefore this indication could not be relied upon as a valid pre-impact position. If the flaps had been asymmetric

as found it would have caused a right roll instead of the left roll that occurred. Therefore it is highly likely that the flap mechanism was damaged in the impact.

Figure 2
G-BHNA accident site

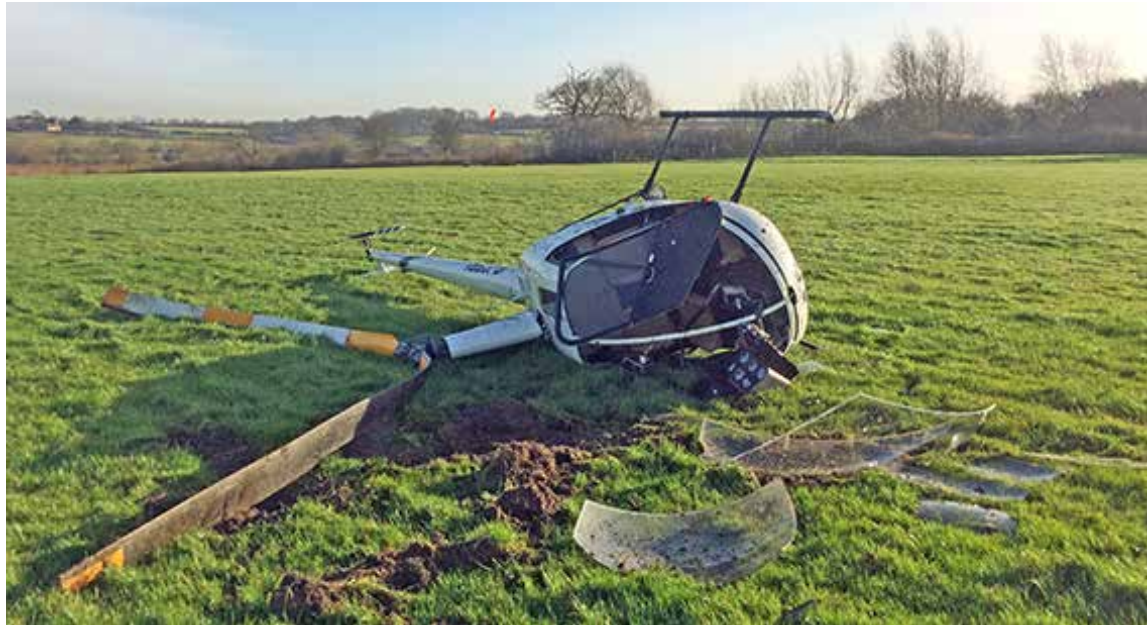
Figure 1

G-CTRL after the accident with the front transparencies broken and the left door open

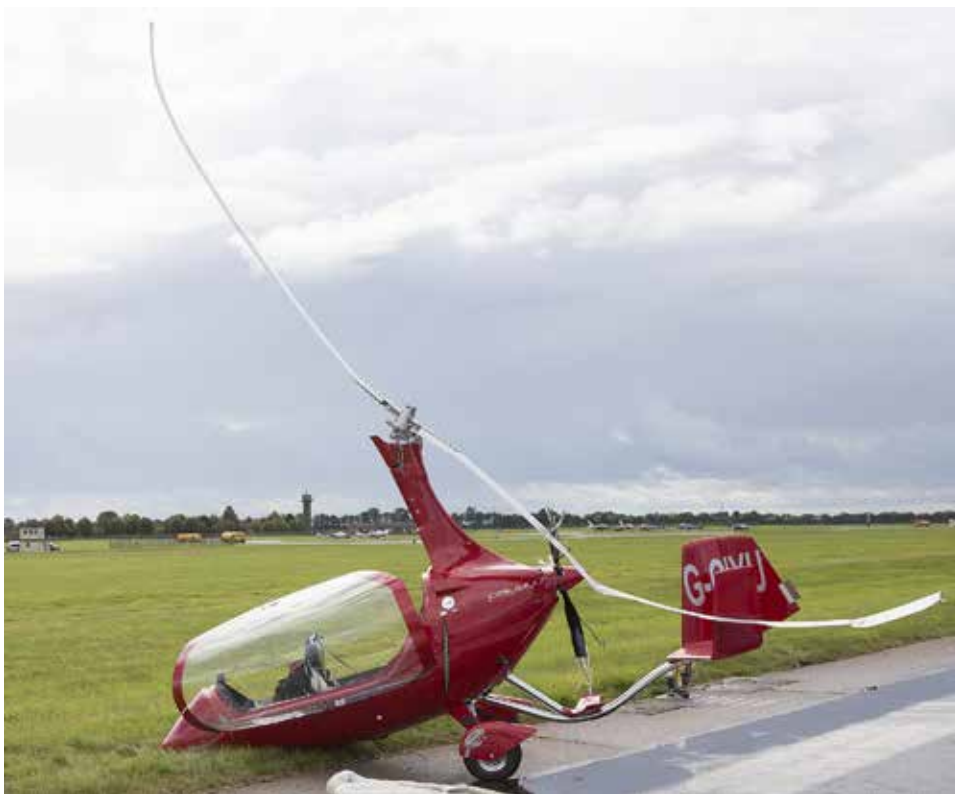
Figure 1

G-CIYU after righting and with the canopy open
(Photograph MoD/Crown Copyright)
