Rail Accident Investigation Branch

Rail Accident Report

Explosion inside an underframe equipment case at Guildford 7 July 2017

Report 05/2018
March 2018

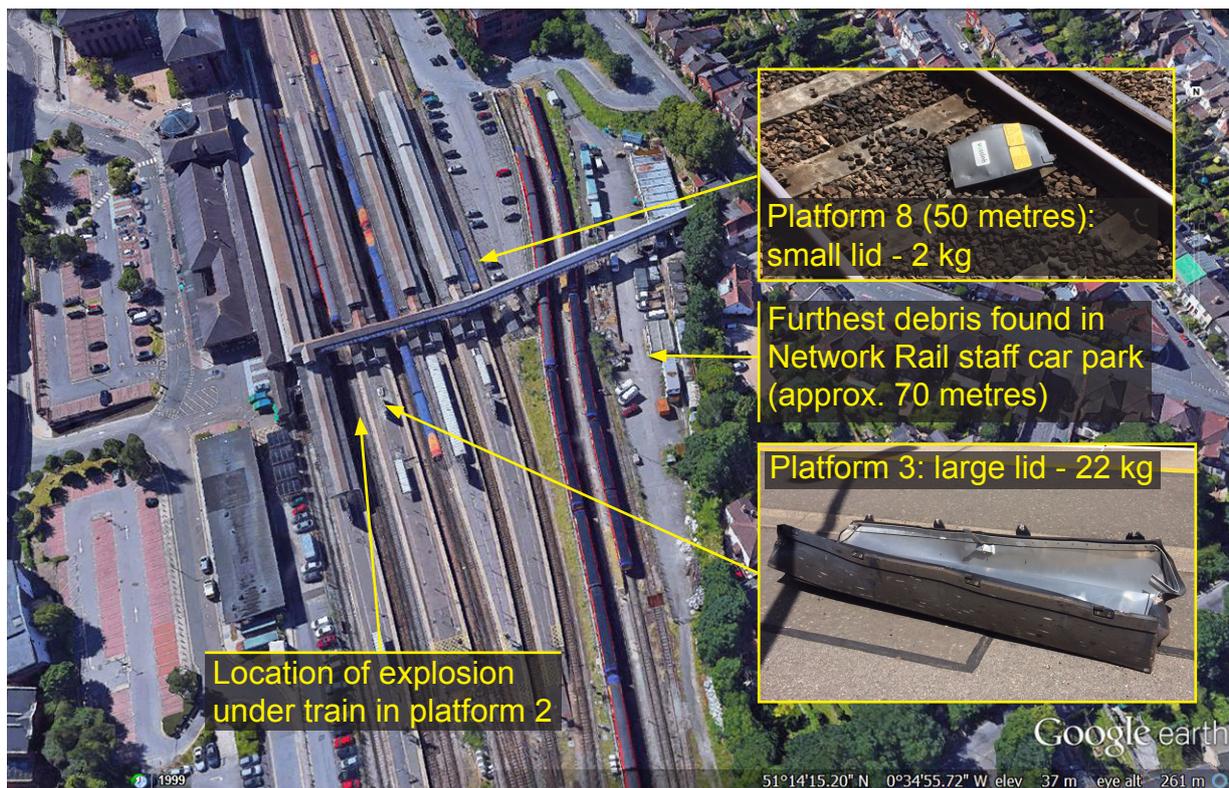
Figure 3: Locations of debris found after the explosion

- 27 A large piece of debris, weighing 22 kg, was found on the neighbouring platform 3 (figure 3), where damage had been caused by the debris to a station seat. Smaller pieces of debris were found adjacent to platform 8 (approximately 50 metres away) and in a Network Rail staff car park (70 metres away).

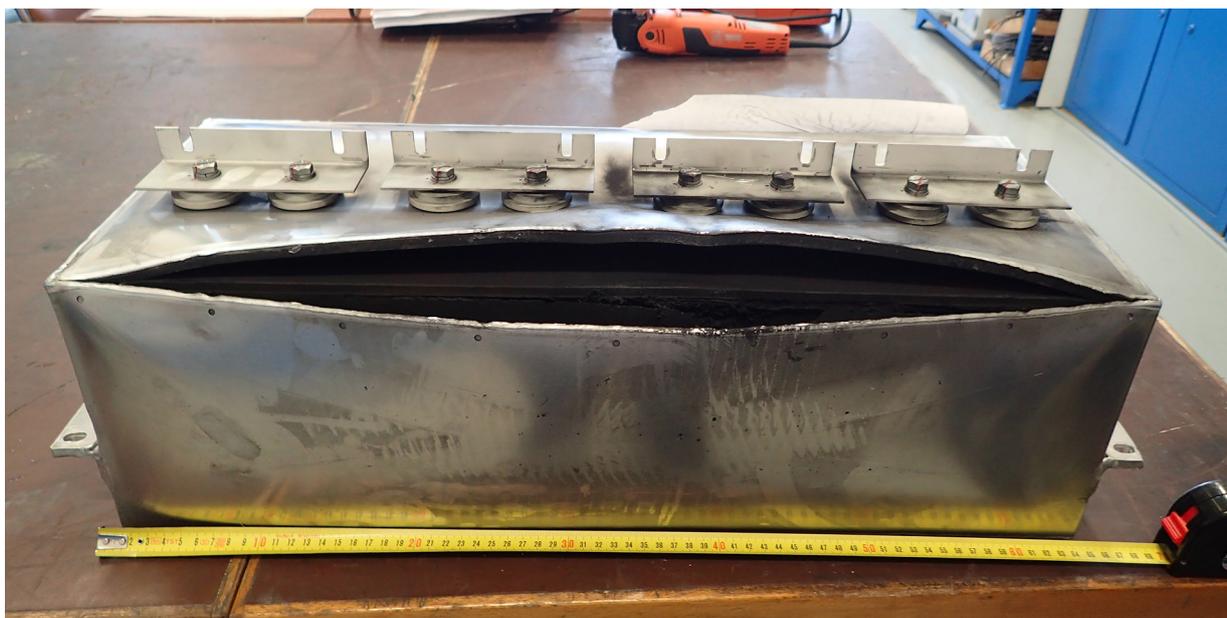
Figure 8: The damaged capacitor removed from coach 62826 prior to examination at Electronicon's facilities in Germany

- 60 The capacitor involved in the accident at Guildford was dismantled and examined at Electronicon's factory in Germany, witnessed by Kiepe and RAIB. The examination (figures 8 and 9) showed that a short winding had failed in a manner which was similar to the failures covered by Electronicon's November 2016 report.

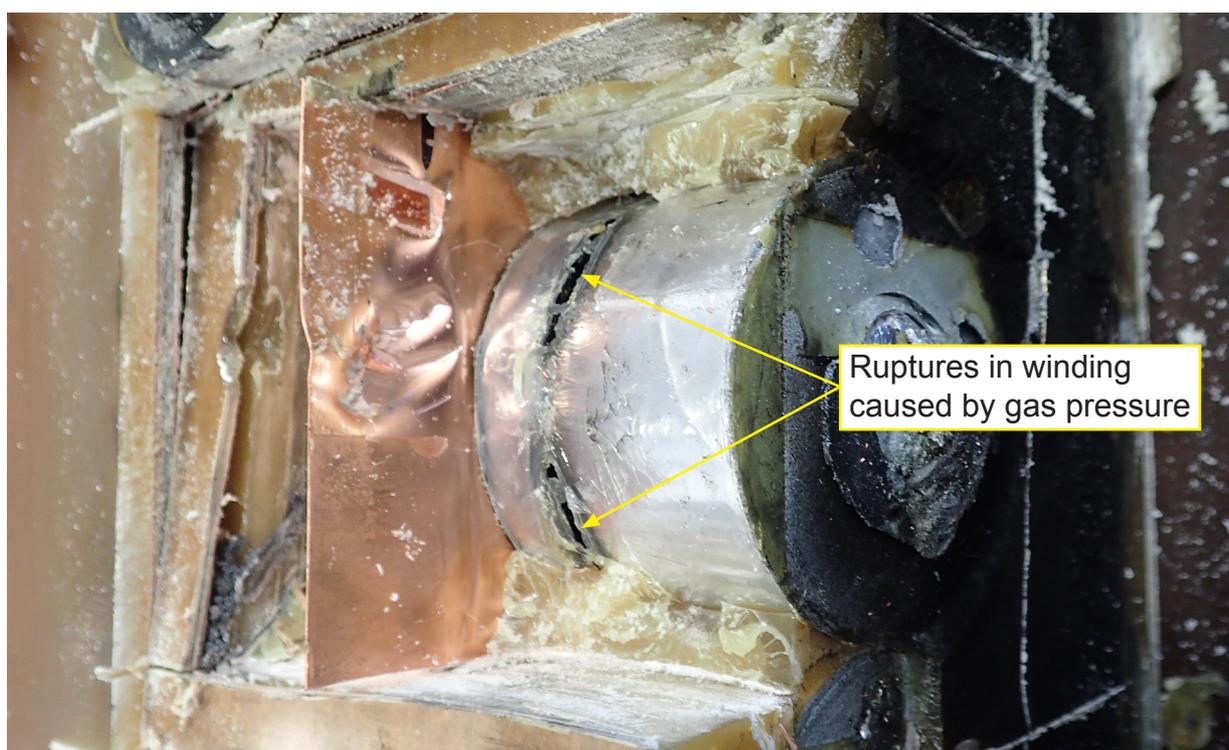
- 59 Electronicon's investigation concluded that the most probable cause of the failures was that an operator of a winding machine had carried out an unauthorised change to the parameters used by the machine to control the feed speed of the metallised polypropylene film, as it was being wound. This change led to damage and irregularities within the winding which in turn led to failures of the capacitor's self-healing capability (paragraph 52).

Figure 9: The failed short winding, with resin cut away to expose the ruptures at the point of gas escape indicated

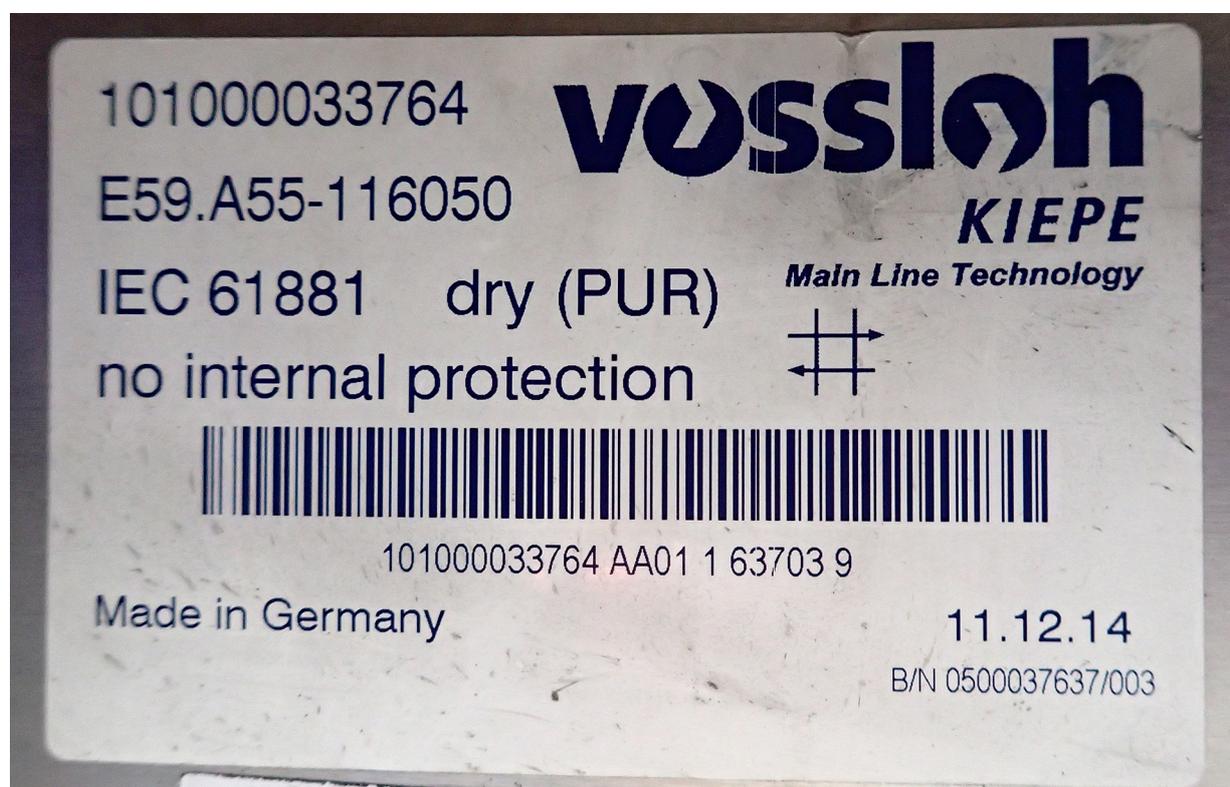
- 89 Electronicon has confirmed to the RAIB that the capacitors it supplies conform to EN 61881-1 (paragraph 62) and are classified as unprotected capacitors⁸. The unprotected status of the capacitors is also stated by the application documentation for the capacitors, and by identification labels on the capacitors (figure 10).

Figure 10: Identification label applied to a capacitor, showing manufacture against EN 61881-1 and confirming that the capacitor has no internal protection

- 90 EN 61881-1, section 9.14 states: ‘For power electronics capacitors, the user has to ensure by qualified installation that no danger appears due to a failing capacitor. The requirement applies in particular to unprotected capacitors.’
