**Fatal man overboard from the potter  
*Enterprise* (SH323)  
6 miles off Scarborough  
6 November 2017**

## SUMMARY

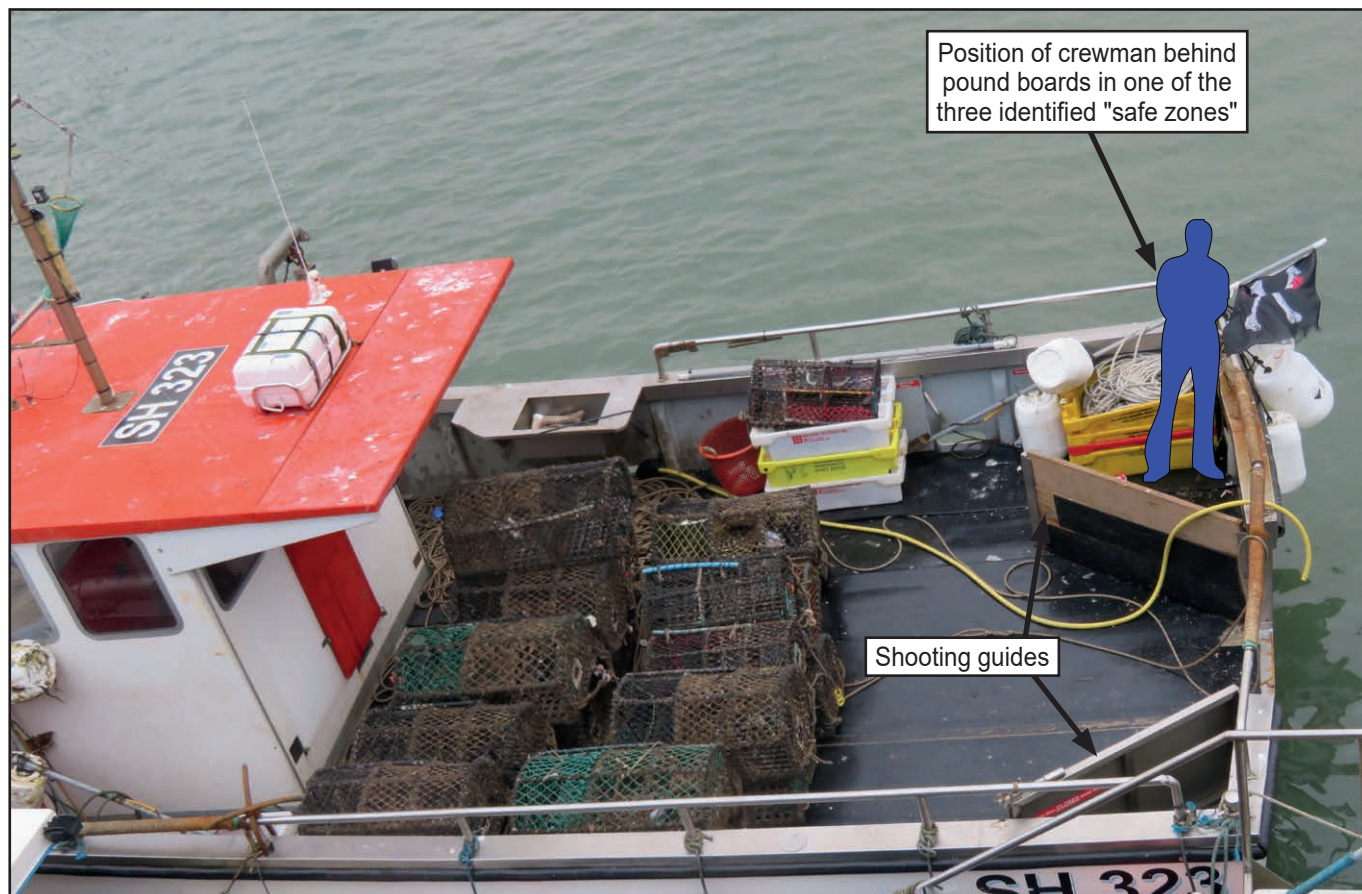
**Figure 2:** Aft deck (from port side)

The working deck was approximately 3m x 5m. When hauling, the fleet of pots was stacked up to two high at the deck's forward end (**Figure 4**). The pots were stacked in sequence, ready for shooting, and were biased towards the port side with most of the backrope flaked out on the deck on the starboard side in way of the bait tray. The anchor and marker float attached to the backrope's inner end were stowed on the port gunnel forward of the pots, and the anchor and marker float attached to its outer end were stowed on the starboard side of the aft transom (**Figures 2, 3 and 4**).

On occasions, Darren had walked forward prematurely and had crossed the backrope that remained on the starboard side of the deck by leaning on the stacked pots with his left hand and the bait tray with his right hand and then swinging his legs over. The owner/skipper and the other deckhand had cautioned Darren on these occasions and reminded him of the danger of entanglement.

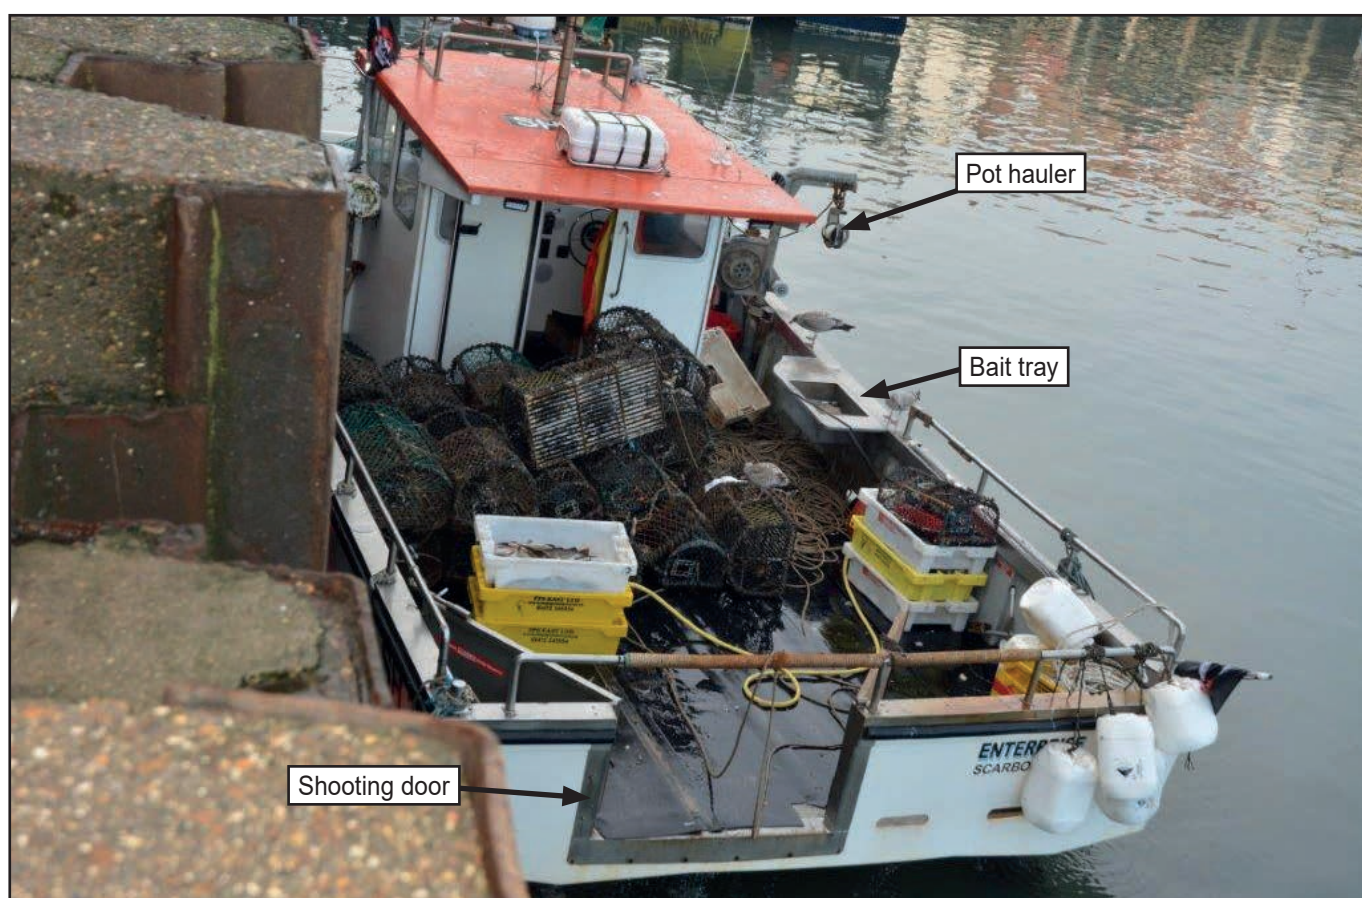
**Figure 3:** Aft deck (from aft)

*Enterprise's* skipper employed a self-shooting arrangement. To shoot away, the skipper set the engine speed to give a speed of about 3.5 knots and steered a steady heading. He then signalled Darren who dropped the aft anchor and marker buoy into the water. Darren then stood in the 'safe zone' between the pound boards and the starboard gunnel. As the anchor dropped to the seabed and then held, the resulting tension on the backrope as the vessel moved ahead pulled the pots through the shooting door in succession. By the time only five to six pots remained on deck, the starboard side of the deck was largely clear of the backrope and Darren moved forward to deploy the fleet's remaining anchor and marker buoy.

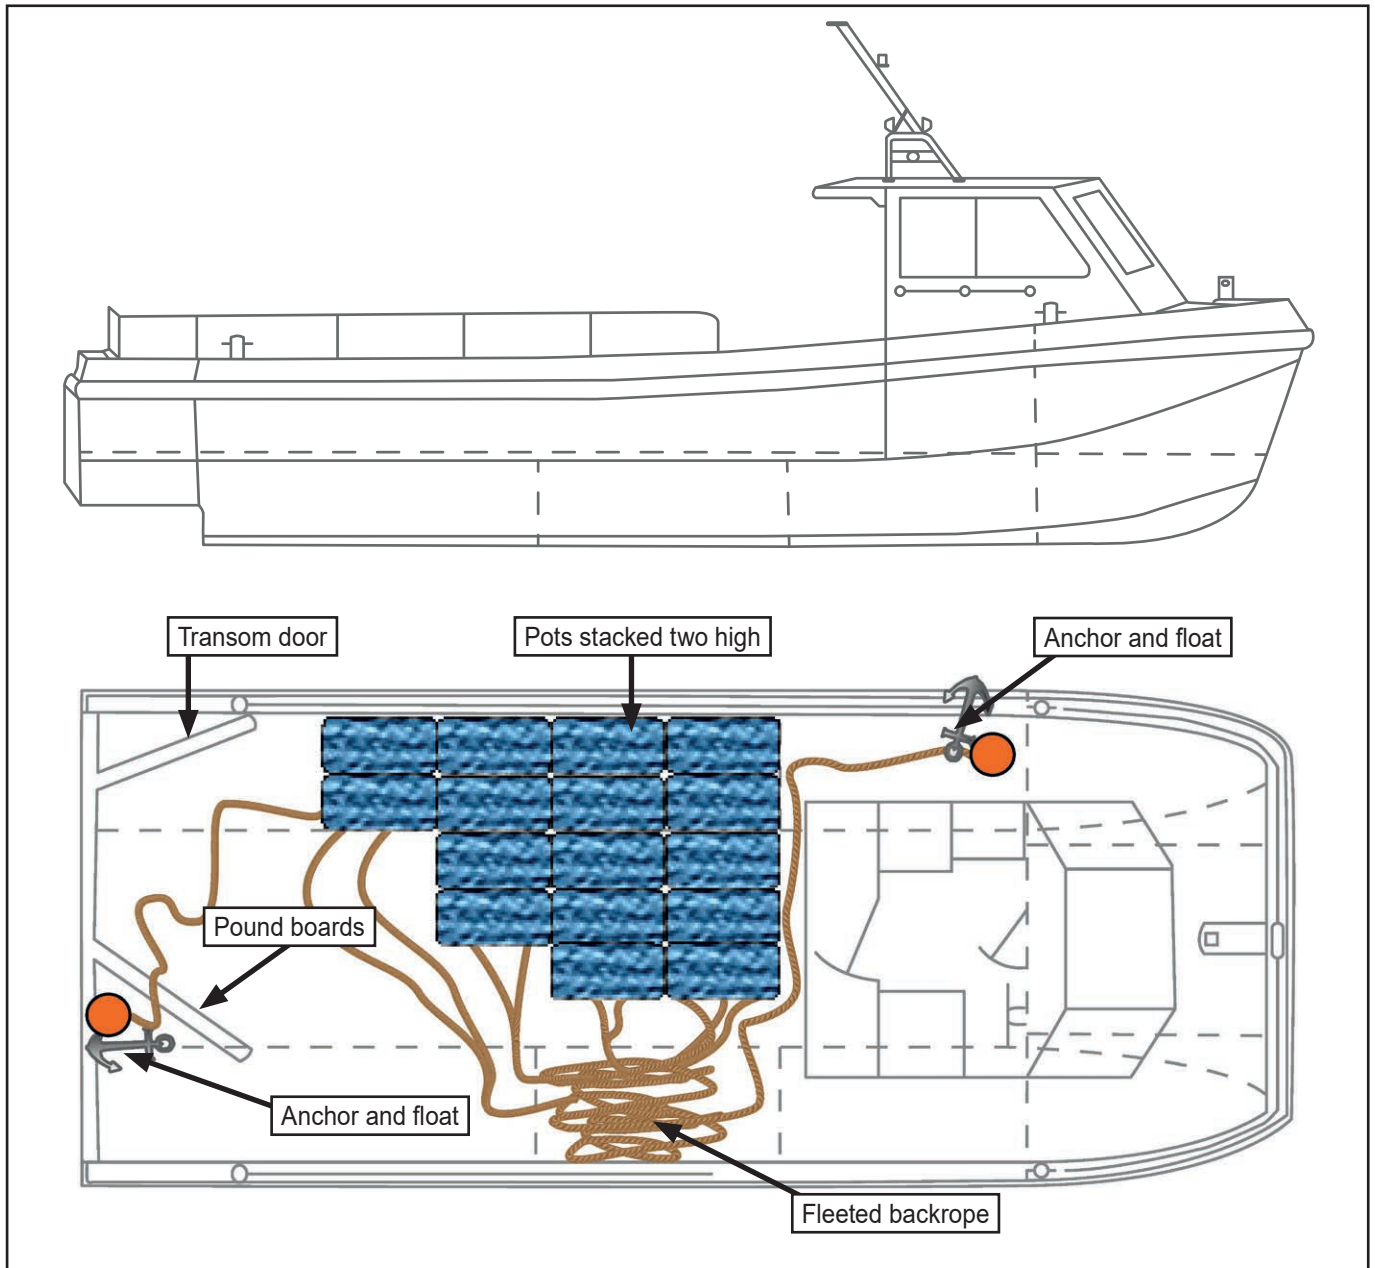
**Figure 4:** Schematic layout and deck plan

Darren became snared in a bight of the backrope as he walked from behind the pound boards towards the wheelhouse. With *Enterprise* making good a speed of 3.5 knots, the backrope would have been paying out at a rate of 1.8m per second and therefore would have quickly tightened around Darren's leg. As the outboard end of the fleet was weighed down by its anchor and eight 20kg pots that had already been shot away, it is not surprising that he was unable to keep hold of the bait tray and prevent himself from being dragged towards the shooting door. The forces involved were too great. There was also no time for either Darren or the other deckhand to grab a knife and cut the backrope.

With two deckhands on board it would have been possible for the second deckhand to deploy the anchor and float at the outer end of the backrope once the final pot had left the deck, and this would have avoided the need for Darren to move out of the safe zone while the pots were deployed.

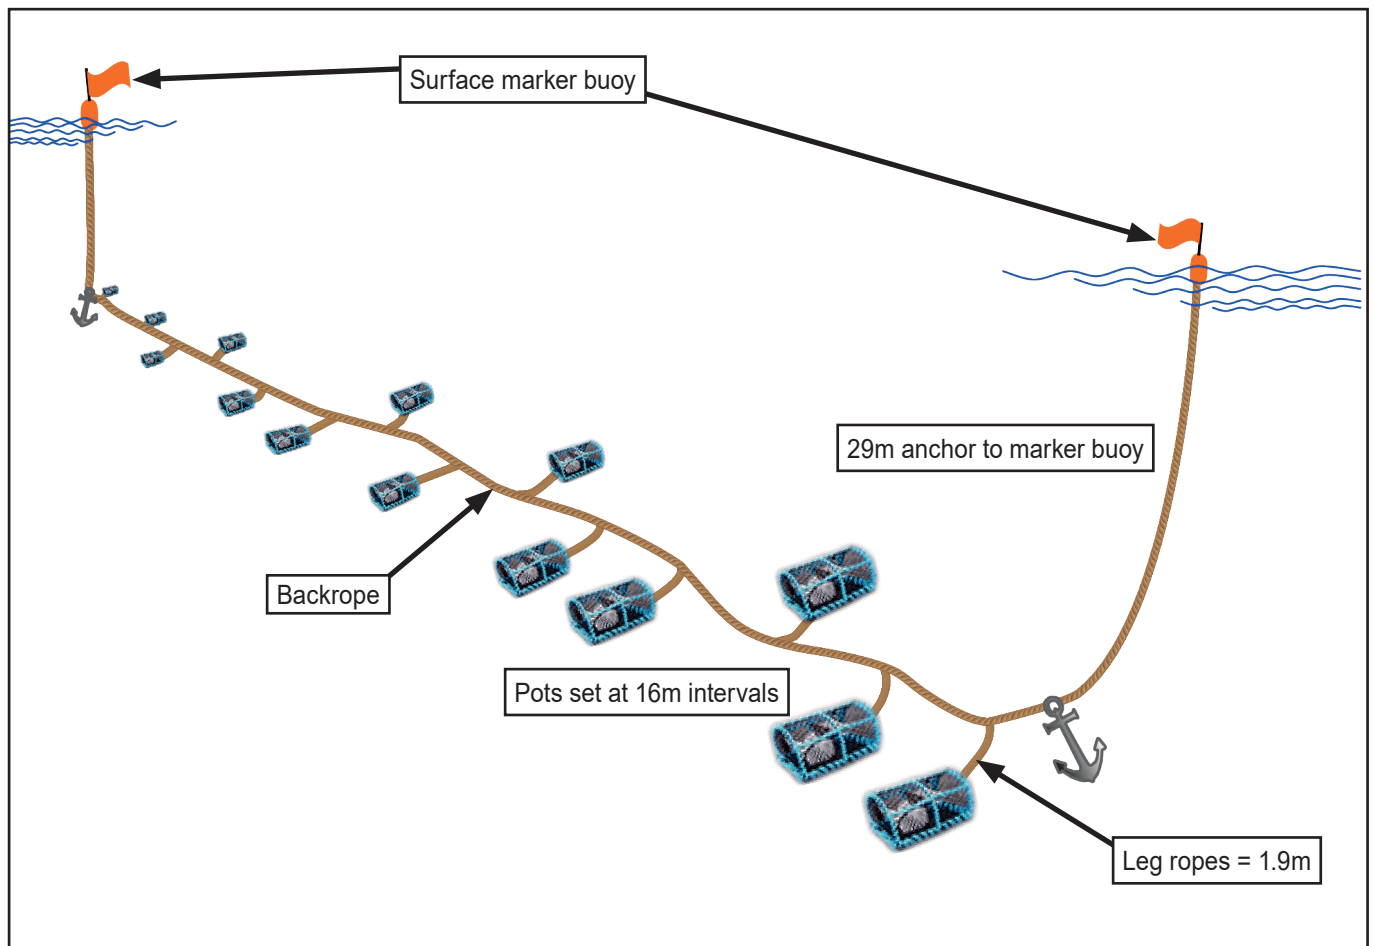
**Figure 5:** Arrangement of potting gear (only showing indicative 14 of the 30 pots)

*Enterprise's* owner/skipper worked 30 fleets of pots and operated the vessel daily, usually in the mornings and in daylight. Each fleet comprised 30 x 20kg pots, spaced at 16m intervals along a backrope. The leg ropes that attached the pots to the backrope were 1.9m in length. The backrope was approximately 620m long with a surface marker buoy attached at each end and an anchor attached 29m from each end (**Figure 5**).

As soon as Darren entered the water, he was quickly pulled under the surface and towards the seabed by the eighth pot, which would have still been sinking as the water depth was 26m, and by the weight of the four pots that followed him into the water. That Darren remained entangled, indicates that the bight of rope around his left leg remained under tension throughout, which would have prevented his escape. In addition, it is likely that Darren would have been debilitated to some degree by cold water shock, as the water temperature was only 7°C, and from hitting the pound boards near the shooting door, which possibly resulted in the abrasions and bruising to his scalp identified during postmortem examination.
