ACCIDENT

Aircraft Type and Registration:	Boeing 737-8AS, EI-EBW	
No & Type of Engines:	2 CFM International CFM56-7B/3 turbofan engines	
Year of Manufacture:	2009	
Date & Time (UTC):	14 January 2017 at 1645 hrs	
Location:	On descent to Manchester Airport	
Type of Flight:	Commercial Air Transport (Passenger)	
Persons on Board:	Crew - 6	Passengers - 89
Injuries:	Crew - 1 (Serious)	Passengers - None
Nature of Damage:	None reported	
Commander's Licence:	Airline Transport Pilot's Licence	
Commander's Age:	31 years	
Commander's Flying Experience:	4,977 hours (of which 4,833 were on type) Last 90 days - 156 hours Last 28 days - 29 hours	
Information Source:	AAIB Field Investigation

Synopsis

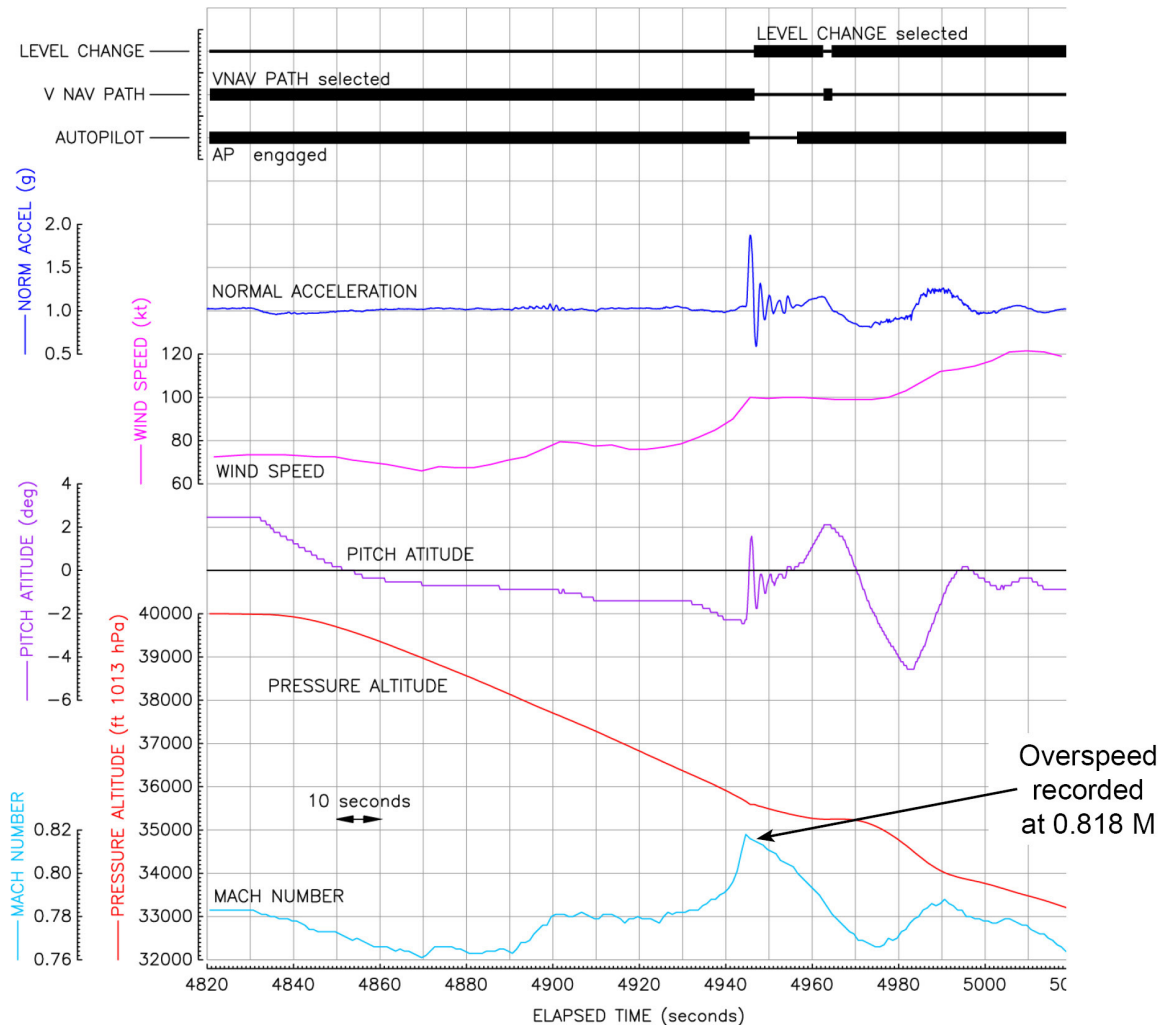
Figure 2
Recorded information

The following parameters were recorded.

There were marked changes in normal acceleration⁹ on the aircraft over a short period.

Further analysis of the data by the manufacturer showed that in the one second during which the autopilot became disengaged the force exerted on the control column by the commander changed from -0.51 lbs to +42.76 lbs.
