ACCIDENT

Aircraft Type and Registration:	Piper PA-28R-201 Cherokee Arrow III, G-CEOF	
No & Type of Engines:	1 Lycoming IO-360-C1C6 piston engine	
Year of Manufacture:	1988 (Serial no: 2837008)	
Date & Time (UTC):	25 May 2017 at 1050 hrs	
Location:	Two miles north-east of Skipness, Kintyre peninsula	
Type of Flight:	Private	
Persons on Board:	Crew - 1	Passengers - 1
Injuries:	Crew - 1 (Fatal)	Passengers - 1 (Fatal)
Nature of Damage:	Aircraft destroyed	
Commander's Licence:	Private Pilot's Licence	
Commander's Age:	62	
Commander's Flying Experience:	Approximately 219 hours (of which 38 were on type) Last 90 days - 8 hours Last 28 days - 5 hours	
Information Source:	AAIB Field Investigation

Synopsis

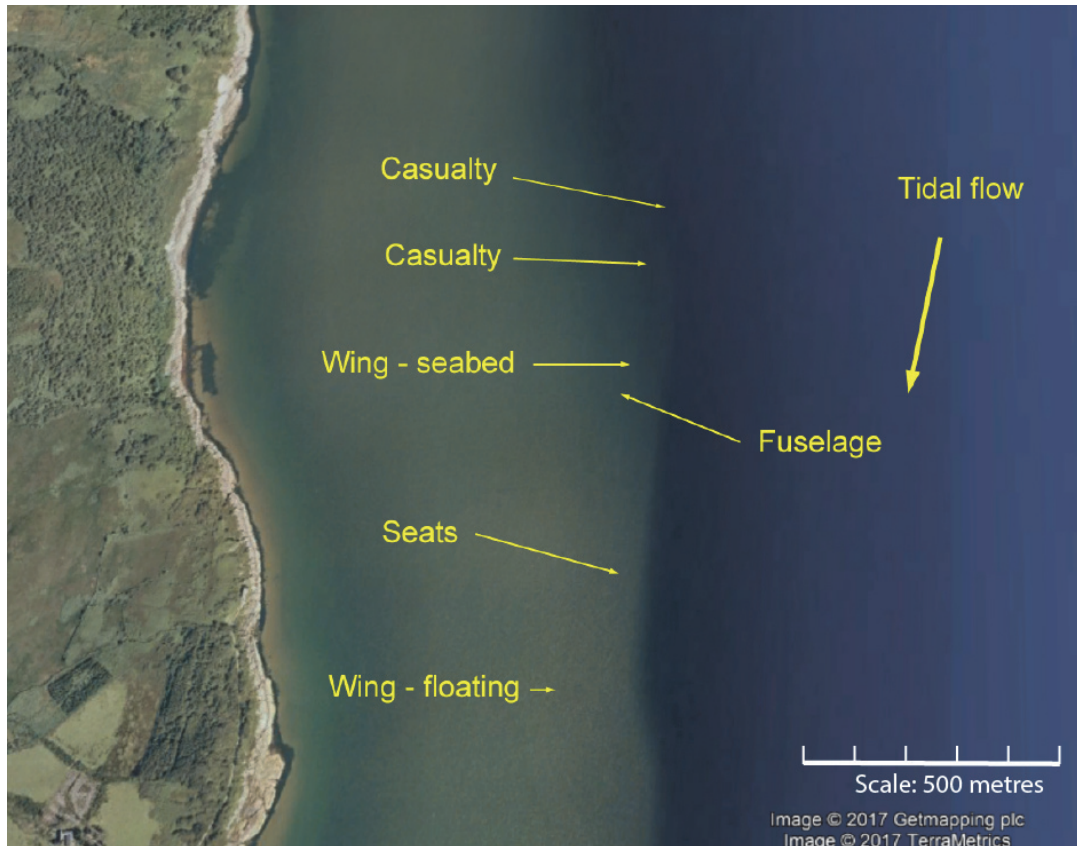
Figure 1

The locations of the casualties and wreckage extended over an area 800 m long and are plotted in Figure 1. It is possible that in the 12 days between the accident occurring and the underwater search beginning, some items of wreckage might have moved as a result of the extensive bottom trawling that is carried out in this area.

At the time of the accident, the wind was calm and the predicted tidal flow was 0.2 kt to the south; therefore, the floating section of wing could not have been the same section of wing found on the seabed. Given the tidal flow, it is likely that the floating wreckage may have settled in an area south of the accident site where submerged cables between Skipness Point and Arran are routed along the seabed; an underwater search could not be conducted in this area. The wreckage might also have remained afloat for some considerable time and moved further down the Firth of Clyde.

Reported position of casualties and wreckage

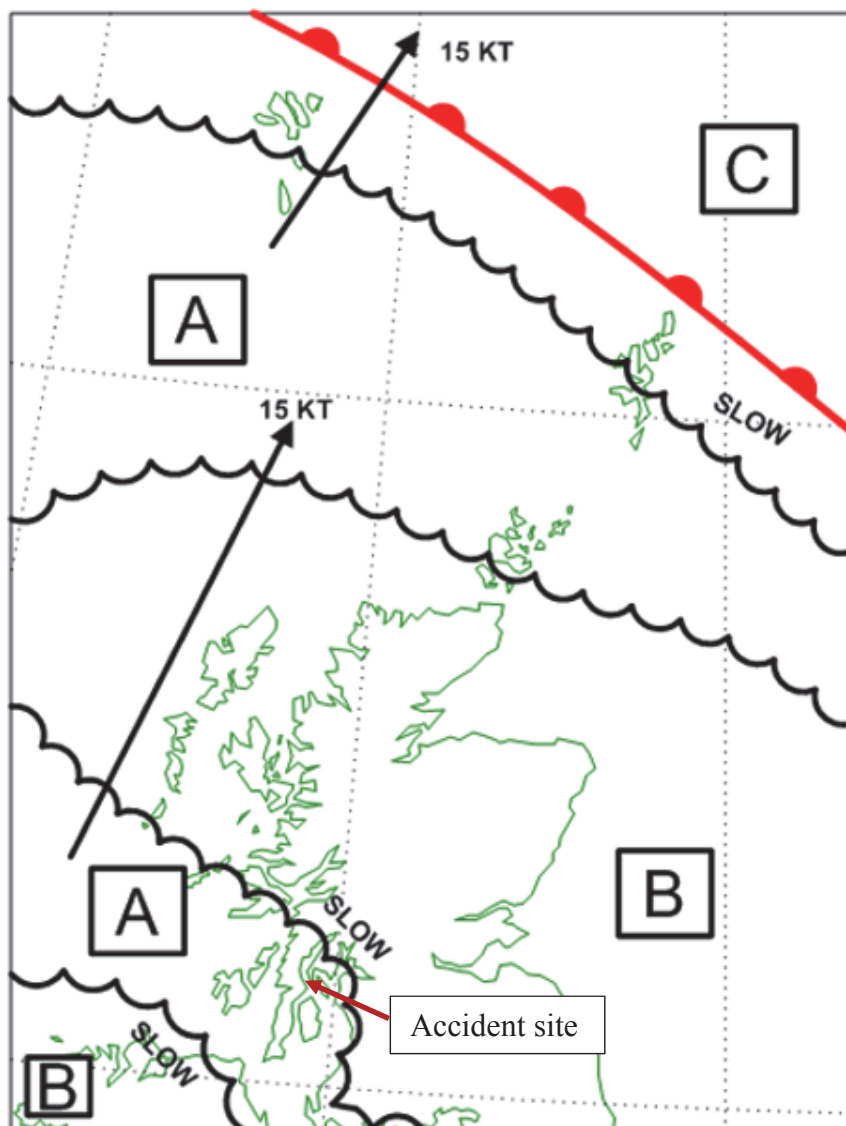
The Met Office forecast (below 10,000 ft), which was valid from 0800 hrs until 1700 hrs on 25 May 2017, reported extensive areas of poor visibility extending from the Irish Sea into Loch Fyne. The wind at 1,000 ft in the area of Skipness was forecast to be from the south at approximately 12 kt. The synopsis map is at Figure 2 and the accident occurred in Zone A. The Met Office text relating to Zone A reported:

Widespread 3000 M in mist and occasional 200 M in fog, along with widespread hill fog. Isolated moderate turbulence was forecast near the fog until 1100 UTC. Cloud structure (all heights AMSL) was expected to be widespread stratus with bases 200-600 FT with tops 1500 FT, bases on the surface were allowed for in fog. Above this stratus, isolated areas of broken stratocumulus were expected in the far N.'

Met Office forecast, below 10,000ft, valid from 0800 hrs until 1700 hrs on 25 May 2017

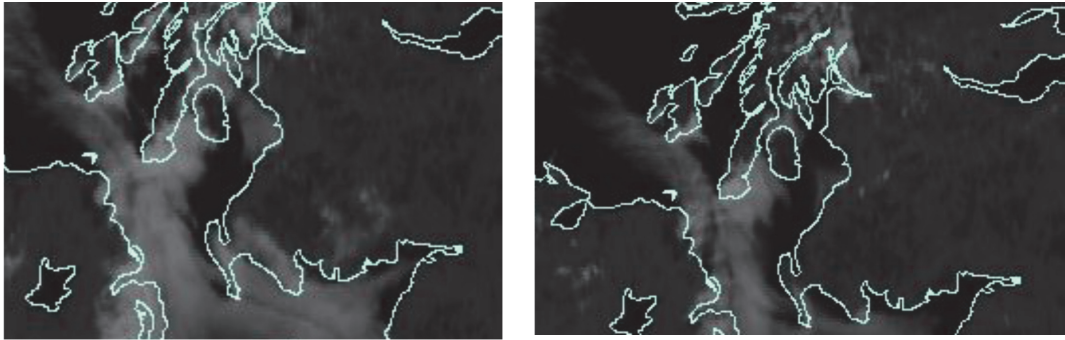
Figure 3

The Met Office high resolution visible satellite images taken at 1000 hrs and 1100 hrs on 25 May 2017 show areas of stratus or fog extending into Loch Fyne, with clear areas to the lee of high ground (Figure 3).

High resolution satellite image for 1000 hrs and 1100 hrs on 25 May 2017

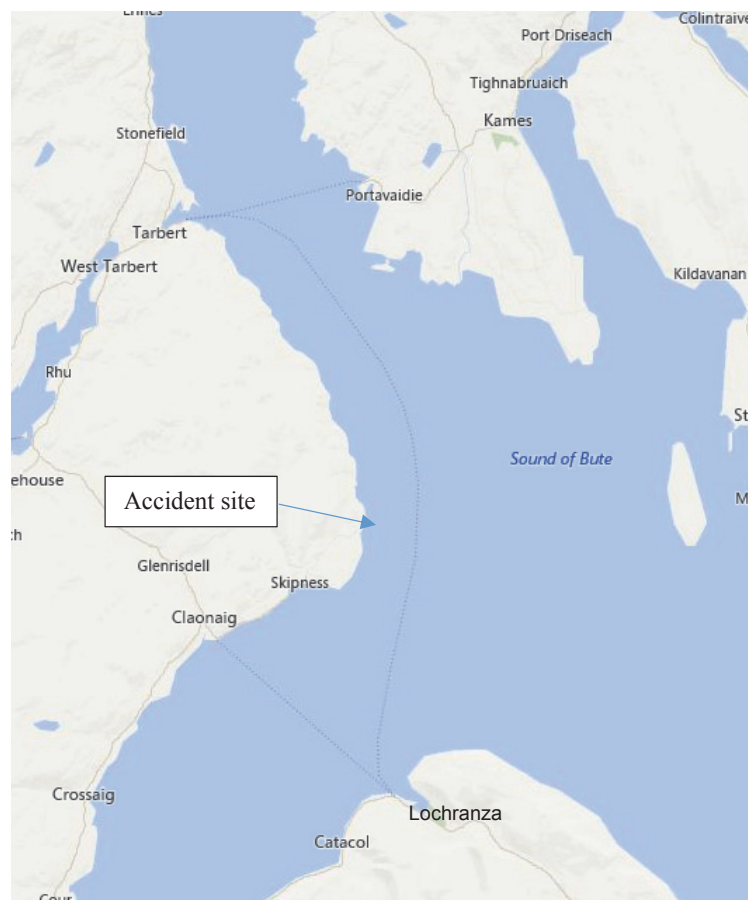
**Figure 4**

Two ferries operating in the vicinity of the accident site suspended services due to poor visibility. The MV Isle of Cumbrae operated a service across Loch Fyne between Tarbert and Portavaidie. The MV Catriona operated between Lochranza on the north of the Isle of Arran and Claonaig on the Kyle peninsula (Figure 4).

Routes of ferry services

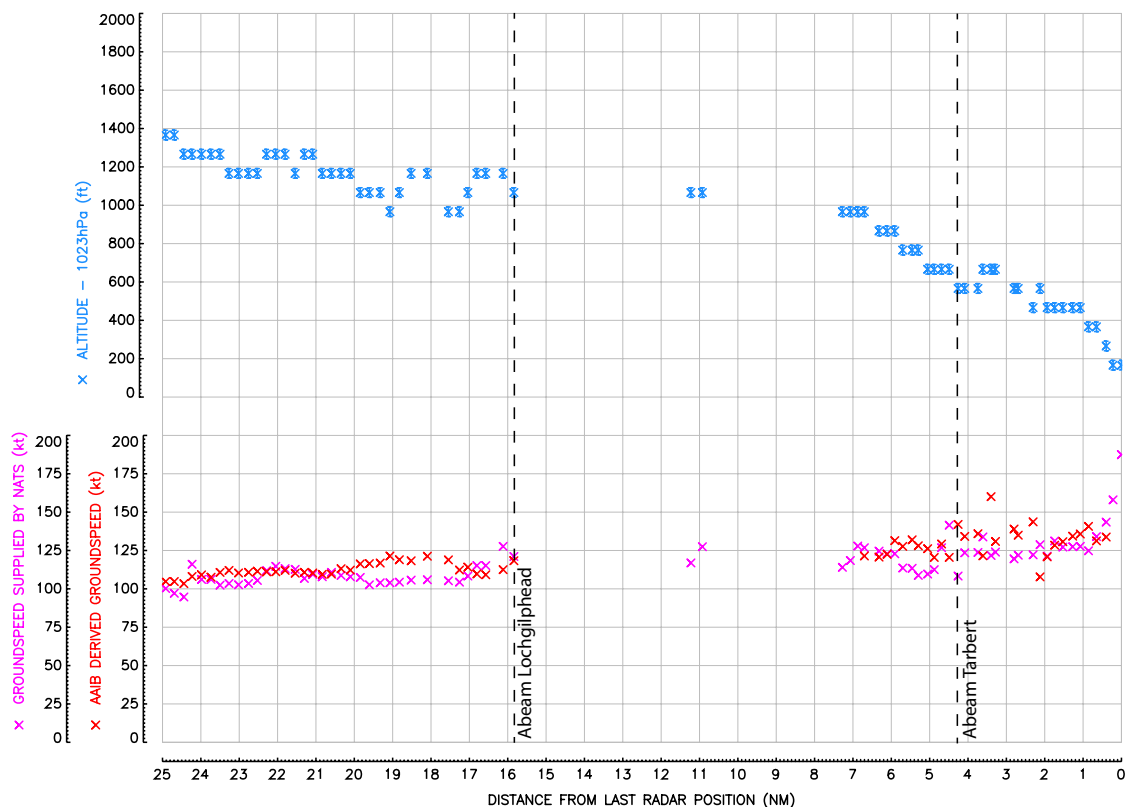
On 25 May 2017, G-CEOF initially followed the planned route from Oban to the island of Luing, but then deviated inland flying along the Crinan Canal towards Lochgilphead, before heading south down Loch Fyne towards the Isle of Arran. The radar data showed that G-CEOF was abeam Lochgilphead at 1042:41 hrs at a height of 1,050 ft and then flew for a further 15 nm down Loch Fyne with the last radar return occurring 7 minutes 43 seconds later when it was at a height of 150 ft. During the first 10.1 nm from Lochgilphead, the aircraft descended approximately 300 ft until it was at a height of 750 ft abeam Tarbert. During the next 4.9 nm, there was an increase in the rate of descent which was estimated to be approximately 500 ft/min towards the end of the flight.

From the radar data, the AAIB was able to derive the aircraft's approximate groundspeed using a moving average calculation, which has been plotted, along with the altitude, at Figure 5 against the distance from the last radar return. There is a gap in the radar data as the aircraft passed Lochgilphead and before it was picked up by the second radar head.

Aircraft altitude and derived airspeed plotted against the distance from the last radar return

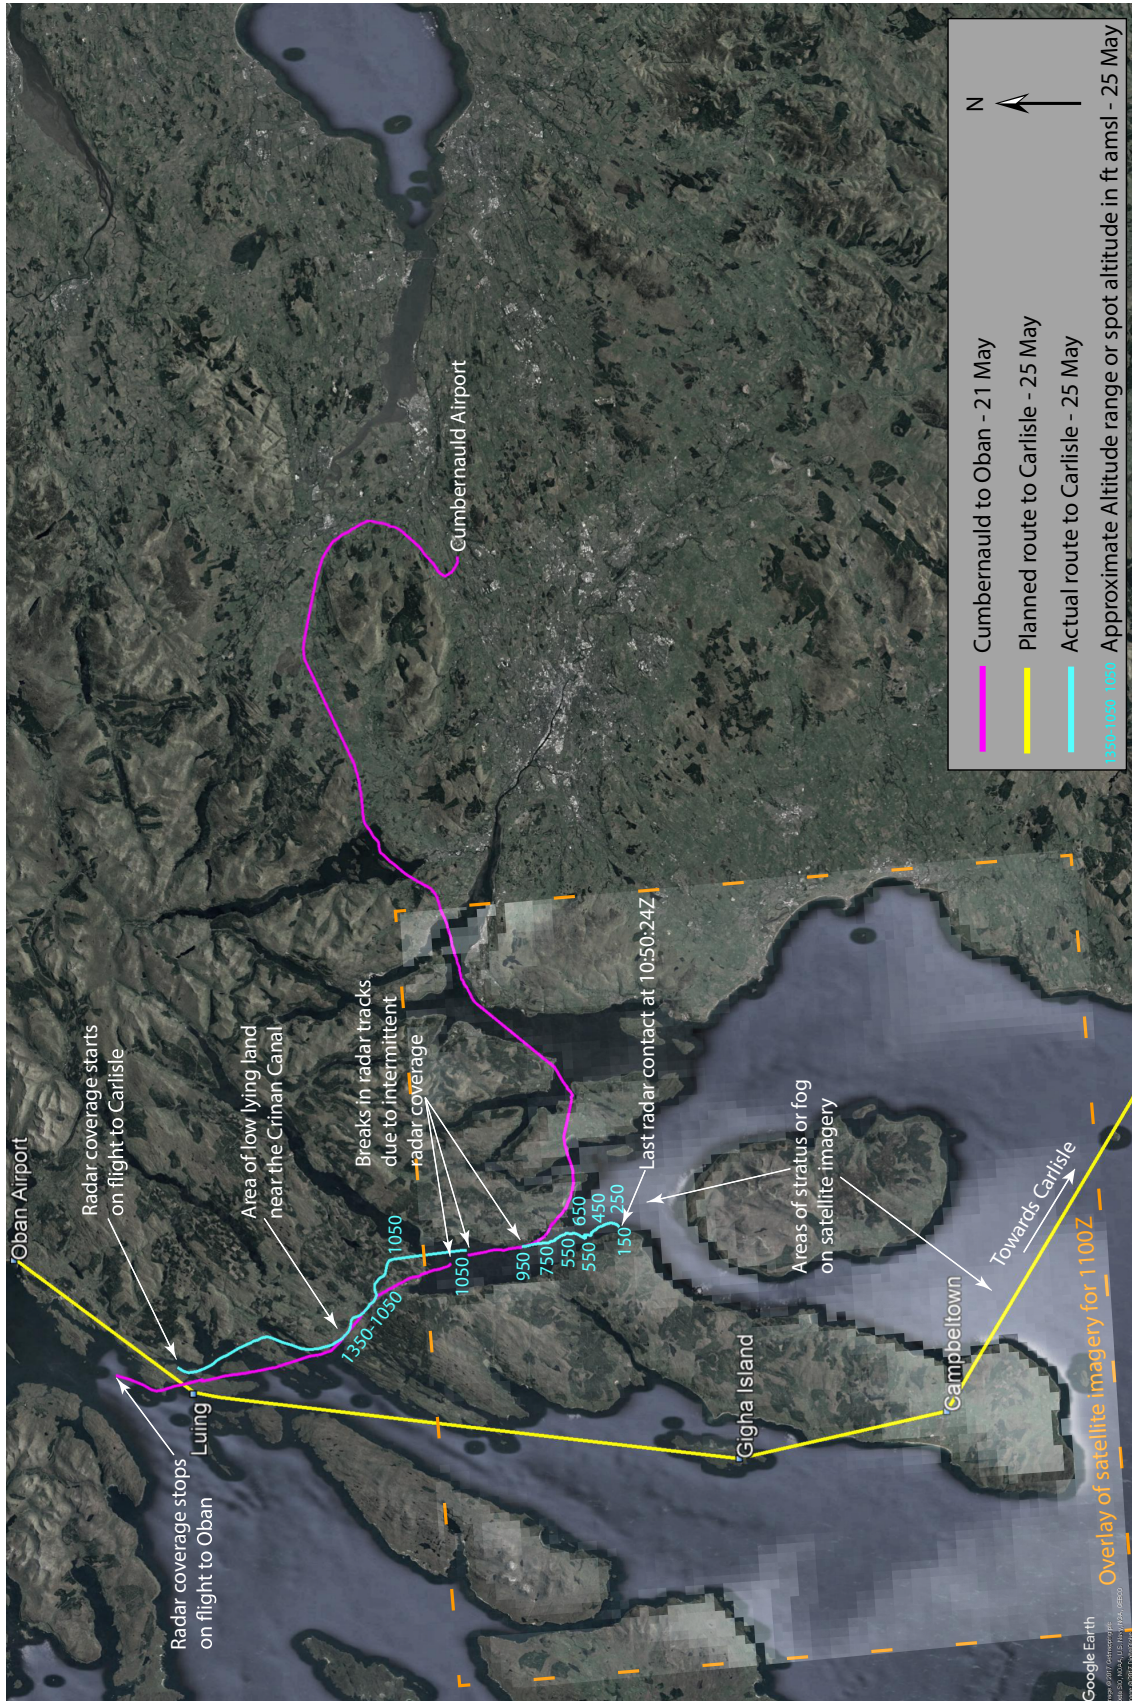
Plotted at Figure 6 are the radar tracks for the flights from Cumbernauld Airport to Oban on 21 May 2017, the accident flight, and the planned route to Carlisle stored on the company’s servers. The tracks are overlaid with the Met Office satellite imagery taken at 1100 hrs on 25 May 2017.

Radar track data and Met Office satellite imagery for 1100 hrs

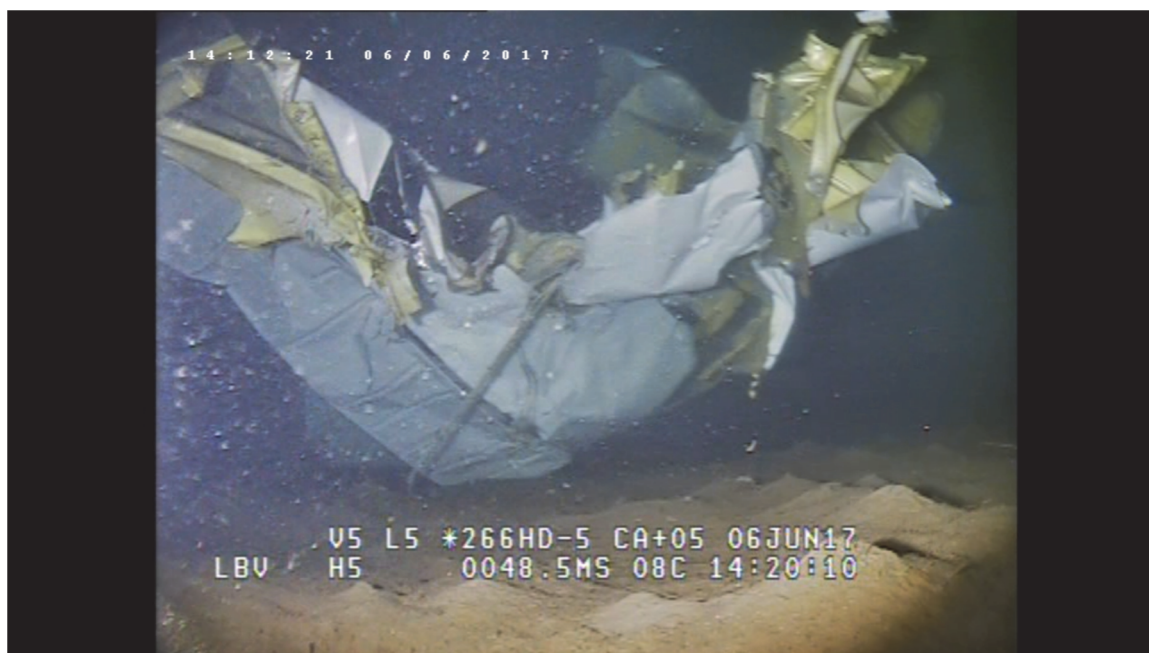
Figure 7

The witness descriptions of the floating sections of the aircraft, the AAIB examination of the aircraft seats, and the condition of the left wing found on the seabed (Figure 7) all indicate that the aircraft broke up when it struck the water.

Left wing on seabed

The wreckage of the aircraft was found close to the last radar contact. While the aircraft was not recovered, the floating wreckage and the condition of the left wing found on the seabed indicate that the aircraft did not undertake a controlled ditching, but broke up when it struck the sea. The post-mortem examination revealed that the pilot and passenger both sustained fatal injuries during the impact, which was not survivable.
