ACCIDENT

Aircraft Type and Registration:	Silence Twister, G-JINX
No & Type of Engines:	1 Ulpower UL260iSA piston engine
Year of Manufacture:	2013 (Serial no: LAA 329-15102)
Date & Time (UTC):	14 May 2017 at 1330 hrs
Location:	MOD Abingdon, Oxfordshire
Type of Flight:	Commercial operation
Persons on Board:	Crew - 1 Passengers - None
Injuries:	Crew - 1 (Serious) Passengers - N/A
Nature of Damage:	Aircraft and engine severely damaged
Commander's Licence:	Private Pilot's Licence
Commander's Age:	49 years
Commander's Flying Experience:	1,154 hours (of which 259 were on type) Last 90 days - 15 hours Last 28 days - 13 hours
Information Source:	AAIB Field Investigation

Synopsis

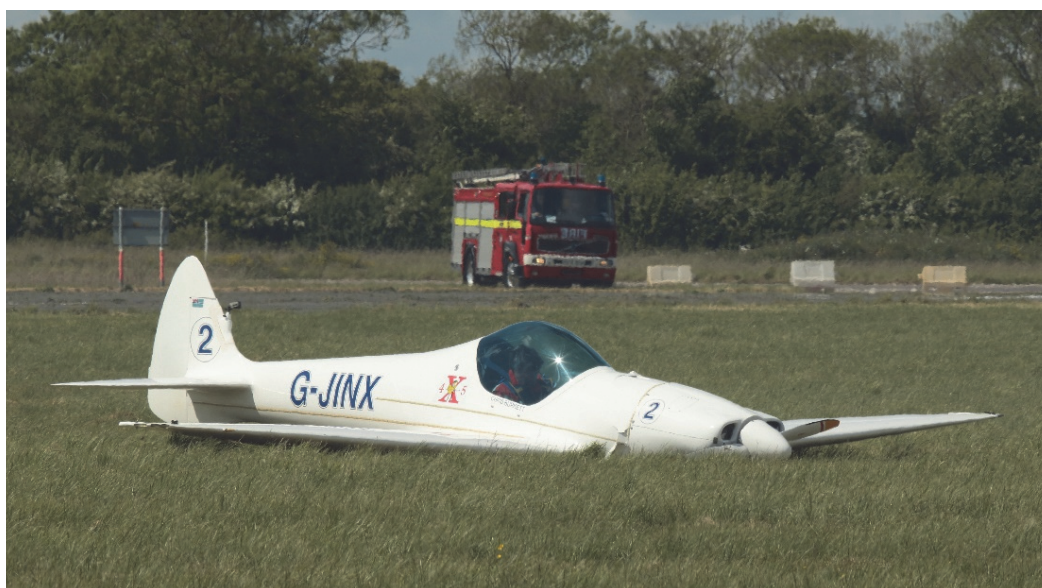
Figure 2

G-JINX after accident
(Picture courtesy of Peter Thomas)

The display controller declared an aircraft accident and sent all on-site rescue resources to the scene, the first arriving within 50 seconds of the aircraft coming to a halt. The pilot was found slumped forward in the cockpit unconscious. The RFFS could not find a way to open the canopy and, as the pilot’s head was very close to the canopy, did not want to break it. The pilot then regained consciousness and opened the canopy from the inside. He was subsequently lifted out of the aircraft and taken to hospital where it was discovered he had sustained serious injuries.

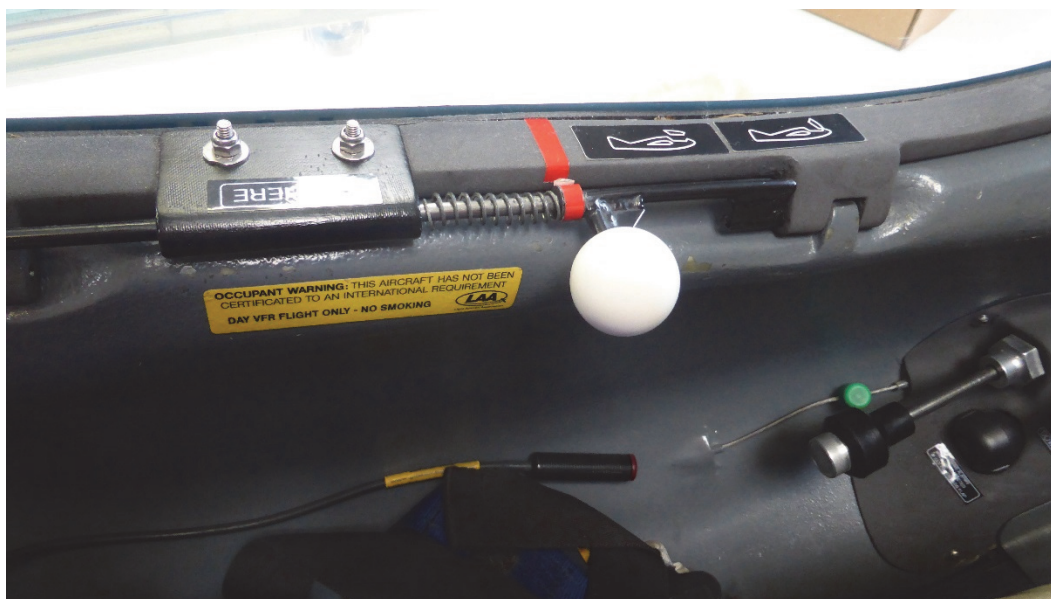
Figure 3
White canopy opening handle

The aircraft is equipped with a one-piece bubble canopy hinged along the right side. The canopy is unlatched by operating a white handle on the left side of the cockpit (Figure 3). To jettison the canopy, the white handle must be operated at the same time as a second black handle on the right side of the cockpit, which removes the pins from the canopy hinges (Figure 4).

The emergency services reported difficulty in gaining access to the unconscious pilot as they did not know how to open the canopy and were concerned that they would further injure him if they tried to break it.

Following the accident to G-JINX, the LAA amended its Technical Leaflet 2.11 'Aircraft Placards, Labels and Registration Marks' to include the following:

'When not otherwise obvious, the external and internal latches on cockpit doors and canopies should be clearly identified by labels or markings sufficiently prominent to be seen in an emergency. In the event of an accident, even a few seconds saved by first responders in rescuing the crew may be critical to a positive outcome, especially where there is the threat of fire. Each normal and emergency exit operating control should be red in colour. Suitable placards

should be near each control and should be designed to clearly indicate its method of operation, especially to a non-aviation person. Where any special procedure must be followed to gain entry, this should be described, for example 'to open canopy in an emergency, reach into cockpit through ventilator aperture and press red button. Canopy hinged on right hand side.'

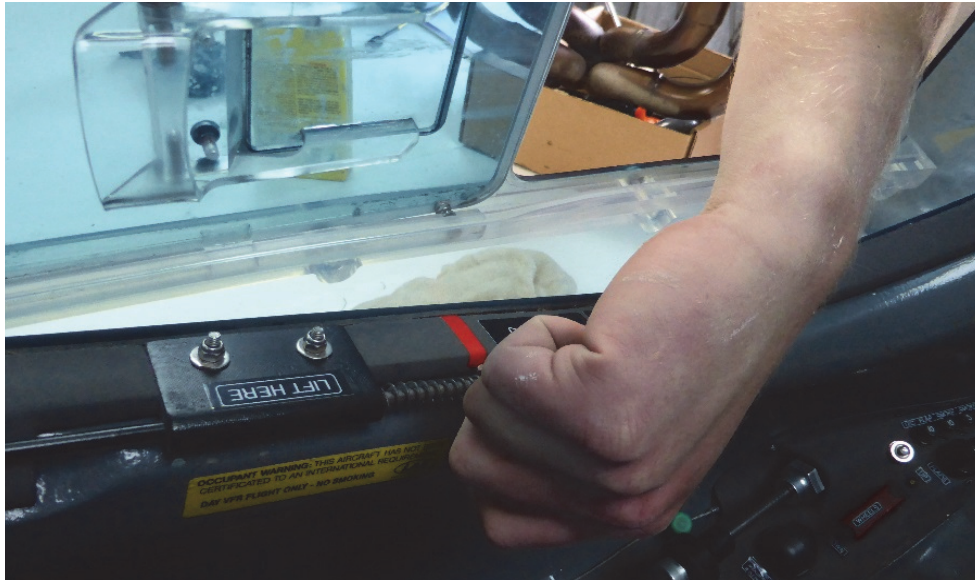
Figure 5

There are no canopy opening or jettison handles on the outside of the cockpit; however, it can be unlatched by reaching through the small ventilation window and operating the white handle (Figure 5). There were no instructions visible from outside the cockpit explaining how the canopy is opened.

Following the accident, the owner fixed labels to the outside of his other two Silence Twister aircraft explaining how the canopy is opened from the outside.

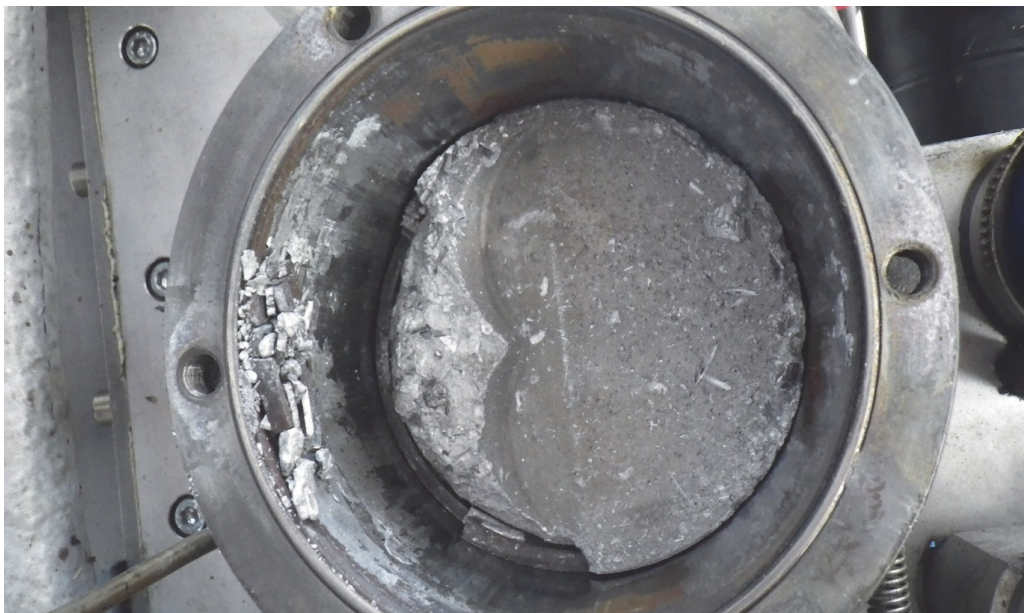
Figure 7

The engine could not be rotated by hand. Externally there was no obvious damage other than to the oil cooler and propeller. On removing the cylinder heads it was discovered that the No 3 piston had been badly damaged and a significant section had broken away (Figure 7). There was no evidence of detonation or cracking of the piston. The inside of the cylinder was dry, and marks on the side of the piston and inside of the cylinder bores indicated that the piston had seized in the cylinder. The piston rings and scraper had all been damaged. The remaining three cylinders were also dry and there was damage to the sides of all the pistons and cylinders indicating that the pistons had expanded and had started to 'grab' the side of the cylinder.

Damage to No 3 piston and cylinder

engine management control system and spark plugs had operated correctly. The connecting rod bearing shells showed signs of wear and slight damage. The piston pins and conrods all had a blue tint which is an indication of overheating. The cooling vanes adjacent to the cylinder head securing bolts were slightly distorted, which normally indicates that the cylinder has overheated.

In summary, the damage to the engine was consistent with a loss of lubrication, and cooling, which resulted in the pistons expanding and seizing in the cylinders.

There was no evidence of cracking on the damaged No 3 cylinder piston; the damage was assessed as consistent with the piston overheating and expanding in the cylinder. It is possible that the damage to this piston accumulated over several flights, with a sudden failure, sufficient to cause the loss of oil, occurring during the accident flight. However, given the level of damage to the piston and cylinder it was not possible to establish if this was the case.

The engine manufacturer advised the AAIB that it would introduce processes to monitor the condition of UL260iSA engines in regular aerobatic use, including:

- Installing additional temperature sensors in the cylinder walls.
- Regularly downloading and reviewing the data from the Dynon EMS-D10.
- The return of the engine to the manufacturer after a number of aerobatic displays for a full strip and examination.

The manufacturer stated that it intended to issue an amendment to the engine manuals recommending that:

- The engine oil level should be between 4 and 4.5 litres prior to the start of an aerobatic display.
- A Teflon based additive should be added to the oil.
- Maintenance activities such as removing cylinder heads and replacing cylinders should be carried out by technicians approved by the manufacturer.

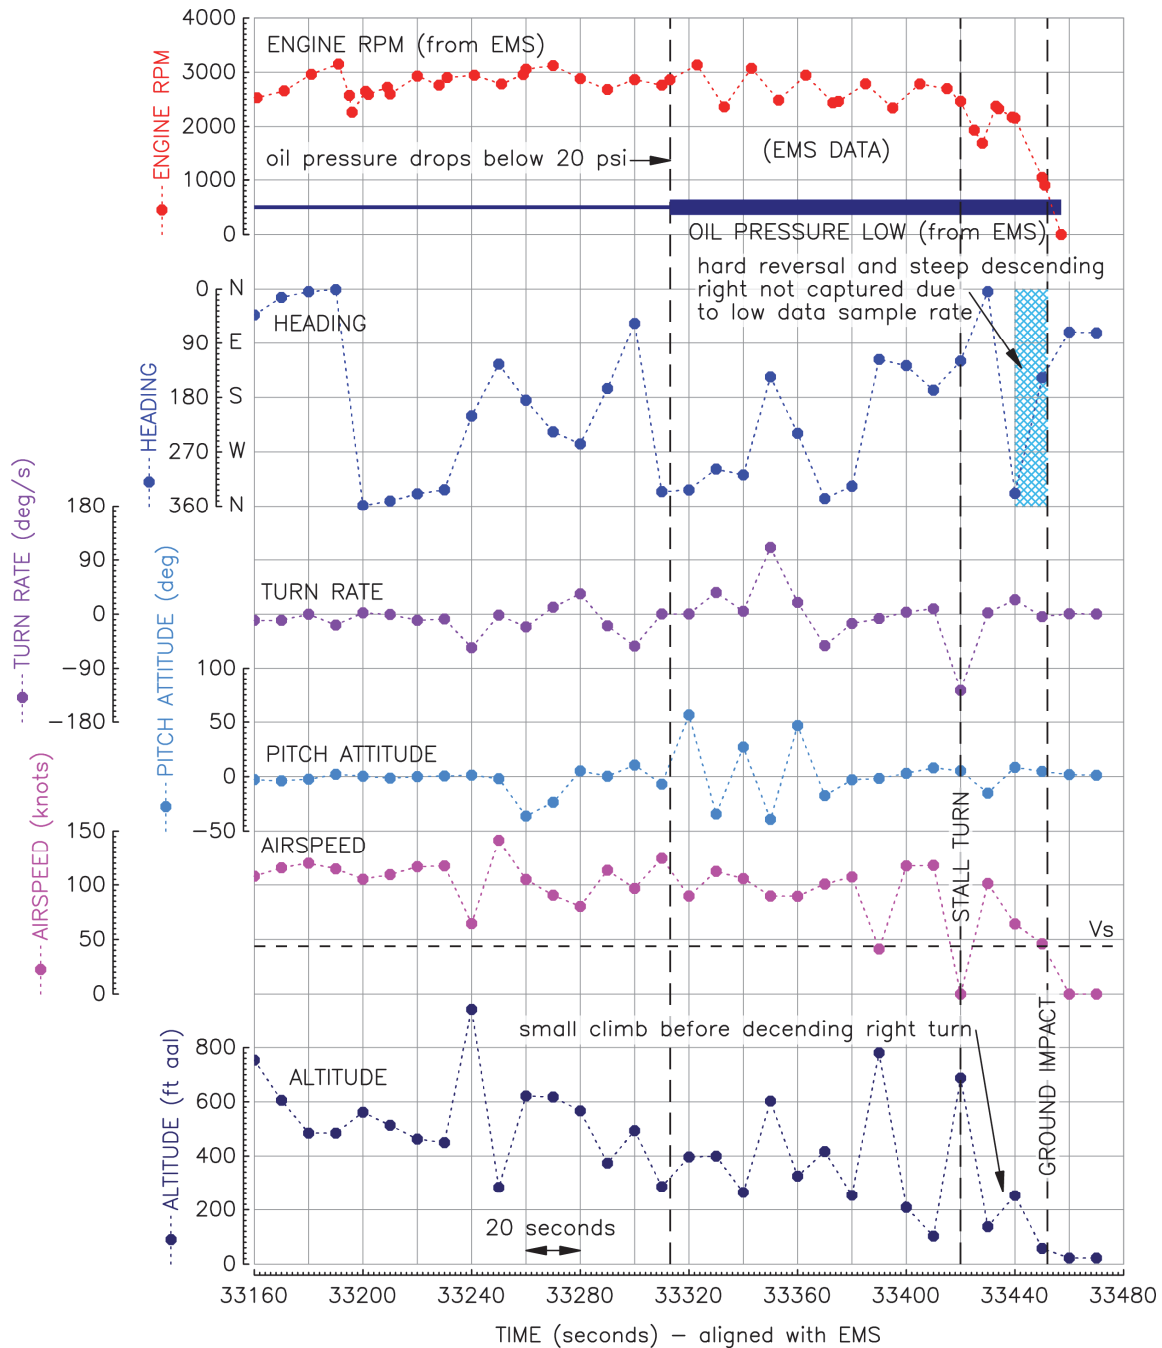
Figure 8
EFIS recorded flight data – accident flight

Figure 8 shows flight data from the EFIS starting as the aircraft descended to the start the display sequence and ending with the aircraft on the ground. EFIS times have been adjusted to align them with EMS. Figure 8 shows when the oil pressure dropped below 20 psi (generating an EMS low pressure warning – also plotted with engine rpm from EMS), the point in the flight where G-JINX performs a stall turn and when (based on timing from video evidence) it struck the ground 32 seconds later.

From video evidence, the right turn and descent to ground impact took 12 seconds, so are not evident in the EFIS data because of the low data sampling rate. However, the turn was through about 180° initially at 65 kt airspeed at about 250 ft aal. During the first half of the turn the bank angle was held at about 45° without significant height loss. The aircraft then began to descend as the bank angle increased and the nose dropped (Figure 9). At just under 60 ft aal the airspeed had reduced to 46 kt, after which the wings were levelled and the nose was raised to a slightly nose-down attitude at impact.

The EFIS data indicates that 12 seconds before ground impact, as the aircraft began the turn to the right, the airspeed was approximately 65 kt, which is the speed stated in the flight manual to be flown in the event of '*Emergency landing with a stopped engine*'. During the first half of the turn this airspeed would have reduced as height was maintained. Halfway around the turn, as the bank angle increased and the nose dropped, the aircraft accelerated towards the ground and continued to do so until shortly before impact. However, the recorded speed at approximately 60 ft agl was 46 kt, at which there would have been limited opportunity to reduce the rate of descent, but he was able to level the wings before impact.

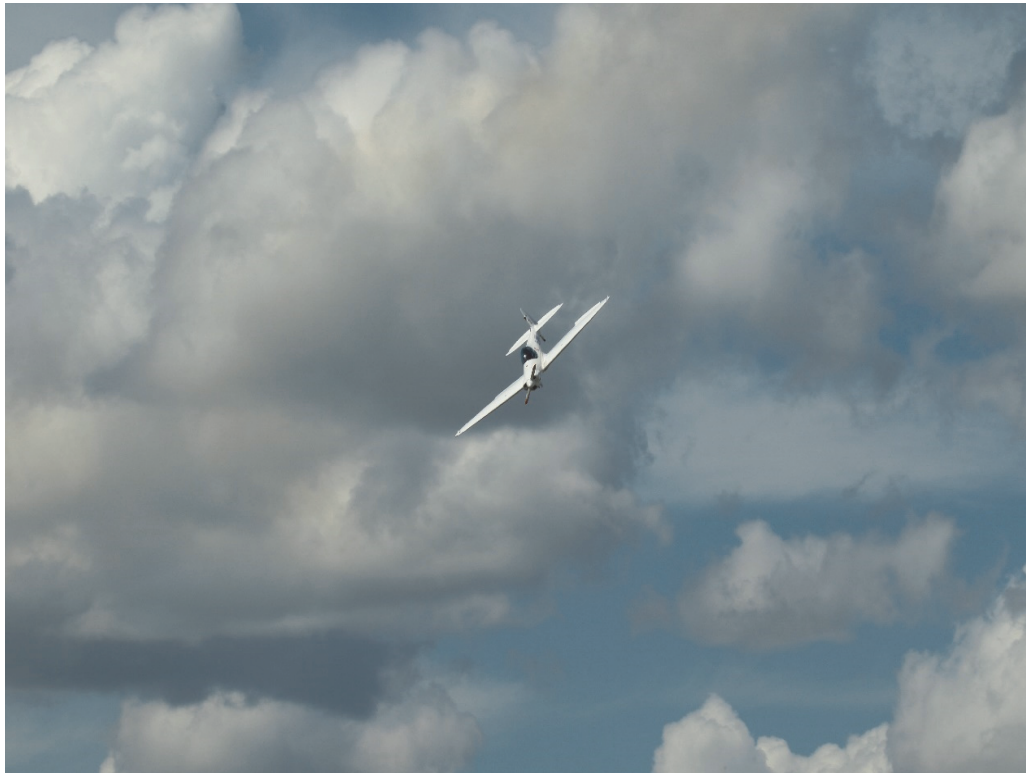
Figure 9

G-JINX shortly before ground impact
(Picture courtesy of Peter Thomas)

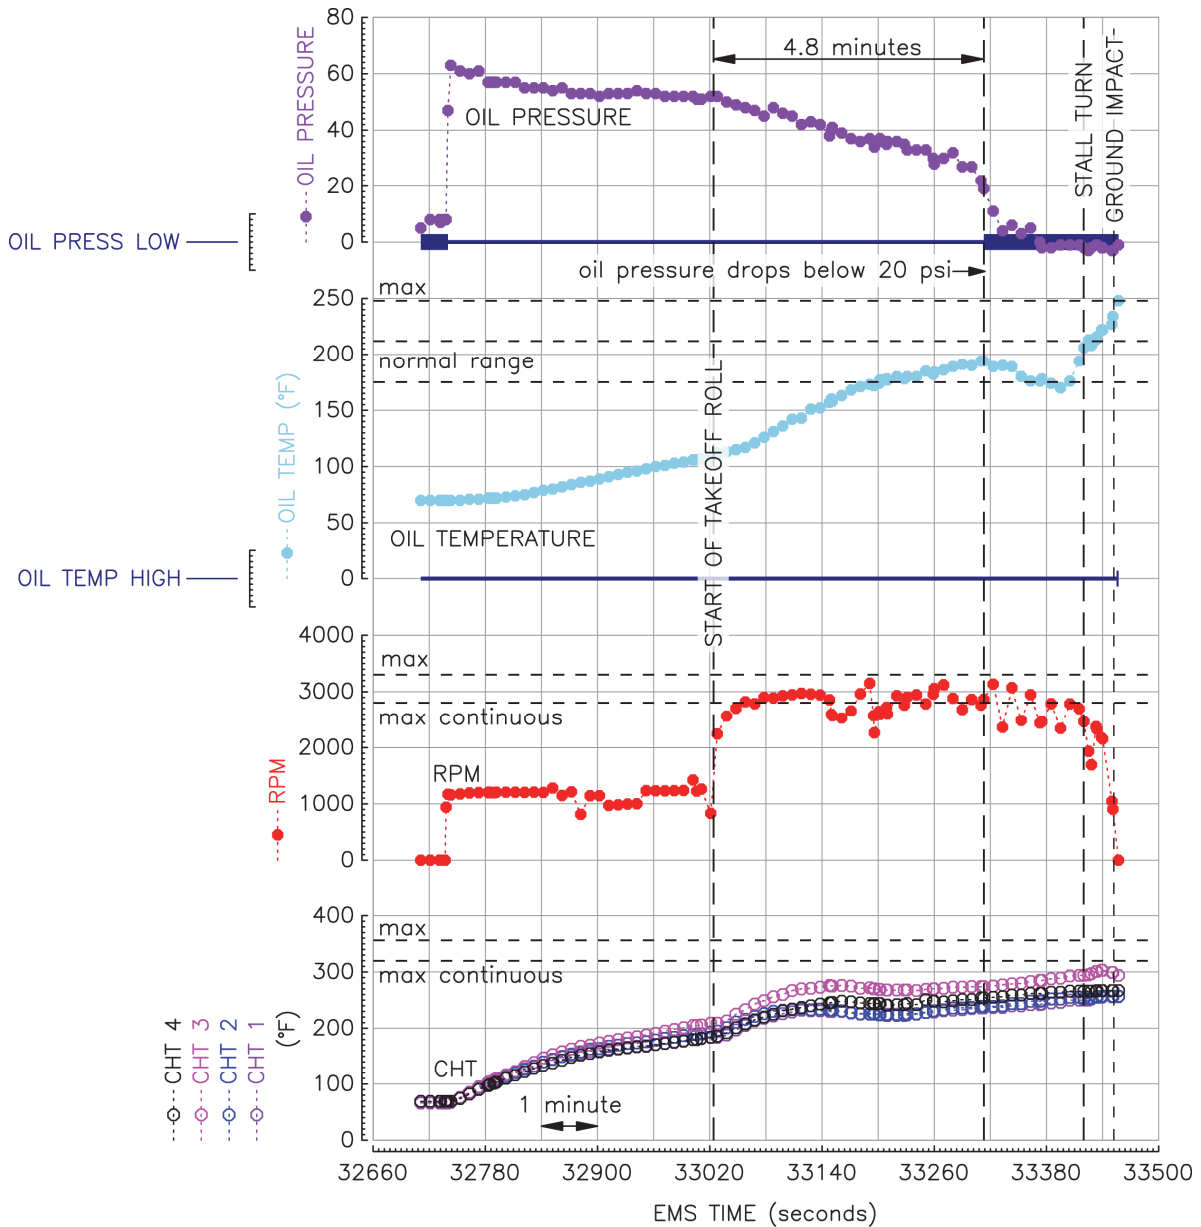
Figure 10
EMS recorded engine data - accident flight

Figure 10 shows relevant engine data from the EMS. It indicates that the time between the increase in engine speed (time 33030, which corresponded to the start of the takeoff roll), and the low oil pressure warning was 4.8 minutes. During this period, as the oil temperature increased and the oil pressure decreased, engine rpm varied around 2,800 rpm (maximum continuous) and peaked briefly at 3,151 rpm. The CHTs also increased with the No 3 cylinder operating between 20 and 30°F hotter than the hottest of the other three cylinders (cylinder No 4). After approximately 4 minutes, the oil pressure had decreased to 30 psi. It then continued to decrease below 20 psi, generating the low pressure warning and reaching zero one minute later. The engine continued to rotate for a further 1.5 minutes.

A comparison of the data downloaded from the EMS with a video of the accident flight showed that the engine stopped approximately 7 minutes after the start of the takeoff run. There were no indications to warn the pilot that there was a problem with the engine, other than the low oil pressure discrete which operated for about 2.5 minutes before the engine stopped. All the other engine parameters were similar to those recorded during a previous display flight. There was no evidence from the previous 12 flights recorded in the EMS that the engine had operated outside its approved limits.

The aircraft owner stated he would consider enabling the EMS intercom audio alert function.

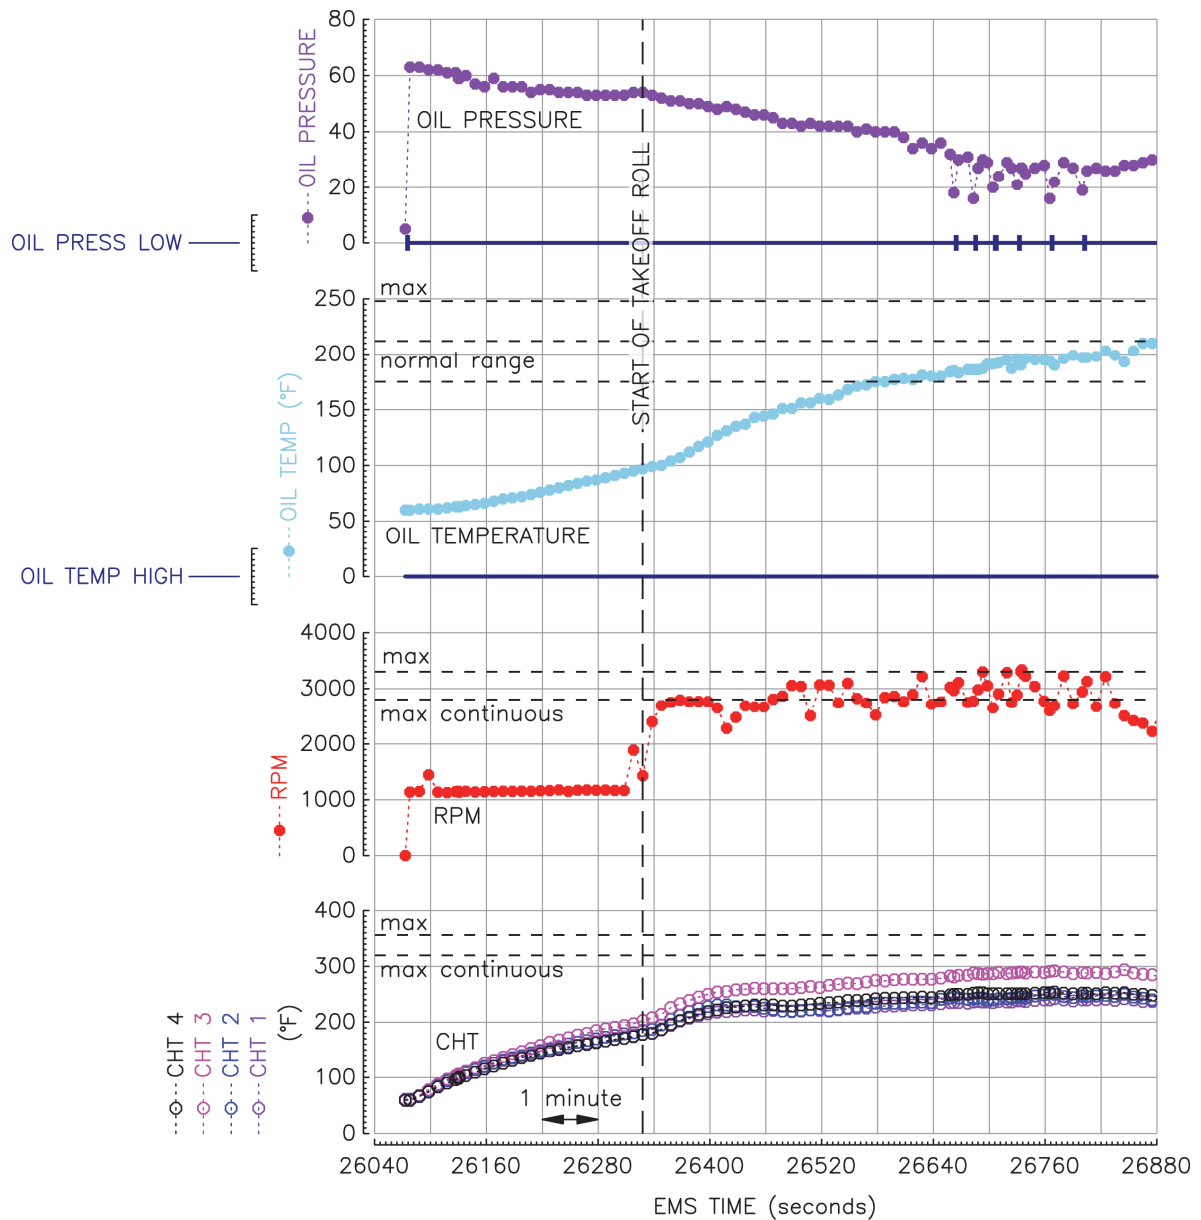
Figure 11

Data from the accident flight was compared with data from a previous flight during which the aircraft flew the same display routine (Figure 11). The engine rpm, oil pressure, oil temperature and CHT profiles (including the hotter running No 3 cylinder) were similar on both flights until five minutes after the start of the takeoff roll, when both oil pressures decreased to below 30 psi. During the earlier display flight there was then a 2.5 minute period in which the oil pressure fluctuated between 16 and 30 psi, causing the low oil pressure warning to activate six times.

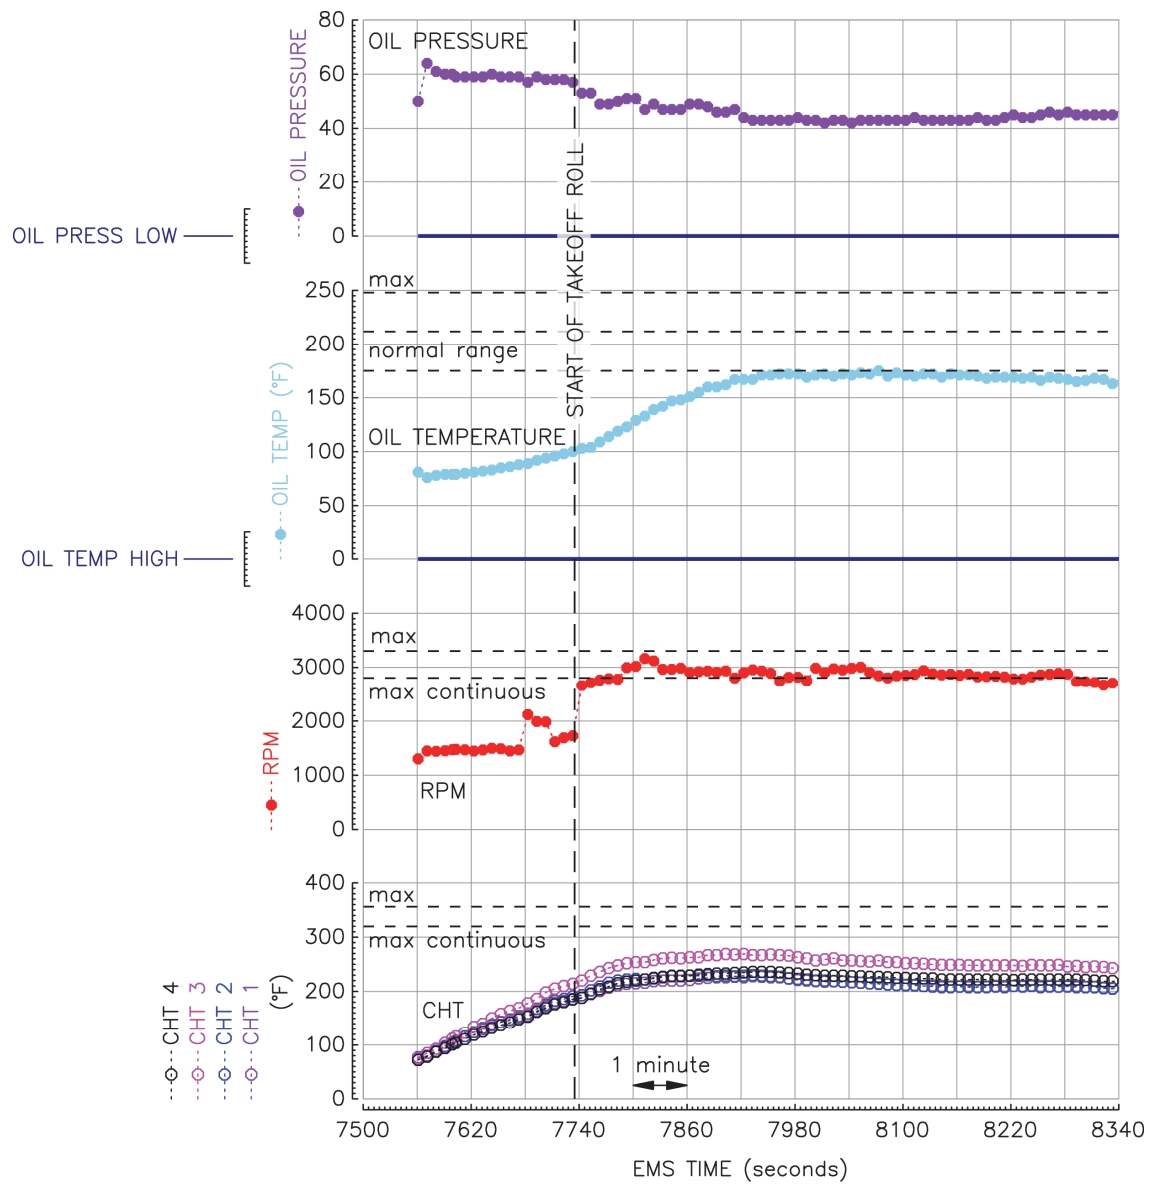
Figure 12
EMS recorded engine data - earlier cruise flight

Engine data from the display flights was also compared with data from the aircraft when it was in cruising flight (Figure 12), during which oil pressure was 43(±2) psi and the oil temperature was stable at 175° F (the lower end of the normal range). The CHTs were also approximately 30° F cooler, with the No 3 cylinder again running hotter by about 20° F.
