## ACCIDENT

<b>Aircraft Type and Registration:</b>	Cessna 182T Skylane, G-LANS	
<b>No &amp; Type of Engines:</b>	1 Lycoming IO-540-AB1A5 piston engine	
<b>Year of Manufacture:</b>	2007 (Serial no: 18281910)	
<b>Date &amp; Time (UTC):</b>	9 December 2017 at 1215 hrs	
<b>Location:</b>	Bodmin Airfield, Cornwall	
<b>Type of Flight:</b>	Private	
<b>Persons on Board:</b>	Crew - 1	Passengers - 2
<b>Injuries:</b>	Crew - None	Passengers - None
<b>Nature of Damage:</b>	Damaged beyond economic repair.	
<b>Commander's Licence:</b>	Private Pilot's Licence	
<b>Commander's Age:</b>	61 years	
<b>Commander's Flying Experience:</b>	197 hours (of which 52 were on type) Last 90 days - 5 hours Last 28 days - 3 hours	
<b>Information Source:</b>	Aircraft Accident Report Form submitted by the pilot

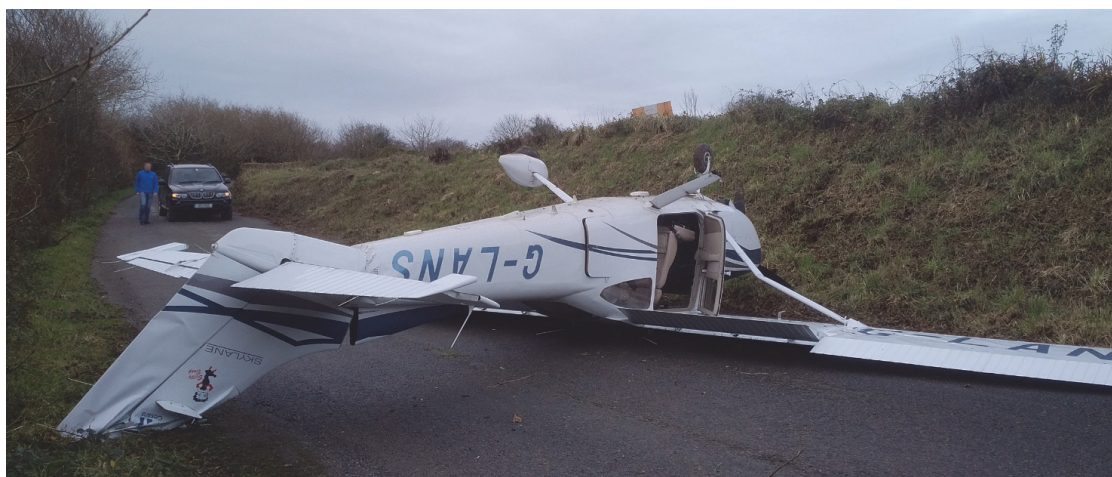
**Figure 1**

The approach was high and fast, and an intermediate flap setting was used to land on a relatively short runway, with a wet grass surface and a net downhill gradient. After touching down, further along the runway than planned, the pilot was unable to halt the aircraft before it overran the prepared surface and overturned onto a roadway. The pilot and his passengers used the doors to exit the aircraft without injury.

G-LANS inverted on the perimeter road following the accident.
