ACCIDENT

Aircraft Type and Registration:	Piper PA-28-140 Cherokee, G-ATPN	
No & Type of Engines:	1 Lycoming O-320-E2A piston engine	
Year of Manufacture:	1966 (Serial no: 28-21899)	
Date & Time (UTC):	11 February 2018 at 1143 hrs	
Location:	Southend Airport, Essex	
Type of Flight:	Private	
Persons on Board:	Crew - 1	Passengers - 2
Injuries:	Crew - None	Passengers - None
Nature of Damage:	Extensive	
Commander's Licence:	Private Pilot's Licence	
Commander's Age:	44 years	
Commander's Flying Experience:	55 hours (of which 6 were on type) Last 90 days - 8 hours Last 28 days - 4 hours	
Information Source:	Aircraft Accident Report Form submitted by the pilot and further enquiries made by the AAIB

Synopsis

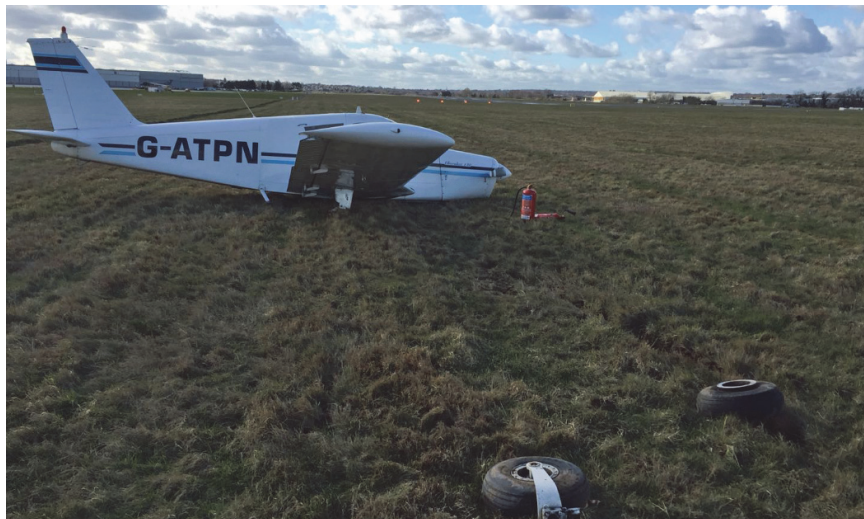
Figure 1

G-ATPN in its resting position approximately 95 m from the centreline of Runway 23

Recordings from the airfield's CCTV system indicated that the aircraft began to flare when approximately 20 ft aal and that it rolled left, and its rate of descent increased, before it contacted the runway having regained a wings-level attitude. The aircraft immediately bounced and climbed in a 25-30° nose-up attitude until it levelled for three seconds at approximately 40 ft aal, with a reduced nose-up attitude at a groundspeed that seemed slower than it should have been. After turning left a few degrees the aircraft began to sink and, as it dropped towards the grass area south of the displaced runway threshold, its rate of descent increased and the right wing dropped. Ten seconds after the bounced touchdown it struck the ground hard, skidded forward a few feet and slewed right before coming to rest.
