ACCIDENT

Aircraft Type and Registration:	Piper PA-28-161 Cherokee Warrior II, G-BSXB	
No & Type of Engines:	1 Lycoming O-320-D3G piston engine	
Year of Manufacture:	1984 (Serial no: 28-8416125)	
Date & Time (UTC):	16 November 2017 at 1141 hrs	
Location:	Wolverhampton (Halfpenny Green) Airport, Staffordshire	
Type of Flight:	Private	
Persons on Board:	Crew - 2	Passengers - None
Injuries:	Crew - 2 (Minor)	Passengers - N/A
Nature of Damage:	Extensive	
Commander's Licence:	Private Pilot's Licence	
Commander's Age:	73 years	
Commander's Flying Experience:	925 hours (of which 755 were on type) Last 90 days - 6 hours Last 28 days - 3 hours	
Information Source:	Aircraft Accident Report Form submitted by the pilot and further enquiries by the AAIB

Synopsis

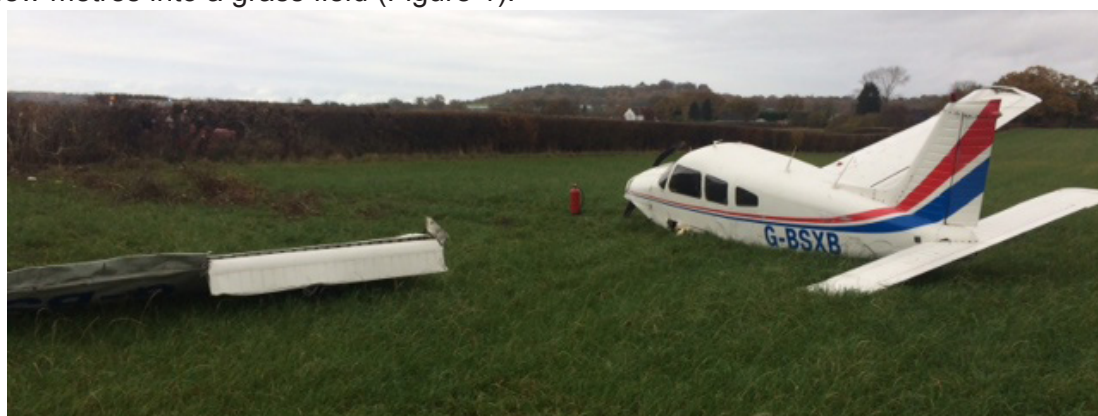
Figure 1

After touching down, the pilot encountered difficulty decelerating due to the wet surface and the tailwind so, when he realised the end of the runway was approaching, he increased power and attempted to go around. Once airborne, he was aware of the left wing dipping, probably because he had not applied sufficient right rudder to counteract the increased engine torque, and the left wingtip then struck a hedge at the airfield boundary. This caused the aircraft to lose height as it crossed a public road and before impacting a second hedge with a co-located fence, on the south side of the road. As a result of the second collision the left wing detached, and the aircraft spun around and stopped abruptly a few metres into a grass field (Figure 1).

G-BSXB, with its left wing detached, facing back towards the second hedge
