ACCIDENT

Aircraft Type and Registration:	Piper PA-28-161 Cherokee Warrior III, G-WARY	
No & Type of Engines:	1 Lycoming O-320-D3G piston engine	
Year of Manufacture:	1997 (Serial no: 2842024)	
Date & Time (UTC):	16 February 2018 at 0940 hrs	
Location:	Shoreham Airport, West Sussex	
Type of Flight:	Private	
Persons on Board:	Crew - 1	Passengers - None
Injuries:	Crew - None	Passengers - N/A
Nature of Damage:	G-WARY wing tip and lower skin damaged, engine shock-load. G-WARZ, wing tip and major disruption to rear fuselage	
Commander's Licence:	Private Pilot's Licence	
Commander's Age:	77 years	
Commander's Flying Experience:	560 hours (of which 475 were on type) Last 90 days - 14 hours Last 28 days - 1 hour	
Information Source:	Aircraft Accident Report Form submitted by the pilot and further inquiries made by the AAIB

Synopsis

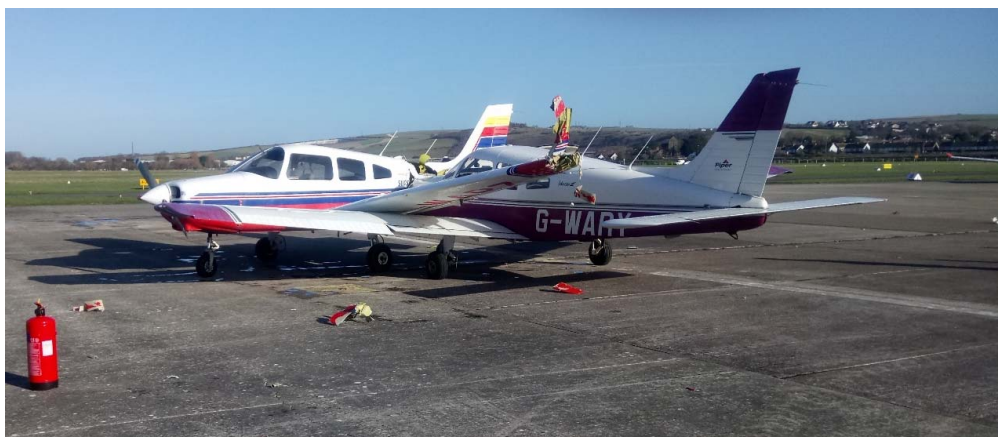
Figure 1

until the turning propeller penetrated its rear fuselage and brought everything to a stop. The aircraft were now interlocked and substantial damage was caused to G-WARZ, as shown in Figures 1 and 2.

G-WARY and G-WARZ interlocked
(Pictures courtesy of Shoreham Airport)
