AAIB Bulletin: 5/2018	G-CCMU	EW/G2017/10/08
ACCIDENT		
Aircraft Type and Registration:	Rotorway Executive 162F, G-CCMU	
No & Type of Engines:	1 Rotorway RI 162F piston engine	
Year of Manufacture:	2004 (Serial no: 6720)	
Date & Time (UTC):	26 October 2017 at 1650 hrs	
Location:	Salterford Farm, Nottinghamshire	
Type of Flight:	Private	
Persons on Board:	Crew - 1	Passengers - 1
Injuries:	Crew - None	Passengers - 1 (Minor)
Nature of Damage:	Extensive	
Commander's Licence:	Private Pilot's Licence	
Commander's Age:	47 years	
Commander's Flying Experience:	60 hours (of which 17 were on type) Last 90 days - 8 hours Last 28 days - 2 hours	
Information Source:	Aircraft Accident Report Form submitted by the pilot

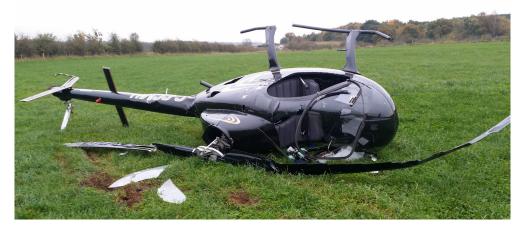
The pilot was returning after a local flight and as he turned onto finals, at approximately 40 to 50 ft, the helicopter yawed to the left. He attempted to correct with right pedal but the turn sped up quickly. The pilot noticed he was losing height and raised the collective lever, but he was unable to stop the descent. The helicopter spun two or three times before striking the grass surface with skids level. It then rolled over, causing extensive damage (Figure 1). Both occupants were restrained by their harnesses and could exit the aircraft through the broken windscreen.

Figure 1 G-CCMU after the accident

The pilot commented that he had allowed his airspeed to reduce excessively during his approach and may have inadvertently entered a hover out of ground effect. This requires a collective input and a significant increase in power. If insufficient engine power is applied, the rotor speed will drop. This can reduce tail rotor effectiveness and is likely to have resulted in the spin.
