## ACCIDENT

<b>Aircraft Type and Registration:</b>	Jabiru UL-450, G-JAXS	
<b>No &amp; Type of Engines:</b>	1 Jabiru 2200A piston engine	
<b>Year of Manufacture:</b>	2001 (Serial no: PFA 274A-13548)	
<b>Date &amp; Time (UTC):</b>	5 February 2018 at 1410 hrs	
<b>Location:</b>	Welshpool Airport, Powys	
<b>Type of Flight:</b>	Private	
<b>Persons on Board:</b>	Crew - 1	Passengers - None
<b>Injuries:</b>	Crew - None	Passengers - N/A
<b>Nature of Damage:</b>	Left strut buckled and fuselage attachment plate distorted. Propeller damaged and engine possibly shock-loaded	
<b>Commander's Licence:</b>	National Private Pilot's Licence	
<b>Commander's Age:</b>	54 years	
<b>Commander's Flying Experience:</b>	114 hours (of which 2 were on type) Last 90 days - 1 hour Last 28 days - 0 hours	
<b>Information Source:</b>	Aircraft Accident Report Form submitted by the pilot

## Synopsis

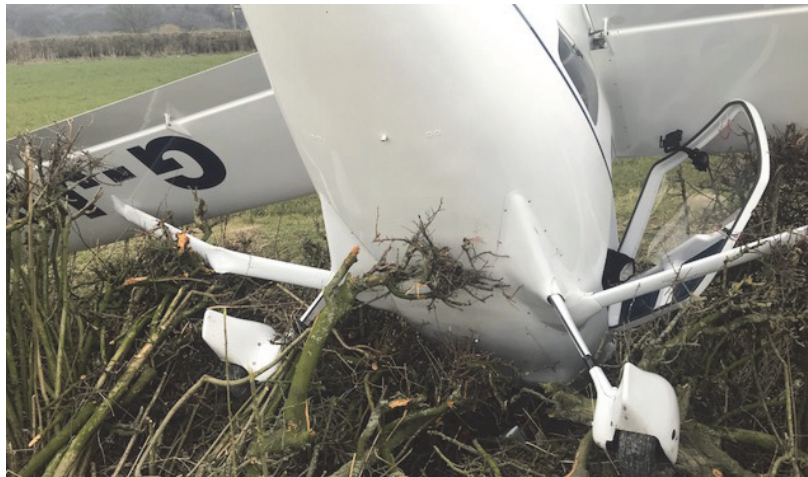
**Figure 1**

The pilot reported that, when he increased the power to begin his takeoff, he applied sufficient right rudder pedal to counteract the torque effect from the propeller. However, as the aircraft began to accelerate, it veered quickly to the left and he was unable to keep it on the runway, which is 18 m wide. He switched off the engine but could not prevent the aircraft from running approximately 46 m across an adjacent grass area and colliding with a hedge. The aircraft came to rest in the hedgerow and the pilot then closed the fuel supply before escaping through the passenger door, as his own door was blocked (Figure 1).

G-JAXS enmeshed in the airfield boundary hedge

After the accident a mark in the grass suggested that the left wheel was not rotating when the aircraft departed the runway. This may indicate that the left wheel was subject to an intermittent fault which caused it to bind, because no wheelbrake issues or defects were apparent when the aircraft was inspected at a maintenance facility.
