Grounding of the general cargo ship *Islay Trader* Margate, UK 8 October 2017

SUMMARY

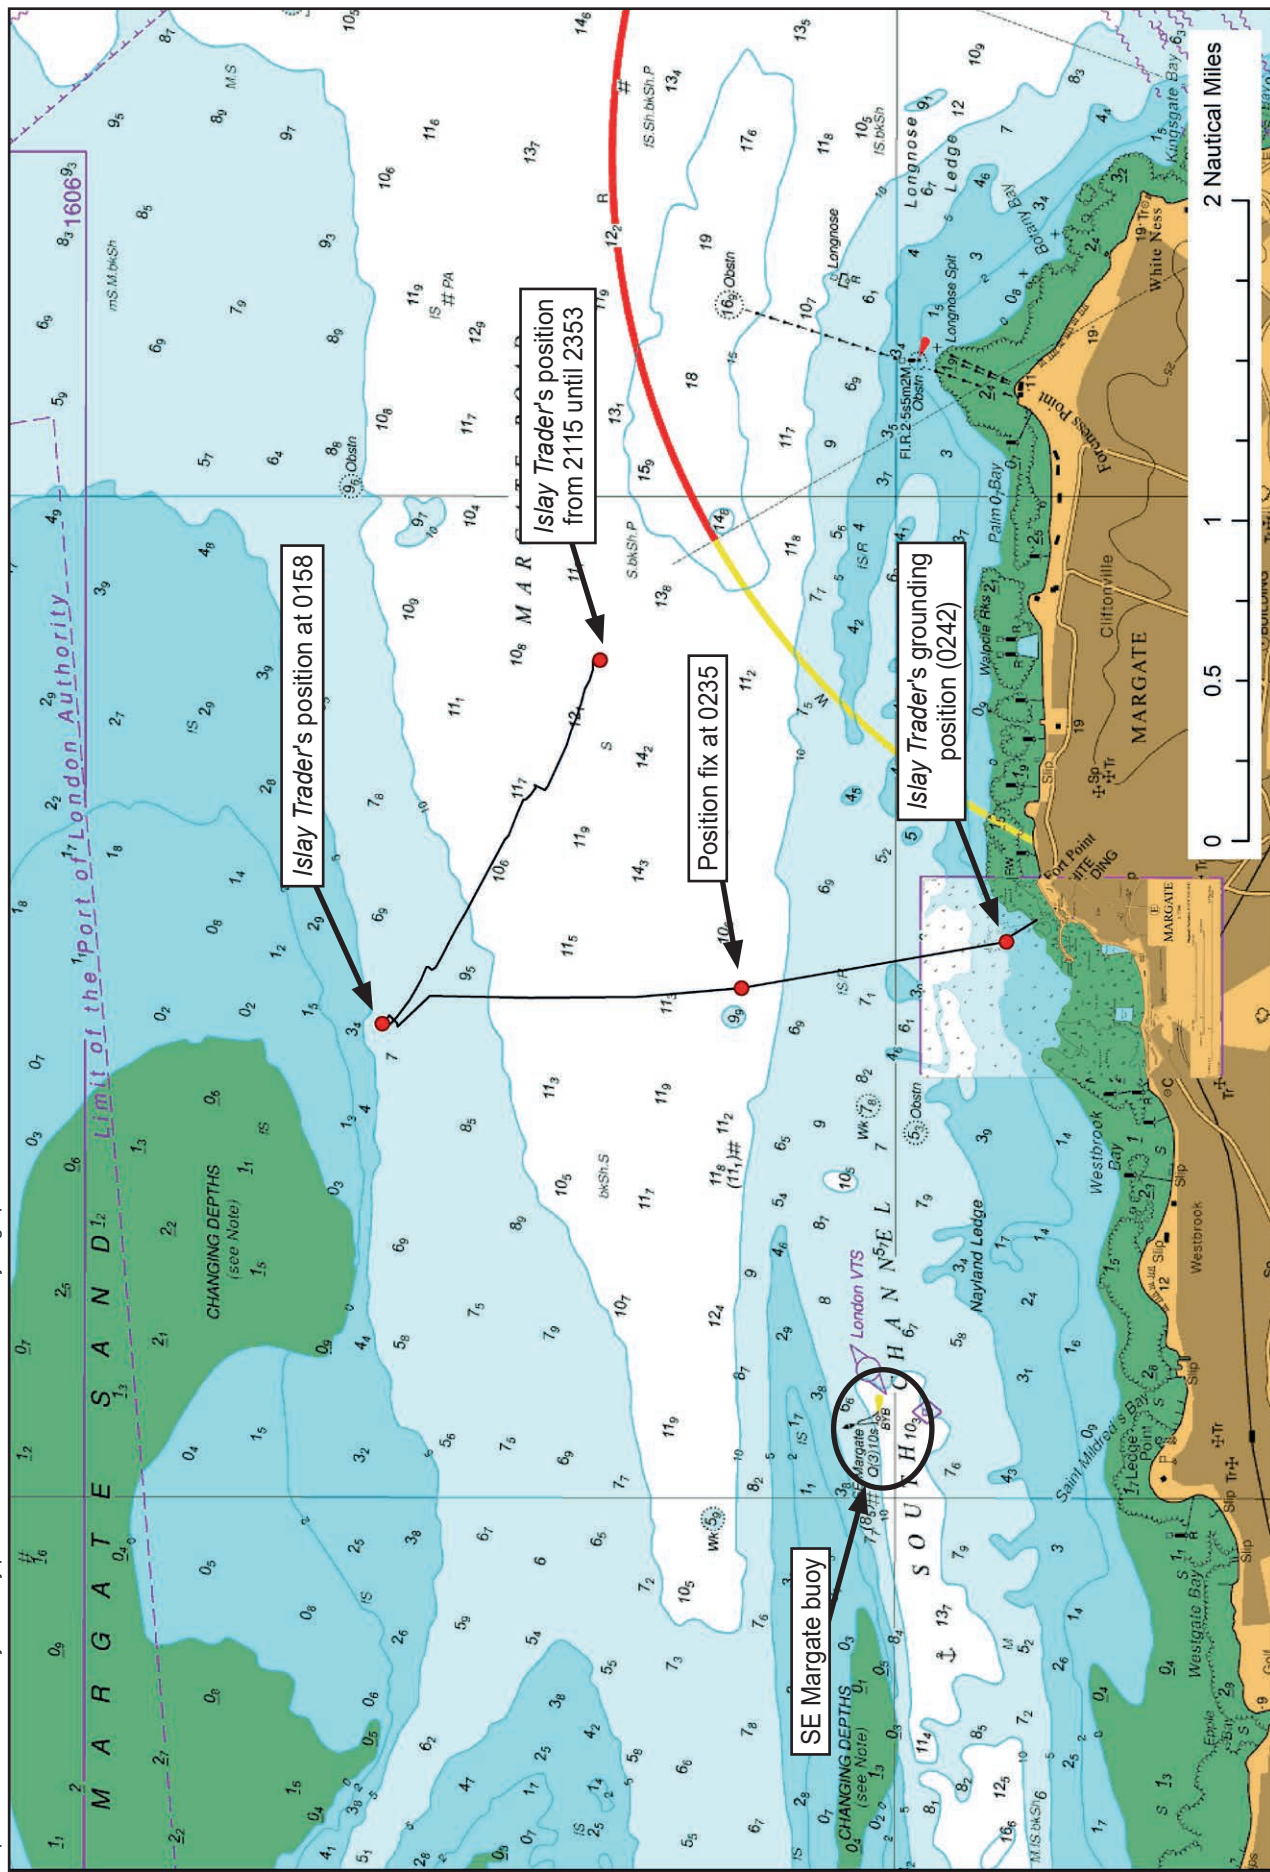
Figure 1: Extract of Admiralty chart 1828 showing Islay Trader's AIS positions

AIS transmissions from *Islay Trader* indicate that the vessel started to drag anchor and move from its initial anchor position towards the north-west at 2353 (**Figure 1**). From then, until being alerted by London VTS at 0158, the vessel's speed over the ground reached a maximum of 1.2kts (0043-0048) and its heading yawed between 023° and 066°. Between 0147 and 0214, *Islay Trader* was stationary on a heading between 052° and 063°.

Between 2353 on 7 October and 0147 the following morning, *Islay Trader* moved 1.3nm to the west-north-west of its original anchorage position. A significant factor contributing to the failure of the vessel's anchor to hold was that only 3 shackles of chain cable was used. For an anchor to achieve its maximum holding power, sufficient cable must lie along the seabed before rising to the hawse pipe. In this case, although the sandy seabed afforded reasonable holding ground, the change of the cable's scope caused by the flooding tidal stream and the rising tide was sufficient to raise the lead of the cable. Consequently, the anchor's holding power was reduced until the vessel entered the shallower water towards Margate Sand.

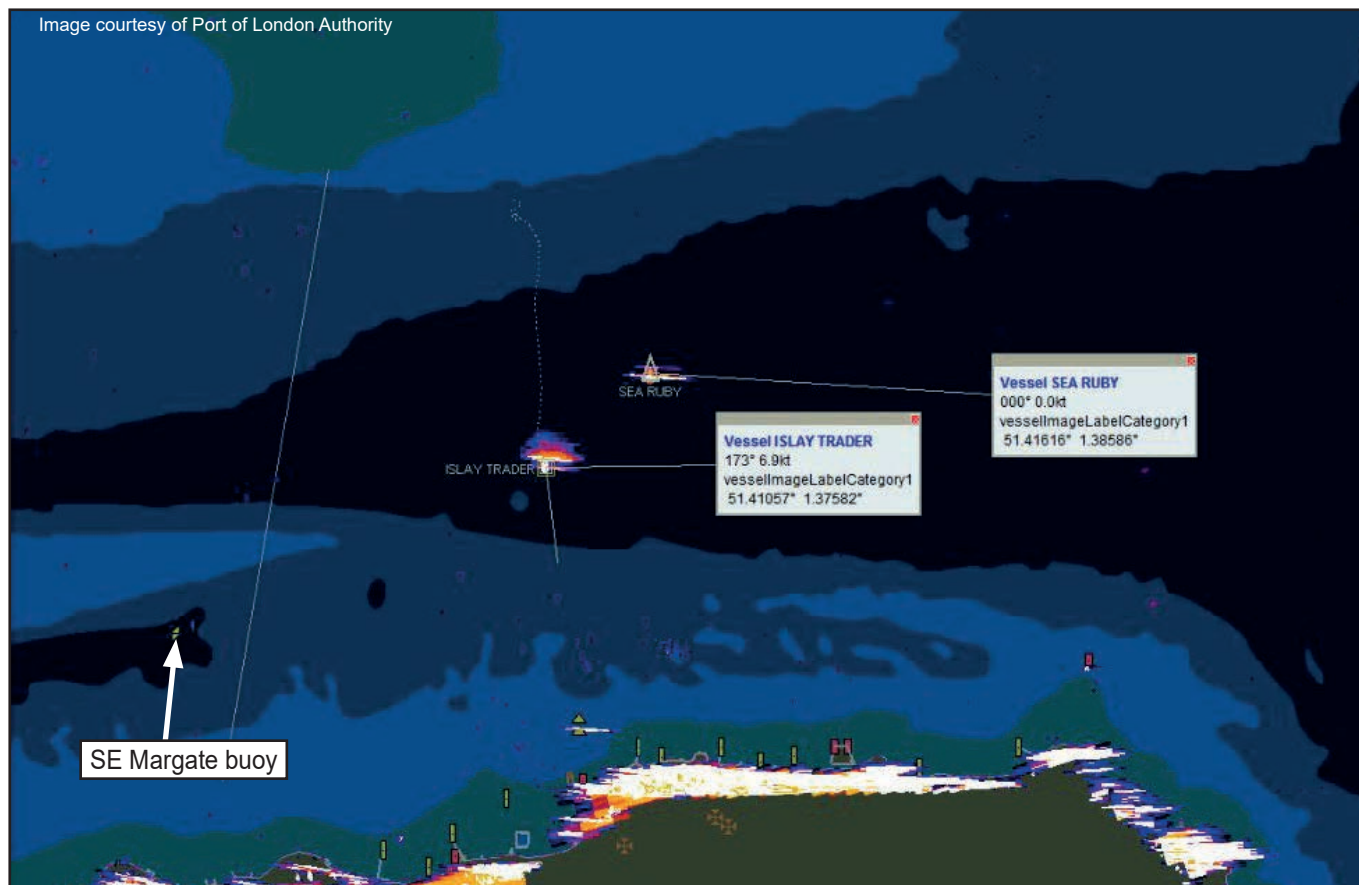
At 0233, the VTSO saw that *Islay Trader* was heading further to the south than he had expected (**Figure 2**) and again called the vessel via VHF radio (**Table 2**)

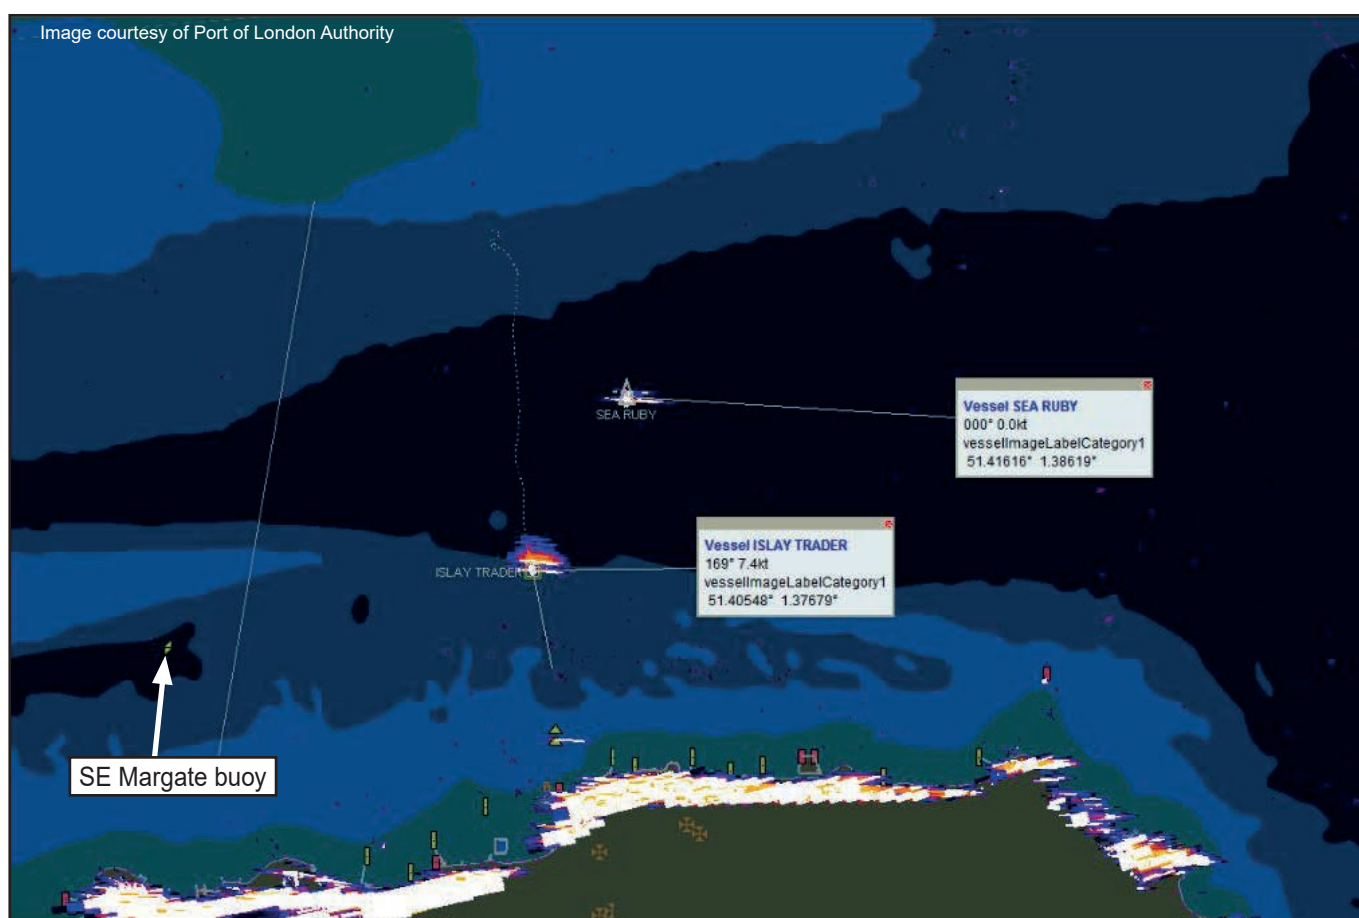
At 0235, *Islay Trader*'s chief officer plotted a GPS position on the paper chart. Meanwhile, the VTSO became increasingly concerned about the vessel's southerly track (**Figure 3**). At 0236, he again called the vessel (**Table 3**):

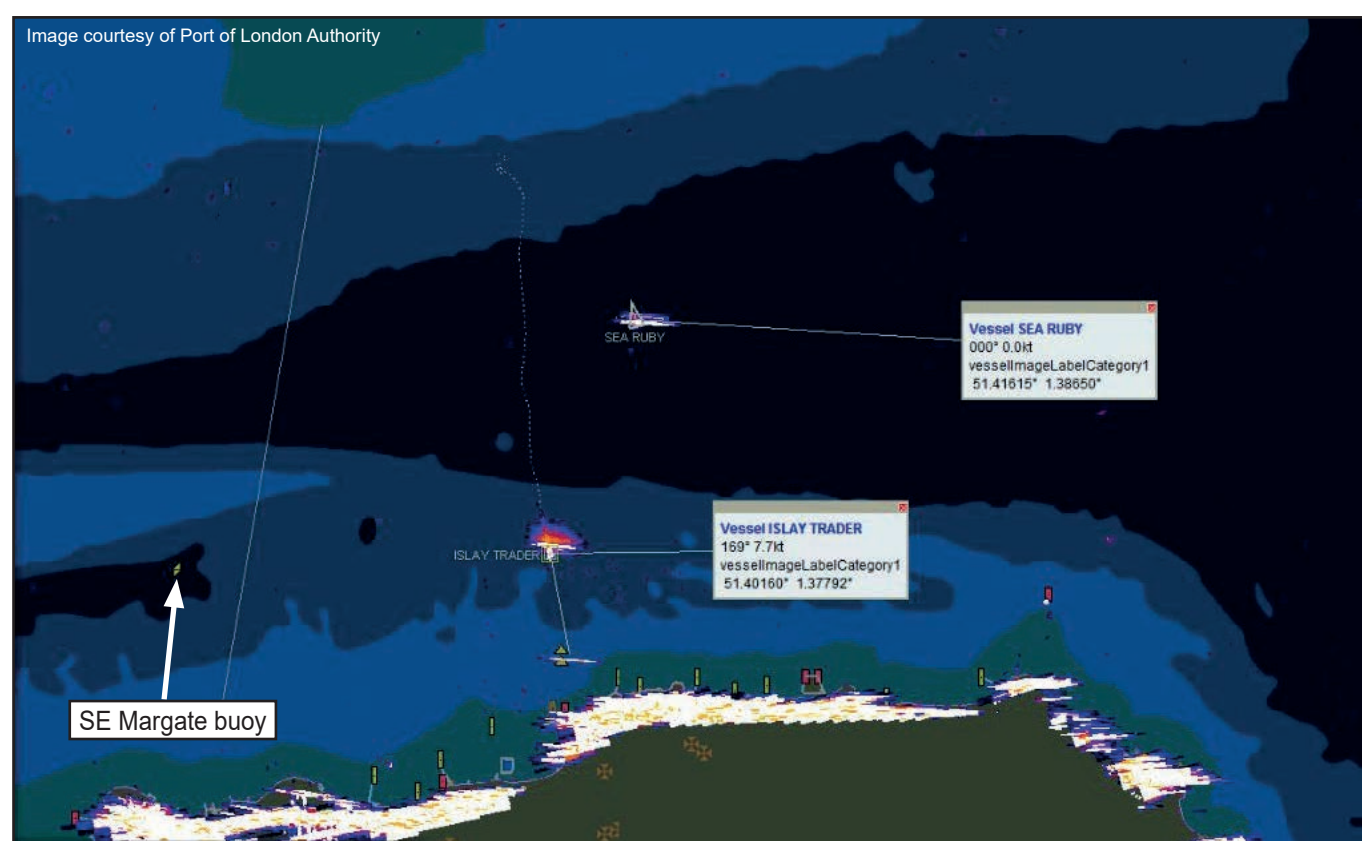
Figure 4: VTS radar extract showing *Islay Trader* at 0238

Although between 0236 and 0239 the chief officer advised the VTSO that he was turning *Islay Trader* to the north and putting the engines astern, the vessel's heading remained steady and its speed did not reduce. It is possible that when he moved the Schottel wheel controls (**Figure 5**) 180° to thrust astern, he inadvertently declutched the Schottel units. Also, with the wheel controls rotated to this extent, operation of the engine speed lever would have been less intuitive and, under stress, the chief officer might have moved the lever in the wrong direction. However, if this was the case, it could only have occurred in the moments before the vessel grounded, otherwise a speed reduction would have been evident.

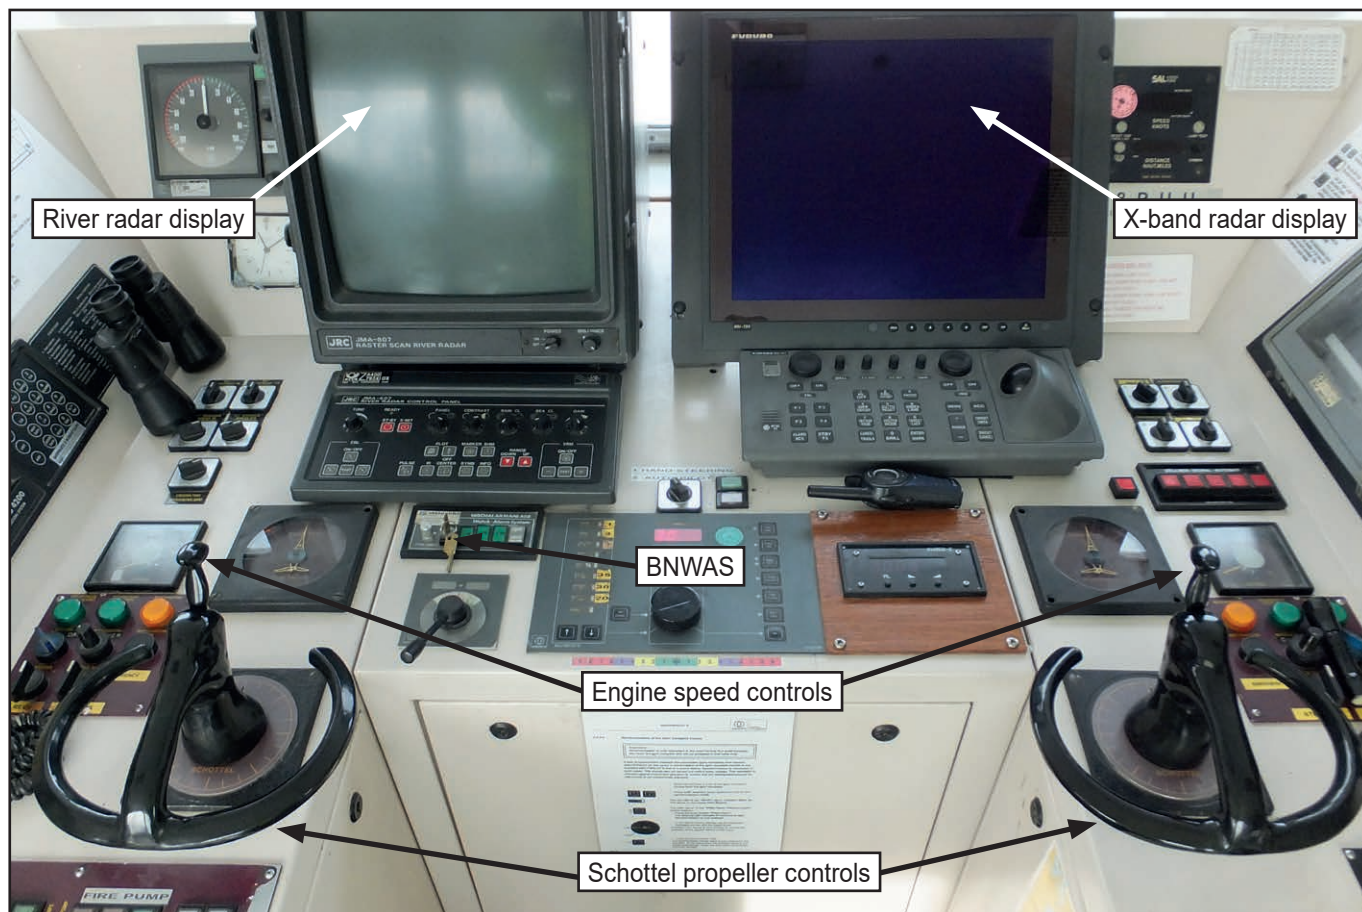
Figure 5: Front console of conning position

At some point, *Islay Trader*’s chief officer moved the controls of the vessel’s Schottel Rudderpropellers (**Figure 5**) to provide propulsion astern, but the vessel continued to head towards the south at about 7kts. He asked the chief engineer if there was a problem. In response, the chief engineer replied that the engines were working as normal. As *Islay Trader* passed a tide gauge, close off Margate’s sea front, the chief officer ordered the ABs on the fo’c’sle to let go the starboard anchor. The ABs did so, and allowed 1 shackle of cable to run free.

Islay Trader's propulsion and steering were provided through two Schottel Rudderpropellers (port and starboard), which were fixed pitch propellers whose direction of thrust could be rotated through 360°. Each Schottel unit was driven by a 324kW Cummins engine and was controlled from the bridge. The direction of thrust for each Schottel unit was controlled via the movement of a horizontally-mounted wheel. Engine speed was controlled by a lever mounted in the centre of each wheel (**Figure 5**). The vessel was also fitted with a 100kW bow thruster.

- A chart table, sited on the starboard side of the bridge and not visible from the conning position.
- Displays for an X-band radar and a river radar on the forward console, which were not visible from the chart table (**Figure 5**).
- An echo sounder, which recorded onto paper and was switched off at the time of the accident.
- Two GPS receivers, both of which had an 'anchor watch alarm' function.
- An AIS transceiver.
- A bridge navigation watch alarm system (BNWAS) adjacent to the river radar, which was reported to be set to alert every 9 minutes. The operating key was in situ (**Figure 5**).

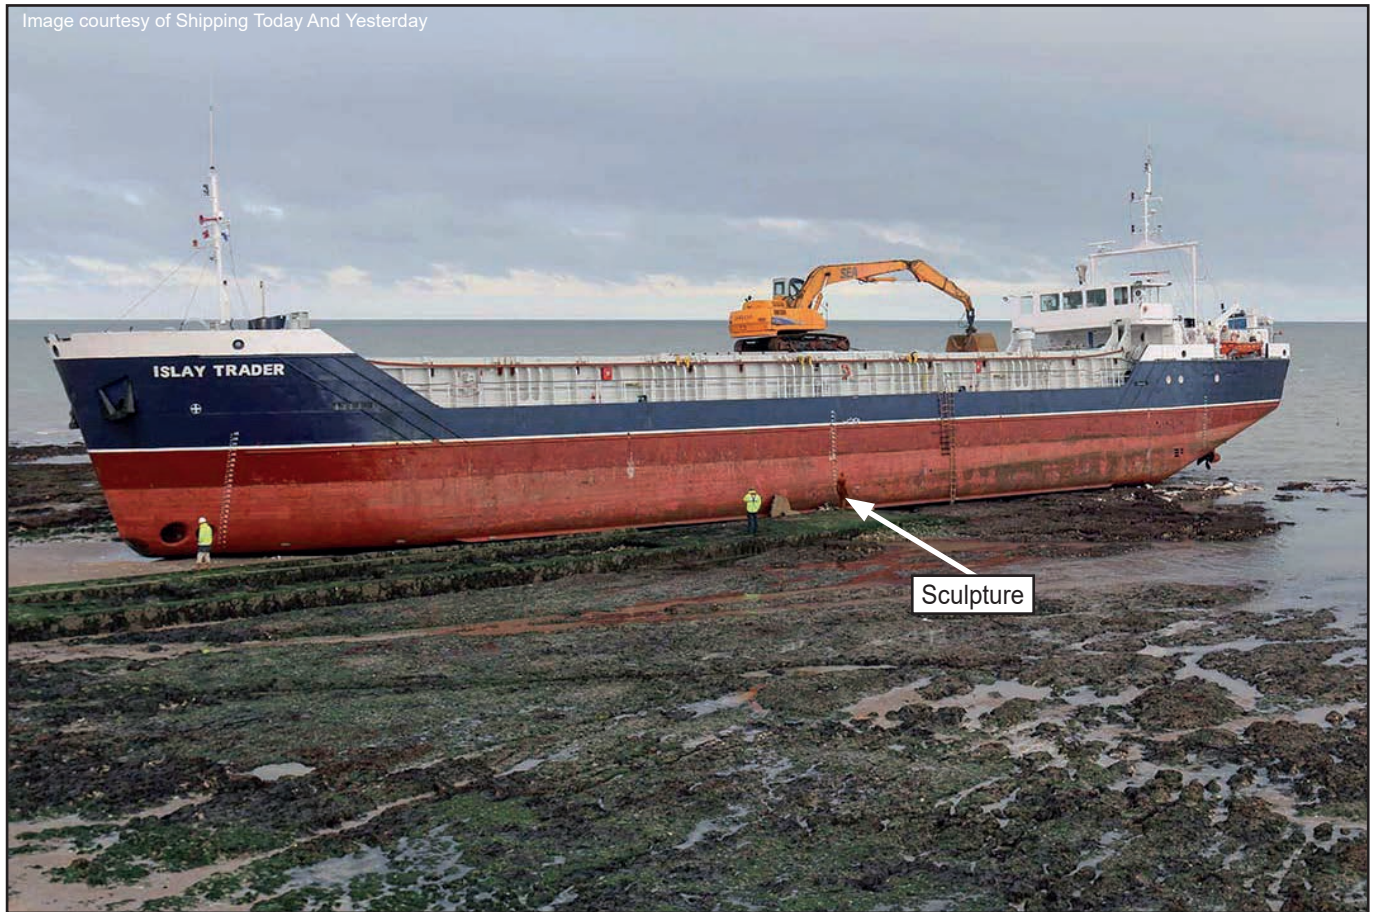
Figure 6: *Islay Trader* aground

using astern propulsion, but his attempts were unsuccessful. The vessel eventually settled bows south onto a slipway, very close to a life-size sculpture by the artist Sir Antony Gormley (**Figure 6**). The ballast tanks were sounded, but no evidence of water ingress or other damage was found. The master informed *Islay Trader*'s owners and Dover Coastguard of the situation.

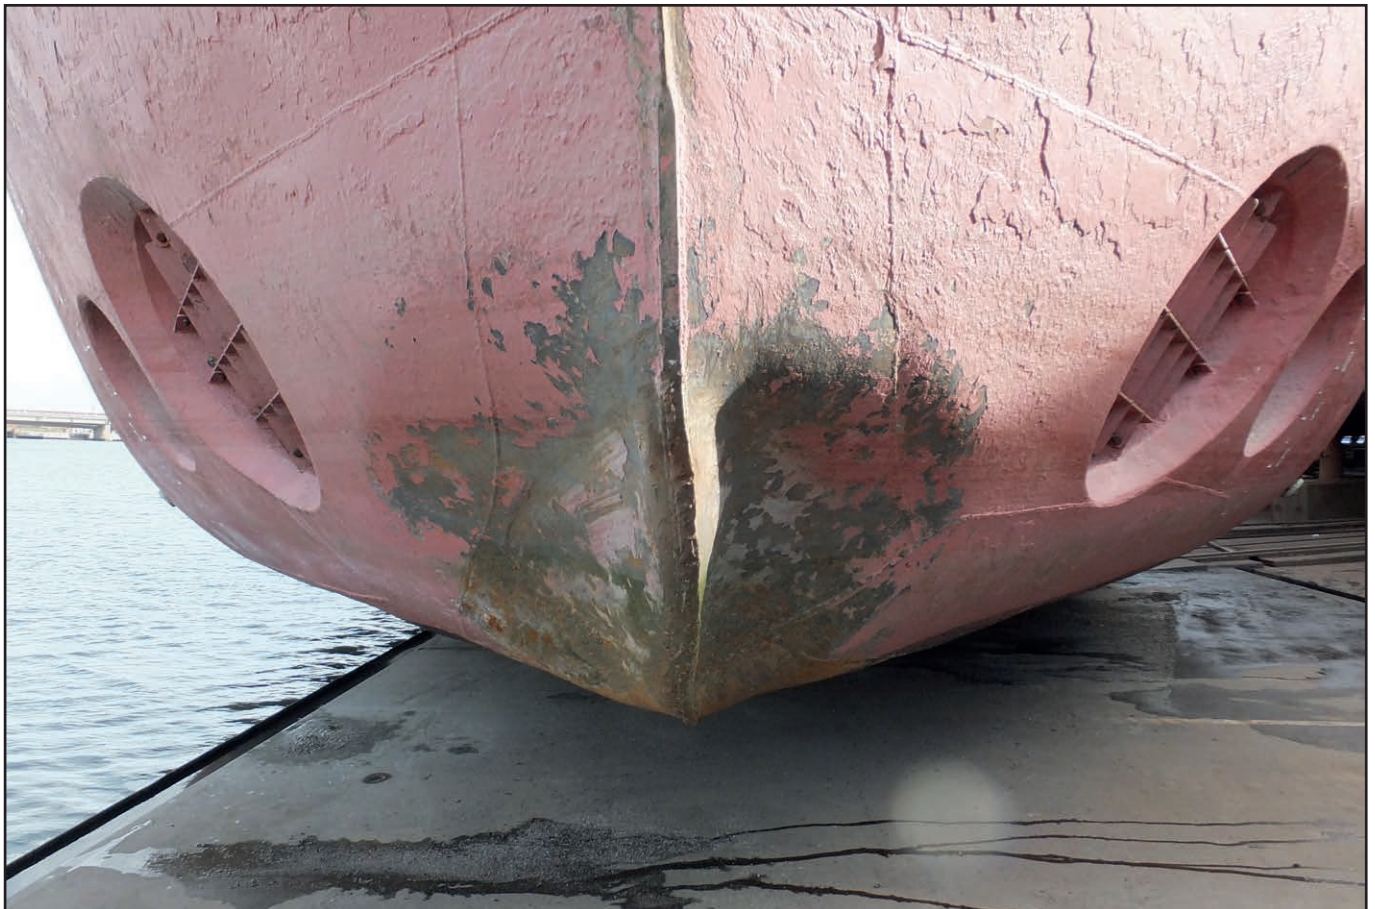
Figure 7: Bow damage

On 12 October, an out of water inspection in Dordrecht identified that *Islay Trader*'s hull was indented below the waterline either side of the bow (**Figure 7**). Five vertical stiffeners were also bent in way of a fresh water tank towards the stern.
