ACCIDENT

Aircraft Type and Registration:	Vans RV-8A, G-HCCF	
No & Type of Engines:	1 Lycoming IO-360-A1B6 piston engine	
Year of Manufacture:	2014 (Serial no: PFA 303-13790)	
Date & Time (UTC):	21 February 2018 at 1400 hrs	
Location:	Old Sarum Airfield, Wiltshire	
Type of Flight:	Private	
Persons on Board:	Crew - 1	Passengers - 1
Injuries:	Crew - None	Passengers - None
Nature of Damage:	Extensive	
Commander's Licence:	Private Pilot's Licence	
Commander's Age:	59 years	
Commander's Flying Experience:	4,310 hours (of which 37 were on type) Last 90 days - 6 hours Last 28 days - 6 hours	
Information Source:	Aircraft Accident Report Form submitted by the pilot

Following a bounced landing, the aircraft's nose landing gear dug into soft grass, the propeller made ground contact and the aircraft inverted.

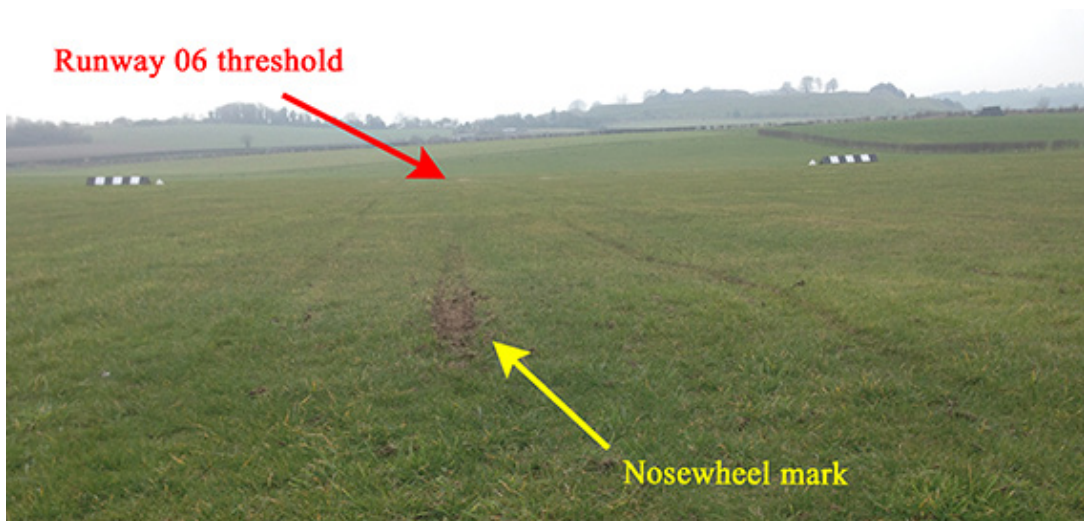
Figure 1

A third approach was flown, for another 'short field' landing, and the aircraft touched down on a part of the runway close to the threshold that felt "bumpy" and had an uphill gradient. The aircraft bounced and both occupants believed that only the mainwheels had touched, but subsequent examination of the ground markings indicated the nosewheel had also made firm contact (Figure 1). This was substantiated by a witness, who described the third landing as heavier than the first two, and who believed the aircraft was in a relatively flat attitude when it bounced.

View of initial ground marks; the aircraft having touched down moving towards the camera position and then bounced

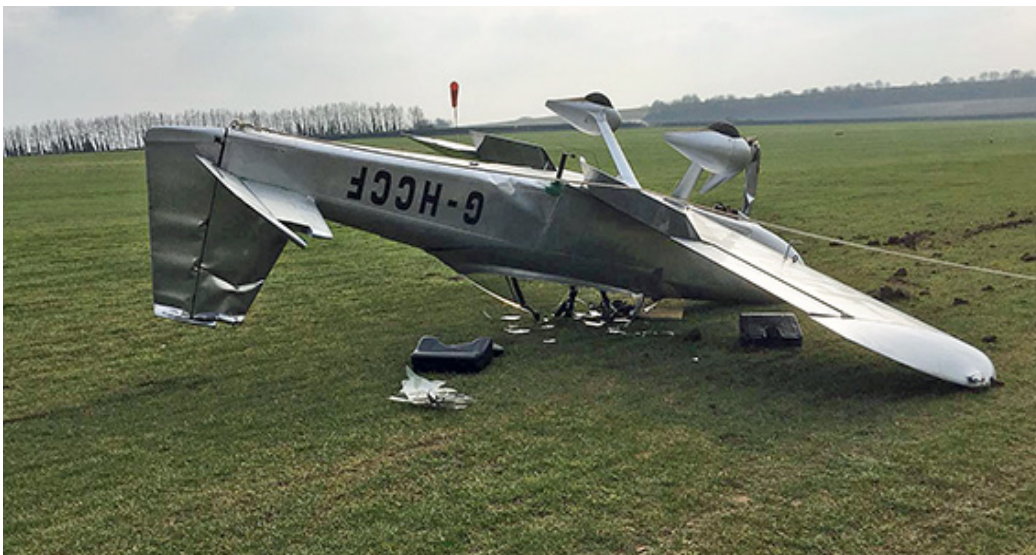
Figure 2

After the bounce, when the aircraft touched down again, the pilot asked the passenger to apply the brakes “more firmly” than he had during the previous landings. The aircraft ran straight and slowed quickly, but the nose dropped and, although the pilot moved the control stick fully aft, the propeller made ground contact. According to the passenger, the aircraft then “flipped over quite slowly” and came to rest inverted, with the canopy broken into several pieces (Figure 2).

G-HCCF inverted and with a line attached in preparation for righting
