ACCIDENT

Aircraft Type and Registration:	Cameron Z-375 hot air balloon, G-VBFO	
No & Type of Engines:	None	
Year of Manufacture:	2008 (Serial no: 11135)	
Date & Time (UTC):	9 October 2017 at 1545 hrs	
Location:	Hyde Hill Farm, Royston, Hertfordshire	
Type of Flight:	Public Transport	
Persons on Board:	Crew - 2	Passengers - 12
Injuries:	Crew - None	Passengers - 1 (Serious)
Nature of Damage:	None	
Commander's Licence:	Commercial Pilot's Licence (Balloons)	
Commander's Age:	44 years	
Commander's Flying Experience:	1,498 hours (of which 400 were on type) Last 90 days - 31 hours Last 28 days - 7 hours	
Information Source:	Aircraft Accident Report Form submitted by the pilot and further enquiries by the AAIB

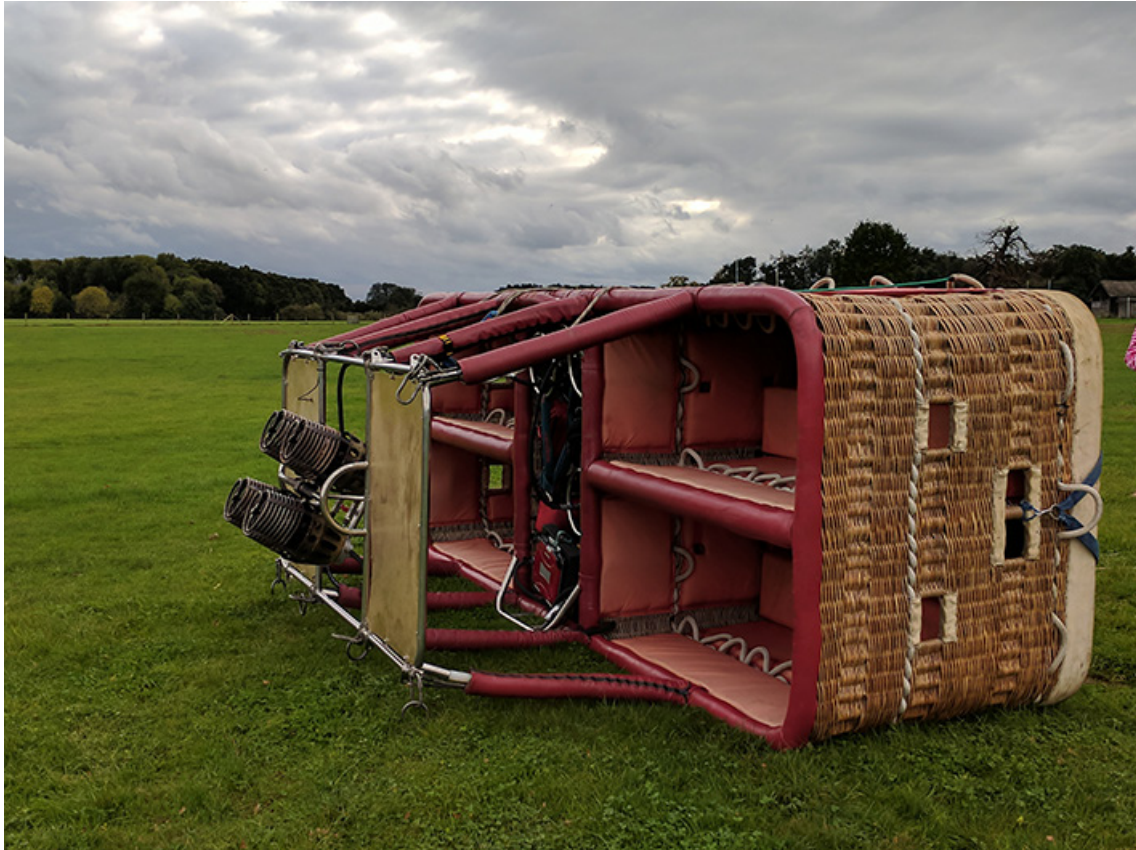
Figure 1

G-VBFO is a Cameron Z-375 hot air balloon. The basket has a central area for the pilot and four passenger compartments, two either side of the pilot (Figure 1). The operator's operations manual specifies that G-VBFO may carry a maximum of 18 occupants.

G-VBFO Basket before the flight

The compartment from which the passenger fell only had three occupants for this landing. If the balloon was full there would be four occupants in each compartment. Following the accident, the pilot observed that when four people occupy a compartment they are packed together tightly, which may prevent individuals from being thrown out in the event of a hard landing.

The injured passenger may have been ejected more easily because there were only three passengers in one of the compartments.
