**ACCIDENT**

<b>Aircraft Type and Registration:</b>	Whittaker MW6-S Fatboy Flyer, G-MYPP	
<b>No &amp; Type of Engines:</b>	1 Rotax 503 piston engine	
<b>Year of Manufacture:</b>	2007 (Serial no: PFA 164-12413)	
<b>Date &amp; Time (UTC):</b>	16 March 2018 at 1130 hrs	
<b>Location:</b>	Lenham Airstrip, near Ashford, Kent	
<b>Type of Flight:</b>	Private	
<b>Persons on Board:</b>	Crew - 1	Passengers - 1
<b>Injuries:</b>	Crew - None	Passengers - None
<b>Nature of Damage:</b>	Damage to one wing spar, both wing struts, fuselage tube, fuselage pod and windshield	
<b>Commander's Licence:</b>	Private Pilot's Licence	
<b>Commander's Age:</b>	59 years	
<b>Commander's Flying Experience:</b>	993 hours (of which 257 were on type) Last 90 days - 5 hours Last 28 days - 2 hours	
<b>Information Source:</b>	Aircraft Accident Report Form submitted by the pilot

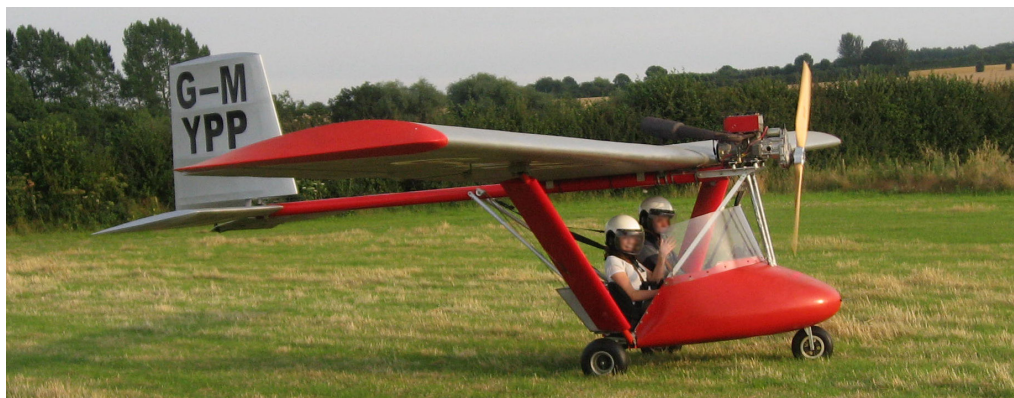
**Figure 1**

G-MYPP pictured prior to a previous flight

After the accident, the pilot discovered that a nipple on the throttle cable had detached, causing the engine to throttle back to idle. He noted that the aircraft (Figure 1), which had last flown four weeks previously, is a low inertia microlight and “does not have a great glide ratio”. He estimated that the elapsed time from the loss of power to impact was 10 seconds.
