*Ocean Way* – extract of Stability Booklet

***Report on aspects of the flooding  
which led to loss of FV 'Ocean Way'  
Marine Accident Investigation Branch***

***April 2017***

### Flooding and foundering of the trawler *Ocean Way* on 3 March 2017

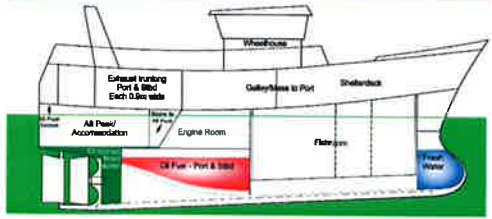
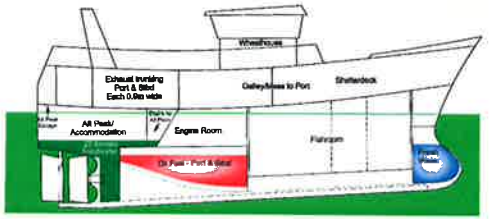
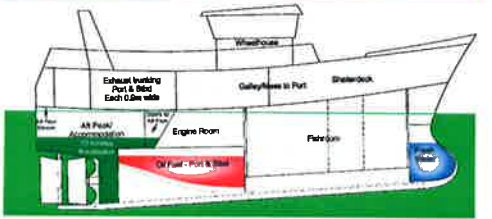
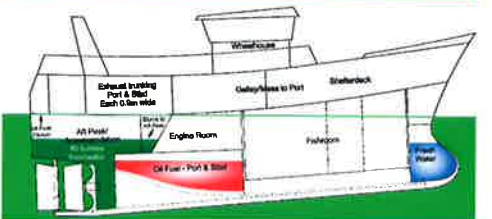
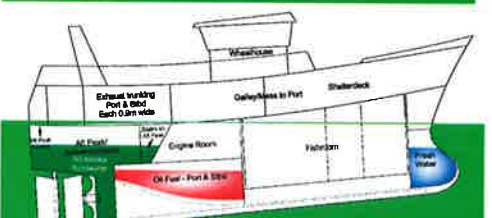
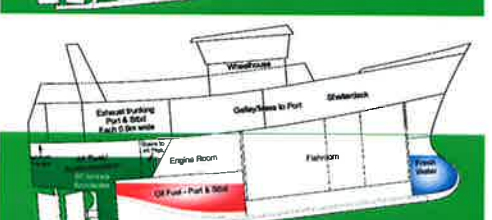
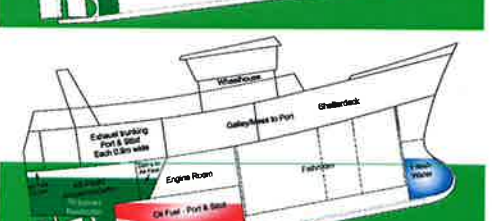
Diagram 5 – Flooding sequence

The diagrams below are snapshots of the aft peak flooding with related trim and stability data at 10 tonne floodwater increments from 0-70 tonnes. Appendix 3 lists the analysis data.

Draught forward .....: 4.364 metres about keel line  
 Draught t AP .....: 5.138 metres about keel line  
 Trim over LBP .....: 0.276 metres by bow  
 GMf upright .....: 0.599 metres  
 Equilibrium angle ....: 0 degrees  
 Floodwater depth ....: 0 metres

Draught forward .....: 4.251 metres about Base Line  
 Draught 1m fwd of AP ..: 4.231 metres about Base Line  
 Trim over LBP .....: 0.021 metres by bow  
 GMf upright .....: 0.524 metres  
 Equilibrium angle .....: 0 degrees  
 Floodwater depth .....: 3.48 metres (flooding via breach only)  
 Head difference .....: 1.71 metres

Draught forward .....: 4.156 metres about Base Line  
 Draught 1m fwd of AP ..: 4.399 metres about Base Line  
 Trim over LBP .....: 0.254 metres by stern  
 GMf upright .....: 0.483 metres  
 Equilibrium angle .....: 0 degrees  
 Floodwater depth .....: 3.75 metres (flooding via breach only)  
 Head difference .....: 1.50 metres

Draught forward .....: 4.048 metres about Base Line  
 Draught 1m fwd of AP ..: 4.578 metres about Base Line  
 Trim over LBP .....: 0.556 metres by stern  
 GMf upright .....: 0.381 metres  
 Equilibrium angle .....: 0 degrees  
 Floodwater depth .....: 4.01 metres (flooding via breach only)  
 Head difference .....: 1.42 metres

Draught forward .....: 3.913 metres about Base Line  
 Draught 1m fwd of AP ..: 4.768 metres about Base Line  
 Trim over LBP .....: 0.897 metres by stern  
 GMf upright .....: 0.291 metres  
 Equilibrium angle .....: 0 degrees  
 Floodwater depth .....: 4.26 metres (flooding via breach only)  
 Head difference .....: 1.35 metres

Draught forward .....: 3.765 metres about Base Line  
 Draught 1m fwd of AP ..: 5.010 metres about Base Line  
 Trim over LBP .....: 1.306 metres by stern  
 GMf upright .....: 0.170 metres  
 Equilibrium angle .....: 0 degrees  
 Floodwater depth .....: 4.51 metres (flooding via breach only)  
 Head difference .....: 1.30 metres

Draught forward .....: 3.582 metres about Base Line  
 Draught 1m fwd of AP ..: 5.339 metres about Base Line  
 Trim over LBP .....: 1.848 metres by stern  
 GMf upright .....: 0.015 metres  
 Equilibrium angle .....: 0 degrees  
 Floodwater depth .....: 4.74 metres (flooding via breach only)  
 Head difference .....: 1.31 metres

Draught forward .....: 2.100 metres about Base Line  
 Draught 1m fwd of AP ..: 5.642 metres about Base Line  
 Trim over LBP .....: 3.178 metres by stern  
 GMf upright .....: -0.241 metres  
 Equilibrium angle .....: 50.4 degrees  
 Floodwater depth .....: 4.98 metres (flooding via breach and escape hatch)  
 Head difference .....: 0.81 metres

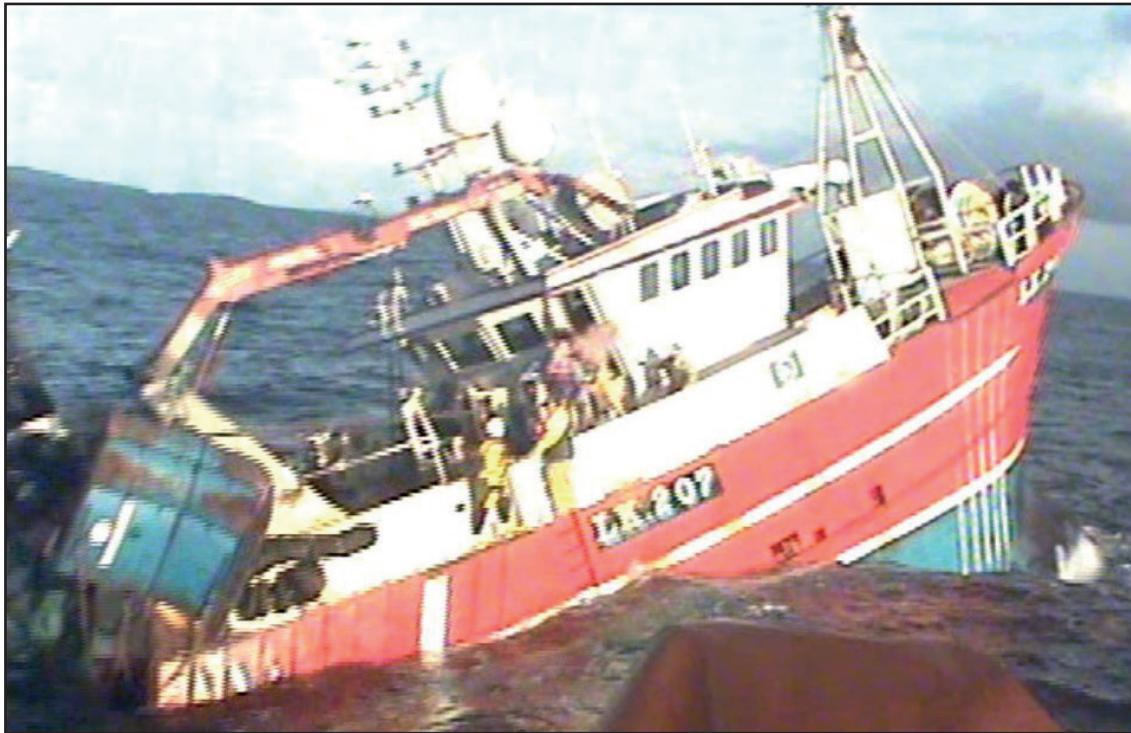
*Ocean Way* listing to port and trimmed by the stern just prior to foundering

At 0834 on 3 March 2017, the twin-rigged stern trawler *Ocean Way* foundered 18 nautical miles north-east of Lerwick, Scotland. *Ocean Way*'s crew was rescued uninjured and returned to shore by the Lerwick lifeboat. *Ocean Way* was lost because of an uncontrolled flood in the aft compartment; the source of the flood was almost certainly hull damage caused during the recovery of the port trawl door after the nets had been fouled on an obstruction.
